SERVICE No. 178 BULLETIN

SUBJECT: Safety Wiring of Control Tube Guide Blocks

MODELS AFFECTED: PA-24 and PA-24 "250"
Serial Nos. 24-80 to 24-1367 inclusive

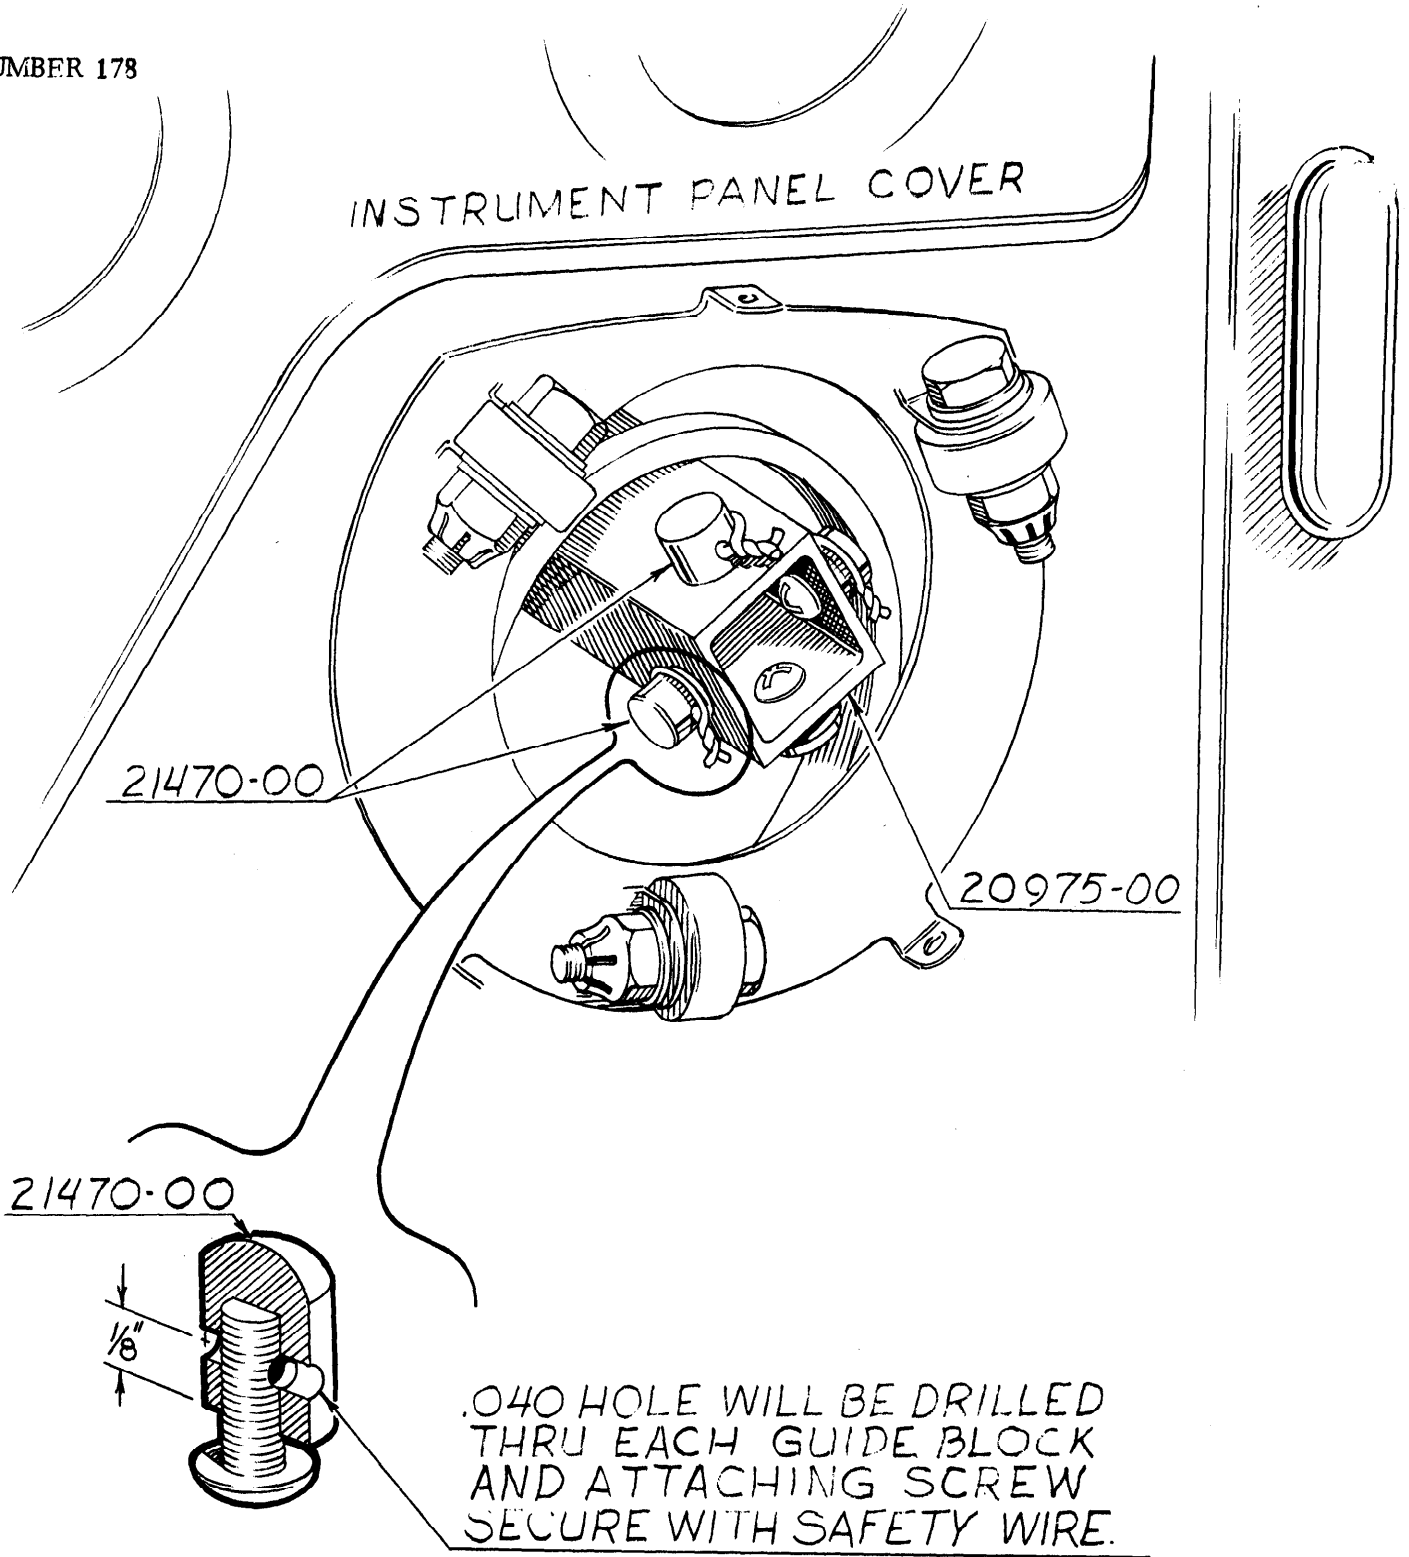
The four (4) nylon guide blocks, part number 21470-00, are attached by screws to each of the square control wheel shaft tube assembly, part number 20975-00.

To eliminate the possibility of these guide blocks loosening on the attaching screws, each control wheel assembly, part number 20965-00, must be removed. The nylon guide blocks will then be accessible.

Drill a .040 hole through each guide block and its attachment screw. Center the hole on the block and locate 1/8" from base. Attachment screws must be checked for tightness in guide blocks before drilling.

Route a piece of safety wire through the blocks or if more convenient, a separate piece of safety wire to each block.
