SERVICE No. 515 BULLETIN

Piper Aircraft Corporation

January 17, 1977

Control Cable Ball Joint Retainer Installation

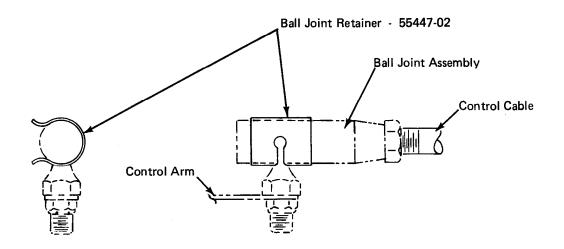
TYPICAL BALL JOINT RETAINER INSTALLATION

<u>Purpose:</u> There have been a few reports received from the field describing inadvertent detachment of the engine controls (i.e., throttle, prop governor and/or mixture) at the control cable ball joint attachment assembly. Failure of this ball joint assembly renders the particular control system inoperative. Although these ball joint attachment assemblies are subject to routine inspection, per published Piper inspection data, excessive wear - over a prolonged period of operation - in conjunction with inadequate inspection of this area - can permit detachment of the ball joint "ball" from its mating socket.

This service release announces availability of a safety device (retainer) that, when installed on the ball joint assembly, prevents disengagement of the ball from the socket (attached sketch/instruction sheet illustrates a typical ball joint assembly retainer installation).

1. Install ball joint retainer 55447-02, as shown above, to the control cable ball joint assemblies located in the engine compartment. See list below for appropriate model, control cable and quantity per airplane.

2. Install ball joint retainer 55447-02, as shown above, to the control cable ball joint assemblies located in the engine compartment and cockpit fuel control panel for the PA-31T. See list below for control cable and quantity.
