Piper Aircraft, Inc.
 2926 Piper Drive
 Vero Beach, FL, U.S.A. 32960

SERVICE NO. 1284B BULLETIN

LYCOMING SERVICE BULLETIN NO. 622A

DATE: March 13, 2019 Service Bulletin No. 622A
(Supersedes Service Bulletin No. 622)
Engineering Aspects are
FAA Approved

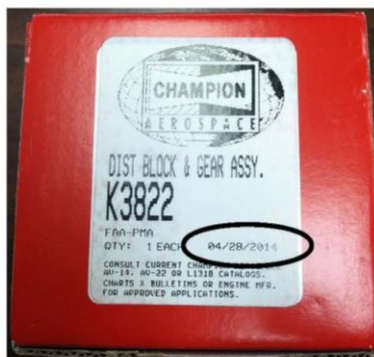
Figure 1. Replacement Kit Box Label Date Code

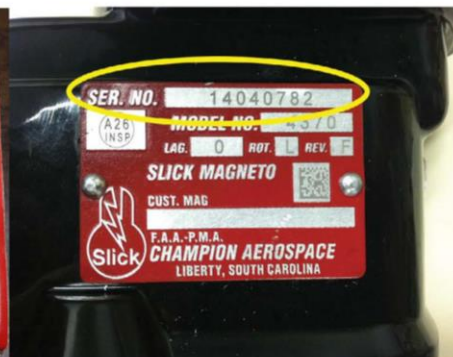
Figure 2. Magneto ID Label Date Code

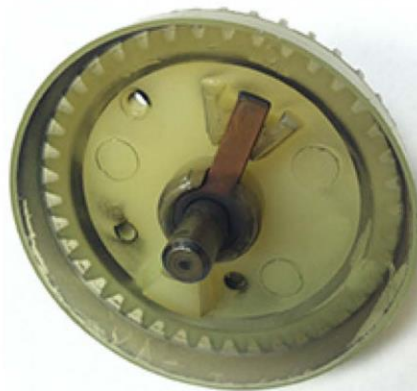
The initial release of SB1-15 was based on a limited number of field reports and product returns, Champion Aerospace has identified a possible condition in the distributor gear assemblies of 4-cylinder magnetos that can lead to decreased service life. Some of the returned products contained distributor gears exhibiting loosening of the electrode finger. This condition was observed in magnetos with a varying number of service hours. Typical symptoms are unusual RPM drop during magneto check, difficulty starting, and/or rough running engines.

Figure 3. Affected K3008 Distributor Gear With Copper Electrode

REMOVE affected distributor gear assembly in subject magnetos and REPLACE with replacement distributor gear assembly, K3008, as soon as possible, not to exceed the next 50 hours. Document Service Bulletin compliance as written entry in applicable Aircraft and/or Engine logbook.

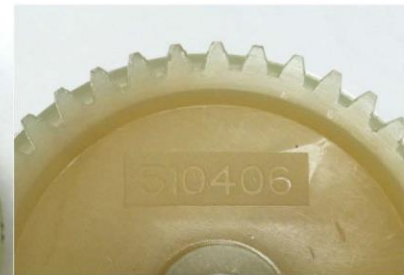
Figure 4. K3008 Distributor Gear Marked 510406 (Backside)

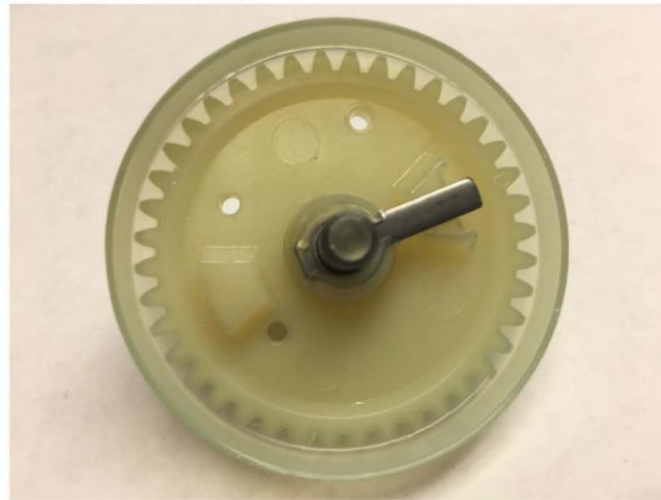
Figure 5. K3008 Distributor Gear With Monel Electrode
