SERVICE BULLETIN

No. 172

Piper Aircraft Corporation

SUBJECT: Inspection of Control Wheel Sprocket Mounting Hole
MODELS AFFECTED: PA-24 "180" and PA-24 "250" Equipped with a Piper AutoControl Serial Numbers 24-1 to 24-764 incl., 24-766 to 24-779 incl., 24-781 to 24-820 incl., 24-822 to 24-842 incl., 24-844 to 24-849 incl., 24-851 to 24-856 incl., 24-858, 24-860 to 24-865 incl., 24-867 to 24-871 incl., 24-875, 24-878, 24-880, 24-881 and 24-885.

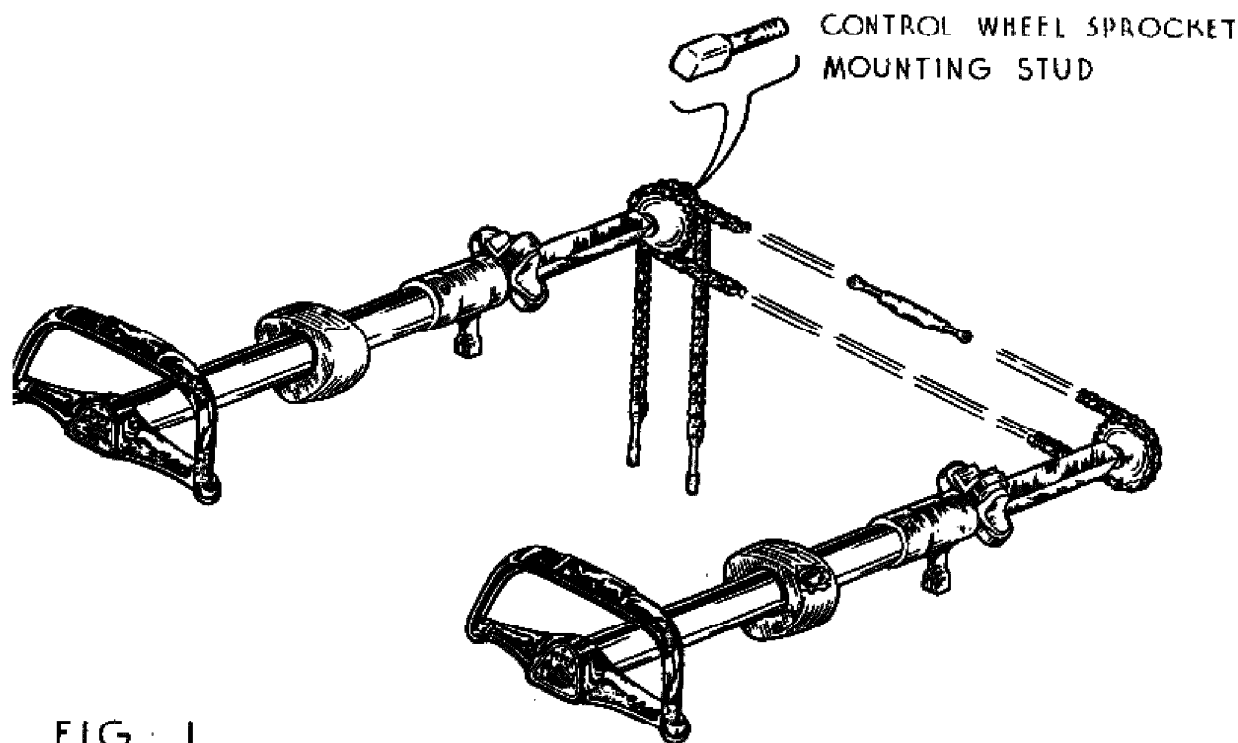
FIG. 1

There is a possibility that the control wheel sprocket mounting stud (See Figure 1 below), at the extreme forward end of the control wheel shaft, has been subjected to an unusual amount of torque due to the improper installation of the AutoControl servo motor drive pin. This condition must be inspected by June 30, 1959 on airplanes 24-1 to 24-102 inclusive on the right control wheel shaft and on airplanes 24-103 to 24-885 inclusive on the left control wheel shaft if an AutoControl is installed or has been installed at any time.

An inspection procedure for the removal and inspection of the control wheel sprocket mounting stud on the above mentioned airplanes is attached to this bulletin. Inasmuch as special wrench, part number 869 865, is needed to remove the sprocket from the mounting stud, it is suggested that you take your airplane to the nearest Piper distributor, dealer or Certified Service Center to have this inspection performed.
