# SERVICE BULLETIN

No. 173

Piper Aircraft Corporation  
F. A. A. Approved

SUBJECT: Aileron Balance Weight Attachment Bulkhead

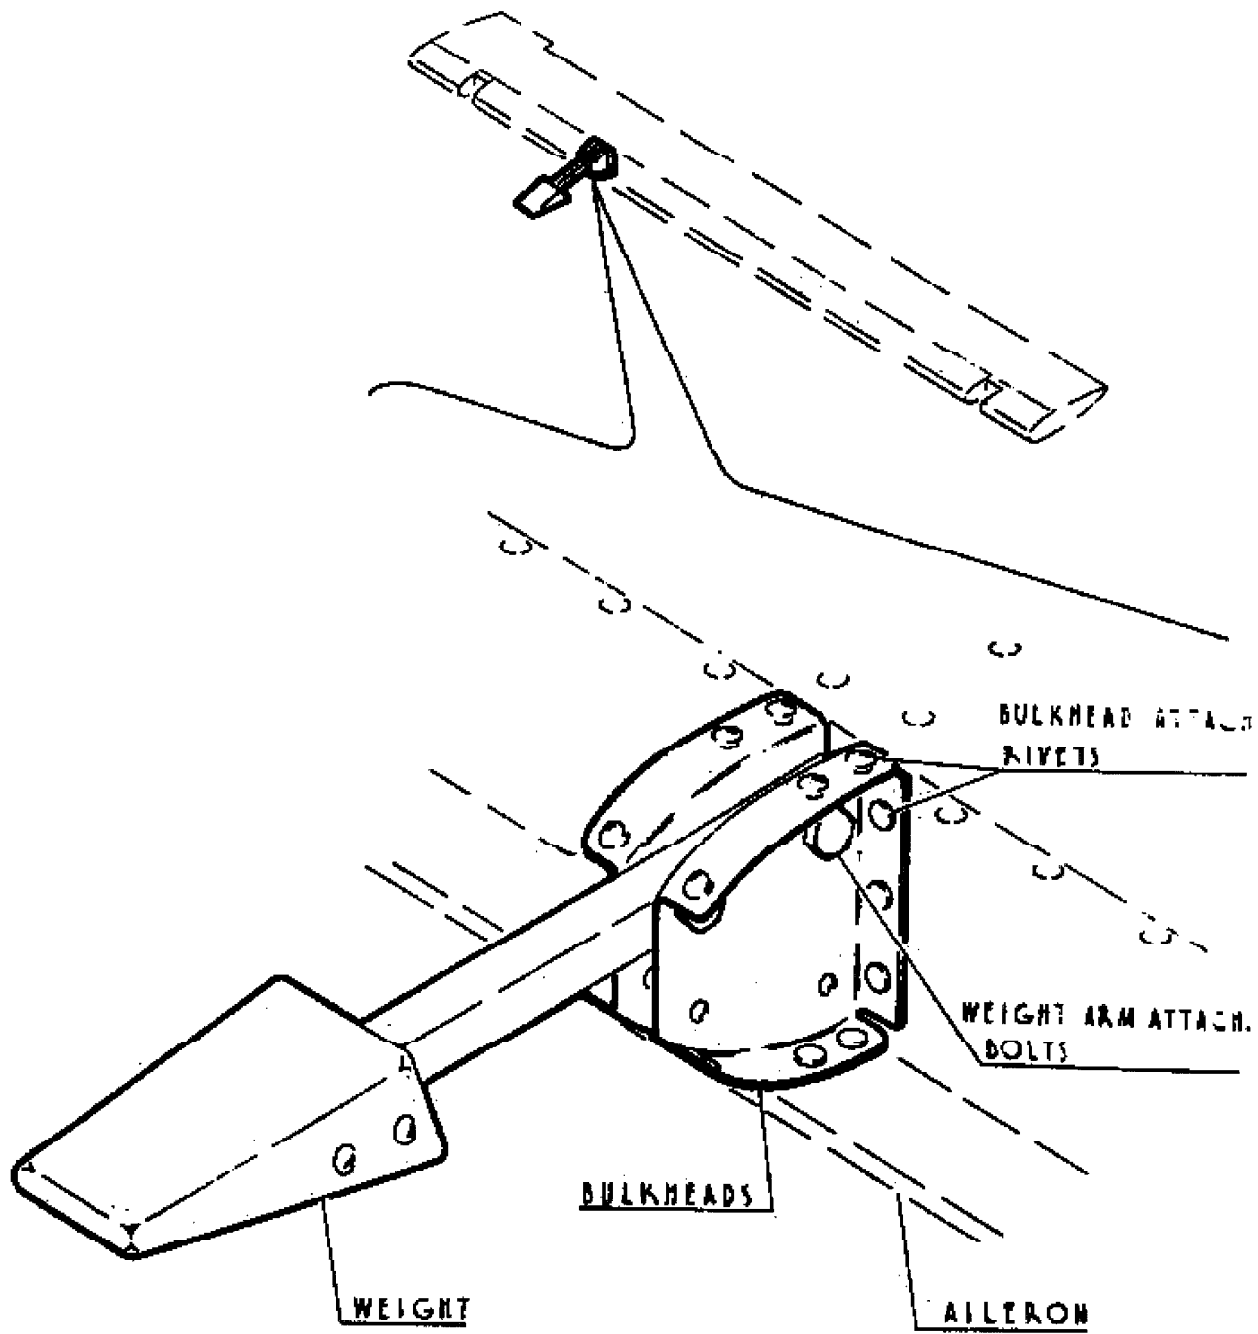
Several reports have been received by the Service Department that cracks have developed in the aileron balance weight attachment bulkheads. These bulkheads are riveted to the front spar of the aileron and are the support to which the balance weight arm is attached. See sketch below this bulletin.

This bulkhead, which has been re-designed to strengthen the area in which cracks have developed in the past, is now being used on current production airplanes.

At the next 100 hour inspection the two bulkheads on both ailerons must be replaced. Service kit, part number 754 233, is available from your nearest Piper distributor or dealer free of charge if the airplane serial number is included on the purchase order.

NOTE: Replace aileron balance weight attachment bulkheads on right aileron only on serial number 24-980.
