SERVICE No. 179 BULLETIN

SUBJECT: Refitting of Door Window

Piper Aircraft Corporation

MODELS AFFECTED: PA-24 and PA-24 "250"

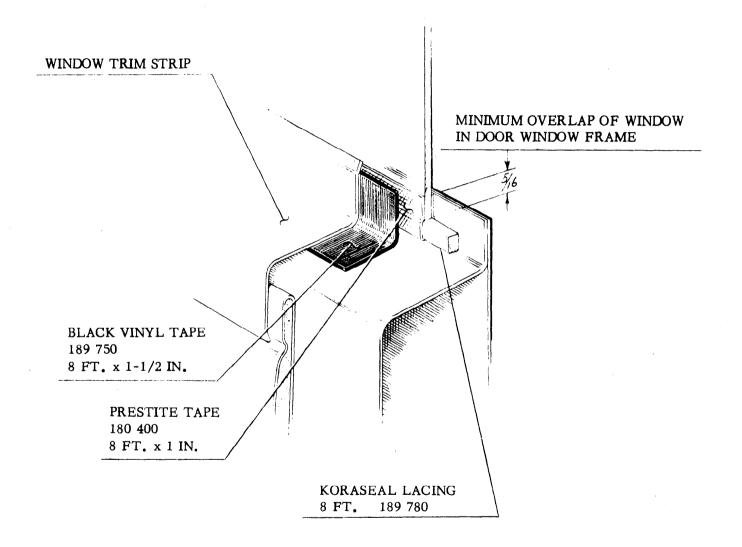
SERVICE BULLETIN Nº 179

The door windows on the Comanche, referred to by the above serial numbers, must be removed and refitted to insure a tighter fit within the door window frame.

The glass, when refitted, must extend into the door frame at least 5/16". This distance must be maintained around the entire window and is measured at the outside window frame. In the event that this measurement cannot be obtained, the Service Department should be advised.

- 1. Remove window trim mouldings.
- 2. Remove Vinyl and Presstite tapes holding window to door frame and remove window.
- 3. With the window removed, attach a length of Koraseal lacing to the edge of the window. The narrowest face of the Koraseal should be used against the window edge. Using a new strip of Presstite tape, center the glass in this tape to permit an equal amount of tape to extend onto both sides of the glass. The Koraseal will now remain in place. Install window with a new length of Vinyl tape over Presstite tape and install window moulding.

NOTE: Individual windows may vary in overall dimension. A full length of Koraseal may not be required to obtain 5/16" overlap of window in frame, others may require a little more.

See sketch on reverse side of this bulletin for part numbers and quantity of material required per airplane.
