SERVICE BULLETIN

No. 202

Piper Aircraft Corporation

SUBJECT: Inspection of Comanche Exhaust System
MODELS AFFECTED: PA-24 "250" Comanches - Serial Nos. 24-103 to 24-1629 inclusive
DATE OF COMPLIANCE: Prior to but not later than next 100 hour inspection

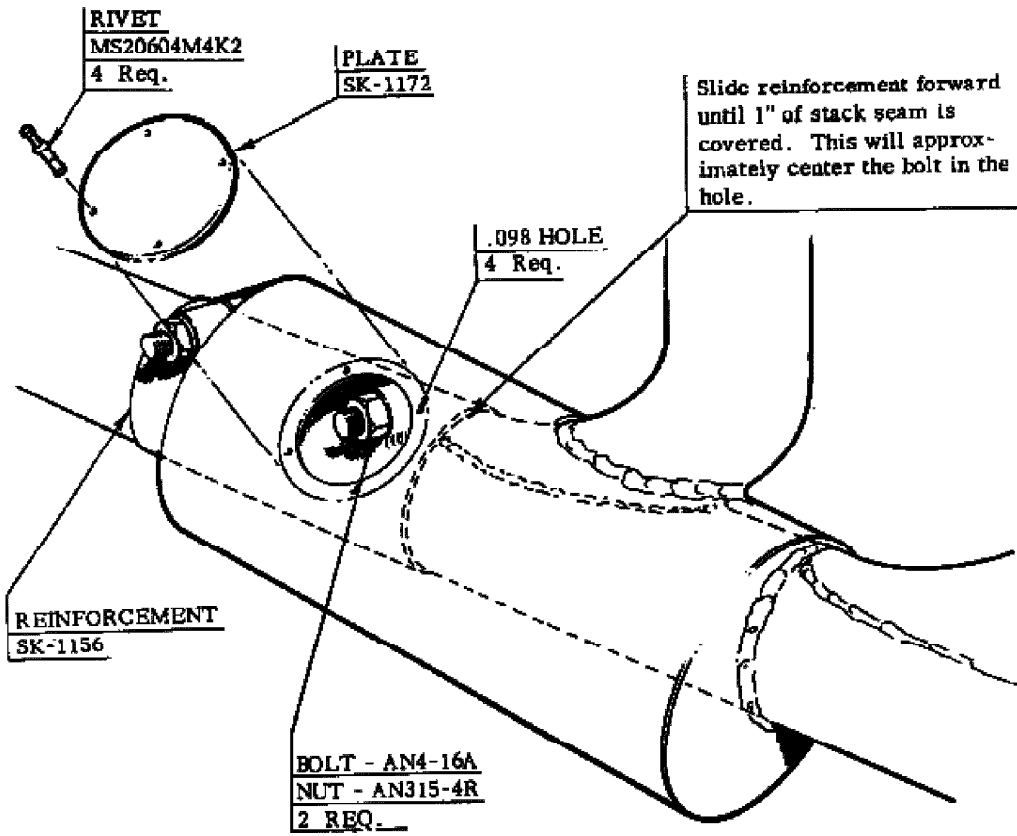
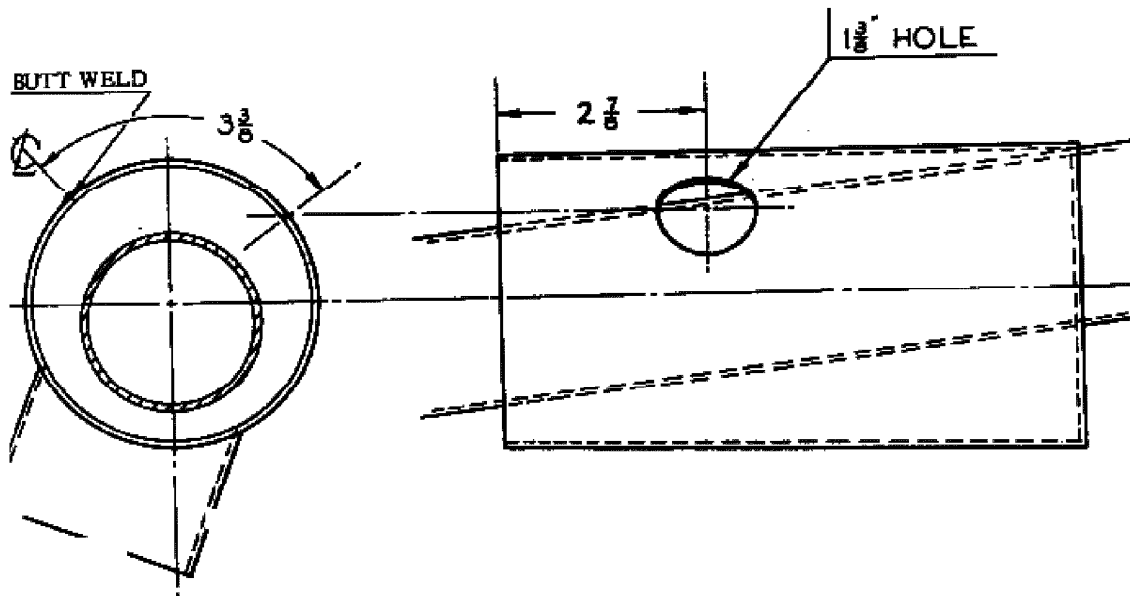
SKETCH "A"

Field service reports indicate that cracks have been appearing in the engine exhaust stack assembly, right side - Part Number 21664-03. It is requested these stacks be inspected for cracks or other indications of deterioration in the following manner:

1. Remove or loosen the shroud assembly.
2. Inspect the exhaust stack assembly for any indication of cracks or deterioration. A thorough examination of the area where the rear cylinder exhaust stack is welded to the exhaust stack assembly should be made. This assembly must be replaced immediately if this condition is noted.
3. Exhaust stacks that have the reinforcement plate welded to the stack in the area where Kit No. 754 396 is to be installed will not be affected by this Bulletin.
4. Stacks that do not have the reinforcement plate but are found to be in satisfactory condition shall be inspected each 50 hours of operation until reinforced with Kit No. 754 396. Installation of Kit No. 754 396 must be accomplished prior to but not later than the next 100 hour inspection. Refer to sketch below and instruction sheet.

3. Locate, mark and drill holes in stationary part of air shroud as per Sketch "A".
4. Make sure all metal filings are cleaned out of shroud before reassembly of air shroud

5. Install reinforcement on exhaust stack. Slide reinforcement forward until bolt is centered in hole cut in air shroud. This should move the reinforcement far enough forward to cover 1" of exhaust stack weld.

6. Torque nuts to 120 inch lbs. on the initial installation of the reinforcement. Run up the engine on the ground at 1500 RPM for five minutes. After ground run up torque nuts to 60 inch lbs.

7. Reassemble shroud, hook up air ducts and make another ground run up for five minutes at 1500 RPM. Again check nut torque value for 60 inch lbs. This procedure allows the reinforcement to seat on the stack assembly Stake bolt threads to safety nuts

8. After final torque check install repair plate Part No. SK-1172 as per Sketch "A".
