Piper Aircraft Corporation

SUBJECT: Gascolator Bowl Drain Valve

MODELS AFFECTED: PA-24 and PA-24 "250" Comanche Aircraft - Serial Numbers 24-2500 to 24-2700 inclusive

SERVICE BULLETIN #208

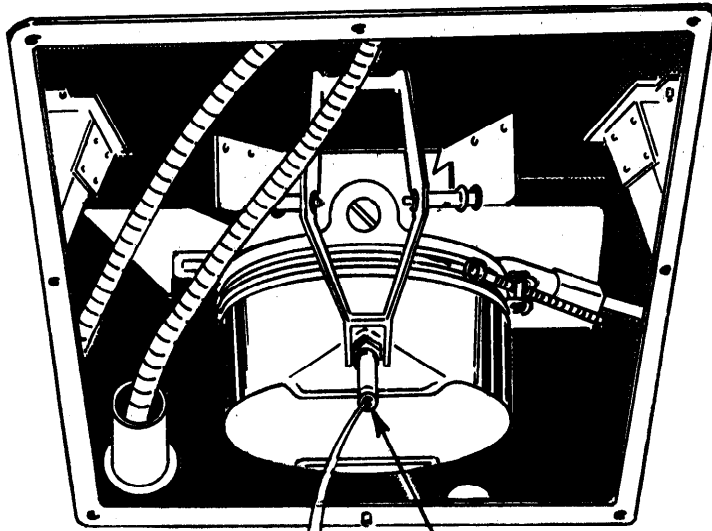
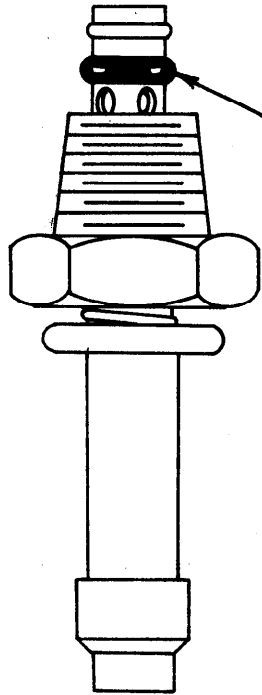
FUEL STRAINER DRAIN VALVE

The failures have occurred as a result of machining the valve. The longitudinal hole drilled through the stem has penetrated the stem too deeply; thus weakening the stem adjacent to the "O" ring. It is requested that the valves installed in the aircraft indicated by the above serial numbers be inspected in the following manner:

1. Remove the belly access panel at the drain valve.
2. Look into the longitudinal hole in the valve stem and note if the cross-drill marks resulting from the cross-drilling of the stem adjacent to the "O" ring are visible.

If the cross-drilling marks are observed, the valve may be considered satisfactory and no further action is required.

If the cross-drilling marks are not observed, the valve must be replaced.

All existing valves, part number 22179-00, now in distributor-dealer stocks must be inspected and replaced if incorrectly drilled.
