SERVICE BULLETIN

224
No.

Piper Aircraft Corporation

SUBJECT: Mitchell Bulletin No. A55 — Modification of Pitch Servo

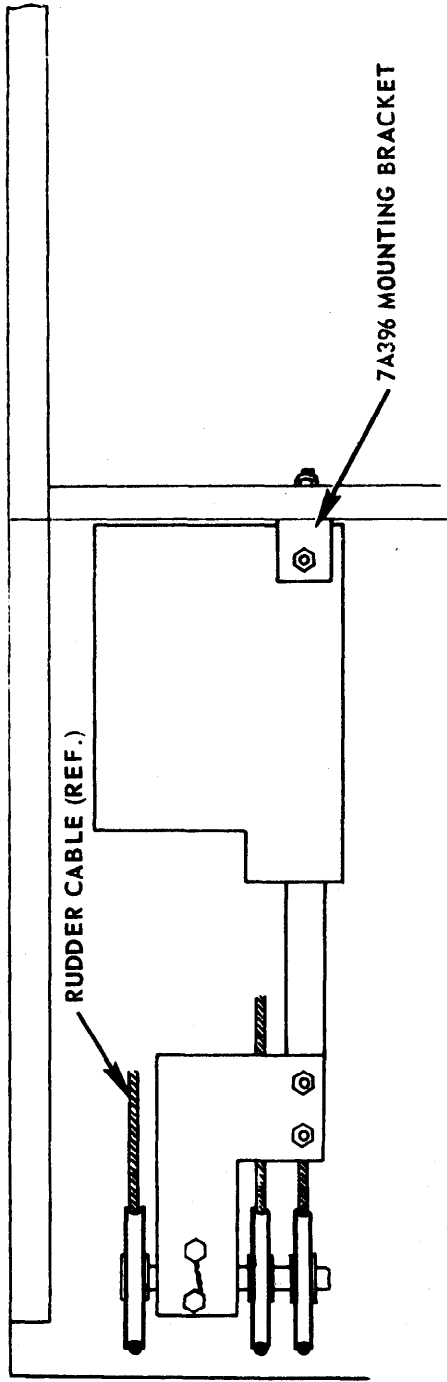
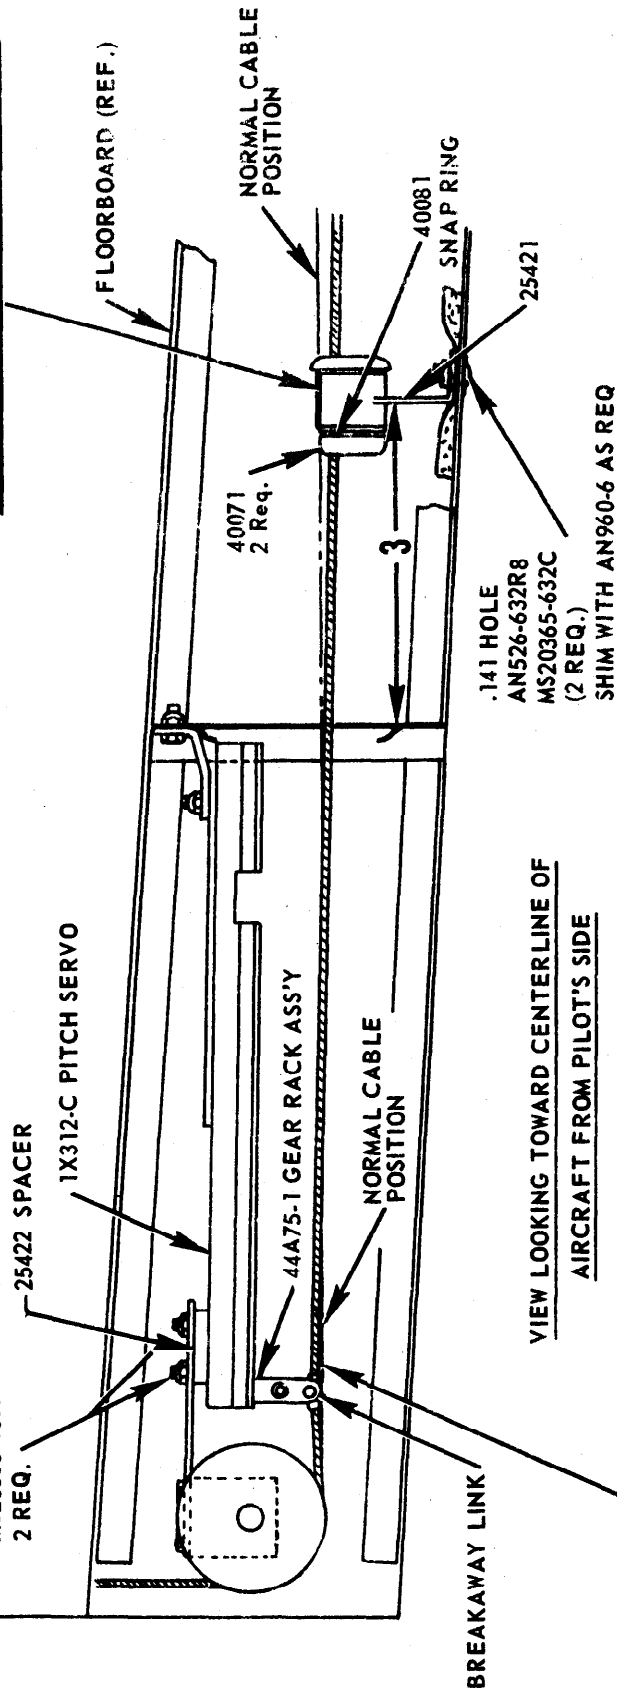
Cable must have upward deflection of 1/16" thru full travel of rack assy.

1. See Piper Electronic News Letter No. EL-48 for lubrication instructions
2. See attached sketch for details and installation of fairlead which is a part of this modification.

Install this bracket so the upper portion of the fairlead contacts the top of the cable. Use shim washers between skin and bracket to prevent cable deflection of more than 1/8 inch from its normal position.

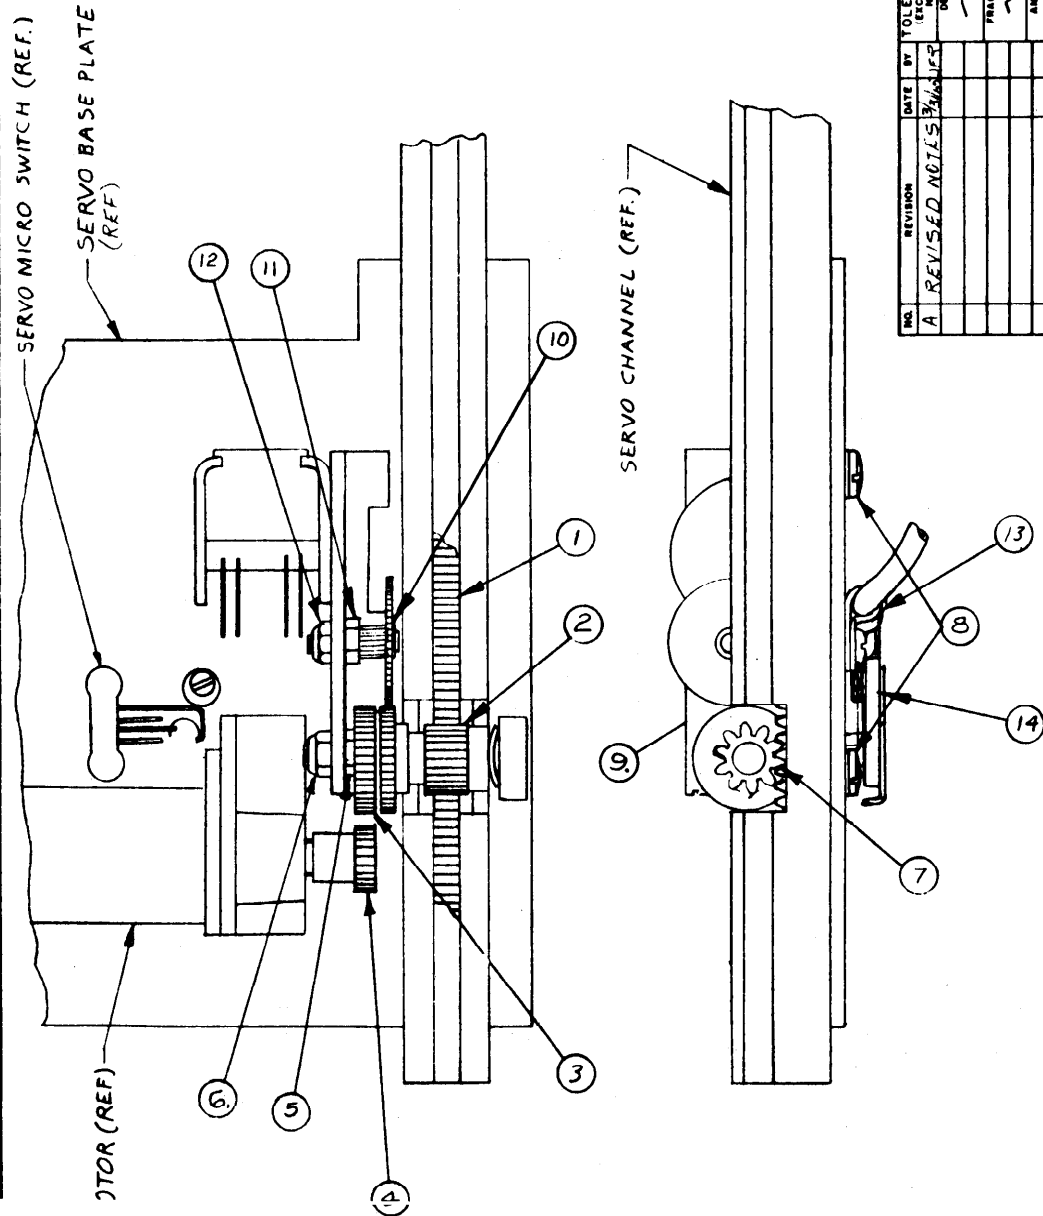
Inspection has revealed that the above pitch servo may have insufficient clearance for maximum safety between the rack post and stabilator cable after the "breakaway" ball is snapped out. To determine if this condition exists, remove scuff plate, carpet and inspection panel from floor below pilots rudder pedals. Snap cable ball free of servo and by moving control column full fore and aft, insure that ball does not catch or drag on servo post in any possible location along the post travel. If ball or cable tends to catch, replace servo rack gear and post assy. with P/N 44A75-1. (See attached Dwg)

1. Disengage servo motor to obtain clearance between motor gear (4) and gear train (3).
2. Slide gear rack (1) into servo channel and under pinion (2). Move gear rack to both extremities in small increments to determine if gap (7) has minimum backlash and rack is free from binding.

3. If not properly adjusted, loosen gear train lock nut (6) and using a 1/2" open end wrench no thicker than 1/16", rotate gear train cam (5) until gear rack (1) will slide freely into position under pinion (2).

4. Idler gear (10) may have to be repositioned to obtain adequate clearance for adjustment of gear train (3). Loosen lock nut (12) and rotate cam (11) to obtain clearance.

5. Adjust cam (5) for minimum backlash between pinion (2) and gear rack (1) without binding.
6. Repeat step 2. to insure proper pinion adjustment.
7. Tighten lock nut (6) while holding cam (5) with 1/2 x 1/16 wrench.

8. Readjust idler gear (10) for minimum backlash without binding to gear train (3) by rotating cam (11), then tighten lock nut (12) securely.
9. Engage motor and observe mesh between motor gear (4) and gear train (3).

10. Servo motor micro switch should make contact before gears (4) and (3) start to mesh. If necessary, gear train support bracket (9) may be adjusted in either direction by loosening clamp screws (8).

11. Recheck all above points after screws and nuts are tightened.
12. After installation in aircraft, the servo lever (13) travel and engage control knob on console may be coordinated by slipping cable housing in the appropriate direction thru housing clamp (14).

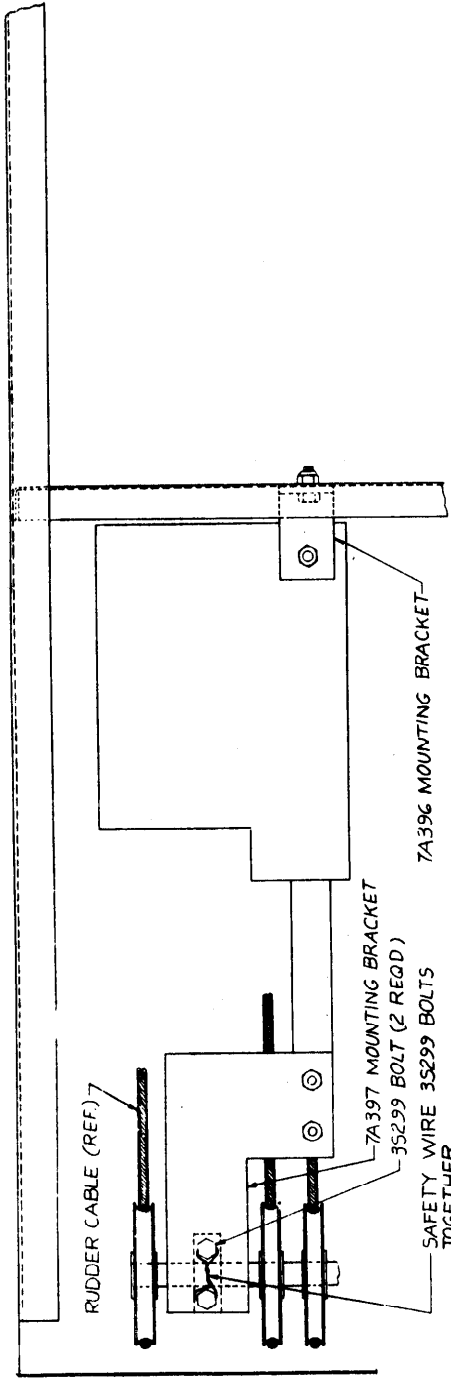
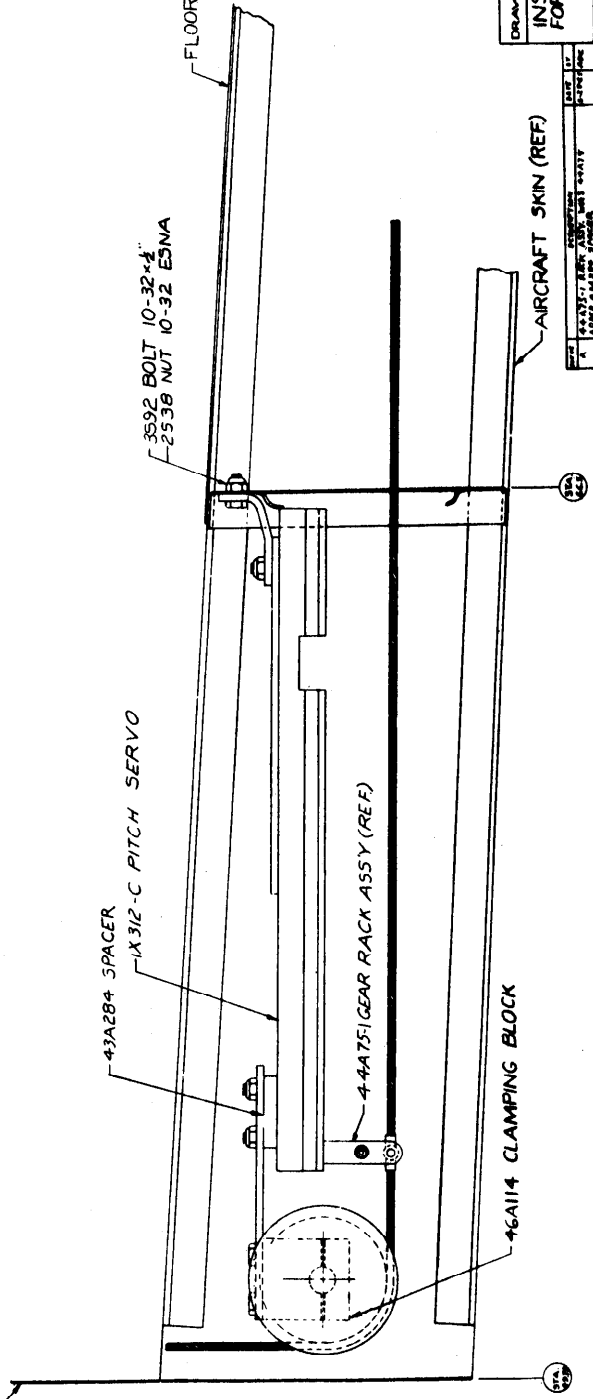
DRAWING NO: 69D326
 INSTALLATION DRAWING
 FOR PITCH SERVO IN
 PIPER ALTIMATIC II
 MITCHELL INDUSTRIES INC.
 MUNICIPAL AIRPORT
 MINERAL WELLS, TEXAS

There have been several reports of interference occurring between the pitch servo rack assembly and the screw heads of the AN510-10R16 screws that attach the forward end of the servo to the forward mounting bracket. These screw heads should be inspected to be sure they are flush.

- A. Remove Pitch Servo from aircraft and orient with adjustment Dwg. 12B20.
- B. With Servo motor disengaged, slide gear rack (1) out of servo channel pulling post out first.
- C. Using replacement gear rack P/N 44A75-1, install and adjust per Spec. Dwg. #12B20.
- D. Re-install servo in aircraft per Dwg. #69D326 using the longer mounting screws and spacer block furnished with kit.
- E. Before snapping cable ball into place on servo, insure that sufficient clearance is possible per instructions in first paragraph. Note: Cable must have upward deflection of at least 1/16" thru full travel of 44A75-1 rack assy. to engage in servo rack post cavity.
- F. Re-time pitch servo follow-up condenser per Piper EL-32A.
- G. Tag old gear rack assembly with pitch servo serial No. and return to Piper Aircraft Corp., Lock Haven, Pa.
- H. Make entry in aircraft log as to compliance with this bulletin.

If the screws are not flush, then the pitch servo spacer block, part number 25422 should be removed and the two (2) holes increased to 1/4" diameter. Any subsequent installation should have the holes in the pitch servo block, part number 25422, drilled to 1/4" before it is installed.
