SERVICE No.235 BULLETIN

Piper Aircraft Corporation

September 16, 1966

Standardization of Never-To-Exceed Airspeed Limit

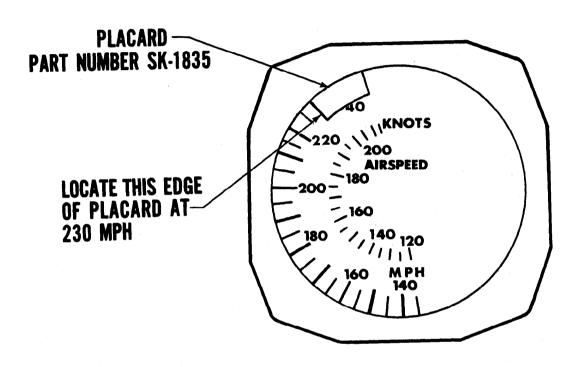
The installation of various optional equipment and S.T.C. approvals in the above referenced basic aircraft has made it desirable to standardize the never-to-exceed airspeed limit. The new never-to-exceed airspeed limit is 230 MPH.

A placard for the airspeed indicator, part number SK-1835, and a revised Flight Manual, Piper Report No. 1269 dated August 31, 1966 reflecting this change are available through your Piper distributor.

Information concerning the installation of the airspeed placard is contained on the sketch on the reverse side of this bulletin.
