# SERVICE No. 496 BULLETIN

Piper Aircraft Corporation

Stabilator Balance Weight Tube Replacement.

PA-24-250 Comanche

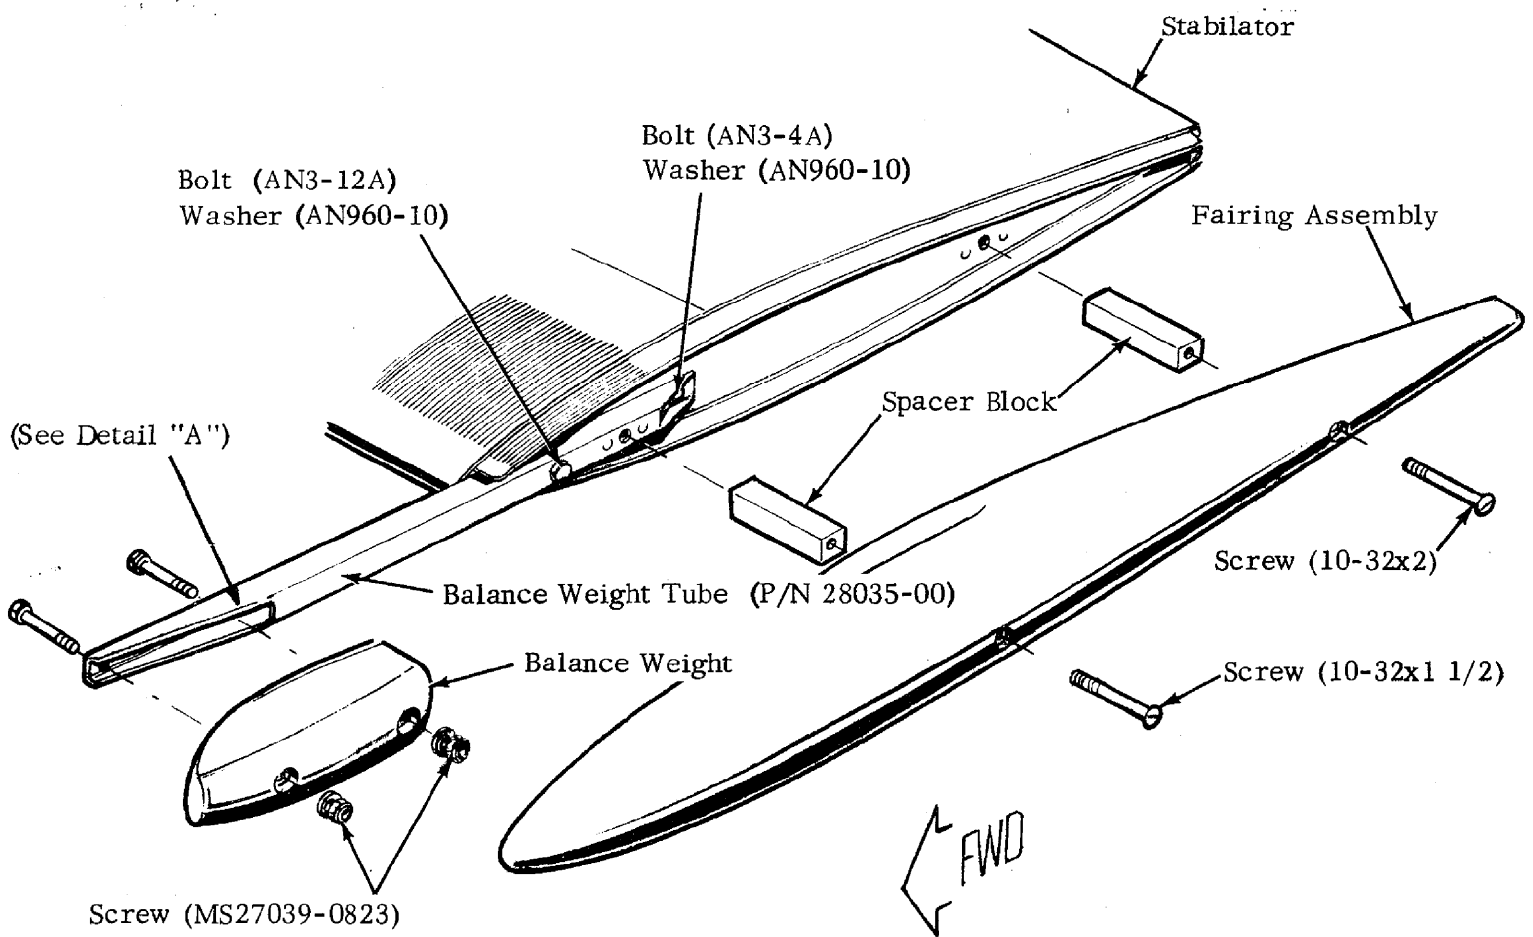
Detail "A" :

Piper Service Letter No. 687 dated June 19, 1974, announced the availability of Stabilator Modification Kit Piper Part Number 760 747 for the above referenced aircraft. Recent factory testing indicates that cracks may develop in the stabilator balance weight tube assembly (part number 28035-00, supplied with the above referenced modification kit) in the corners of the balance weight cutout.

Previous Tube - "squared" corners

New Tube - rounded cutout

This service release provides material to replace the stabilator balance weight tubes on aircraft that have had stabilator modification kit, Piper part number 760 747 previously installed. New stabilator balance weight tubes are provided and are redesigned with a reshaped balance weight cutout (radius cut corners) to preclude corner cracks.

1. Remove fairing assembly and balance weight from left and right stabilators.
2. Remove existing balance weight tubes and install new tubes P/N 28035-00.  
Torque bolts to 20-25 inch pounds.
3. Reinstall balance weight and torque screws to 7-9 inch pounds.
4. Reinstall fairing assembly.
5. Make appropriate log book entry.
