# SERVICE BULLETIN

No. 751

Piper Aircraft Corporation

Subject: Spar Cap Chafing Inspection

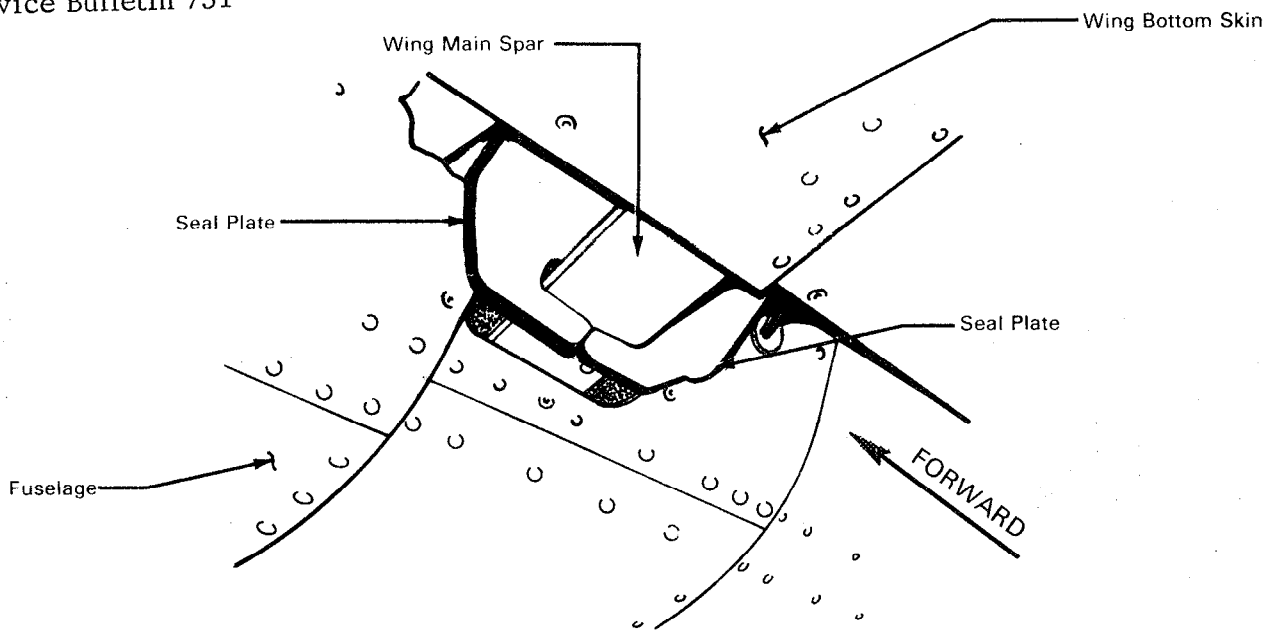
LEFT SIDE SHOWN

Several cases have been reported of chafing of the wing main spar lower cap where the spar enters the fuselage. This is caused either by deterioration of the rubber baffle material attached to the front and rear seal plates or by improper re-installation of the subject plates. Either situation may allow the seal plates to contact and chafe the lower spar cap.

1. Obtain access to the affected area of the lower spar cap by removing the lower wing root fairing.
2. With reference to the attached sketch, trim off the lower portion of each seal plate using a pair of aviation sheet metal shears.
3. Visually inspect both the upper and lower surfaces of the bottom spar cap where it passes through the seal plates. A mirror and flashlight will be necessary to properly inspect the upper surface. If no chafing is found, no further action is required.
4. If chafing is evident, perform a dye penetrant check of the chafed area. Provided no cracks are found, the chafed area should be polished to a smooth contour with progressively finer grades of "wet or dry type" emery paper. Final polishing should be accomplished with a 400 or 600 grade paper. The depth of the contoured area after smoothing and polishing

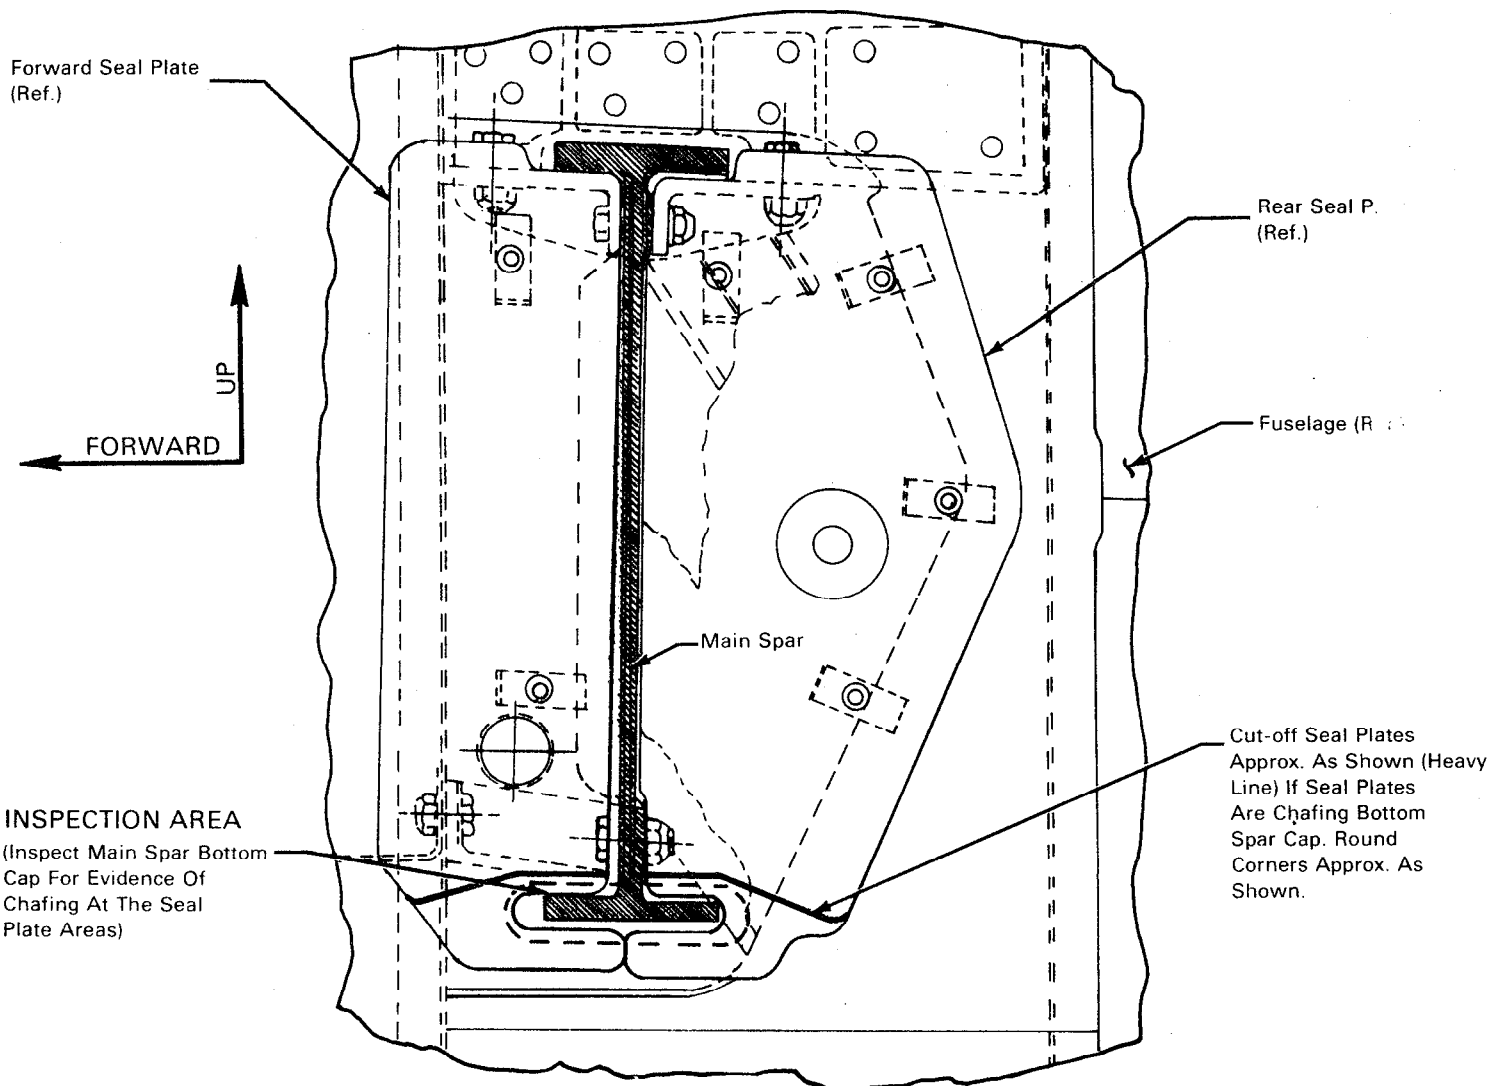
LEFT SIDE SHOWN, RIGHT SIDE OPPOSITE

**INSPECTION AREA**  
(Inspect Main Spar Bottom Cap For Evidence Of Chafing At The Seal Plate Areas)

should not exceed the values in the Table of Limits, below. If the depth exceeds those in the Table of Limits, the affected parts must be replaced.
