Service Letter No. 207

June 18, 1953

SUBJECT: Oil Quick Drain Valve Assembly, Part Number 12956-04

MODELS AFFECTED: All Models incorporating the use of the above valve

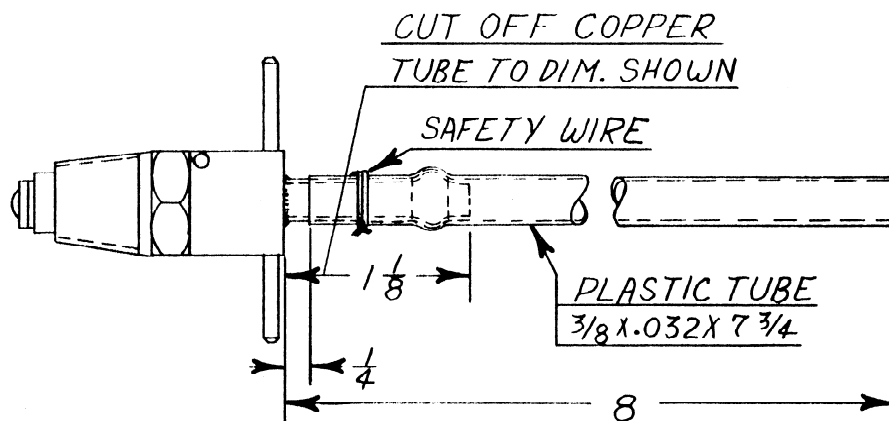
It has been brought to our attention that vibration has caused the quick oil drain valve to break at the rubber washer seal and also at the point where the copper drain tube is soldered.

To eliminate this condition it is recommended that the valve be modified in accordance with the sketch shown below. The plastic tube may be obtained from the Service Department of the Piper Aircraft Corporation on a No Charge basis. This plastic tube will be furnished on a No Charge basis until June 1, 1954.
