Service Letter No. 339

July 12, 1960

SUBJECT: Insulation of Wiring at Starter Solenoid Switch

MODELS AFFECTED: PA-24 and PA-24-250 Comanches
Serial Numbers 24-1 to 24-1881 inclusive, 24-1883 to 24-1919 inclusive, 24-1921 to 24-1932 inclusive, 24-1934 to 24-1962 inclusive, 24-1964 to 24-1981 inclusive, 24-1983 to 24-1987 inclusive, 24-1989 to 24-2001 inclusive, 24-2003 to 24-2006 inclusive, 24-2008 to 24-2010 inclusive, 24-2012 to 24-2021 inclusive, 24-2023 to 24-2026 inclusive, 24-2028 to 24-2030 inclusive, 24-2032, 24-2033, 24-2035, 24-2037 to 24-2040 inclusive, 24-2042 to 24-2044 inclusive, 24-2046 to 24-2069 inclusive, 24-2071 to 24-2078 inclusive, 24-2080 to 24-2085 inclusive, 24-2087 to 24-2092 inclusive, 24-2094 to 24-2105 inclusive, 24-2107 to 24-2109 inclusive, 24-2113 to 24-2118 inclusive, 24-2120, 24-2122, 24-2123, 24-2125, 24-2128 to 24-2132 inclusive, 24-2134, 24-2135.

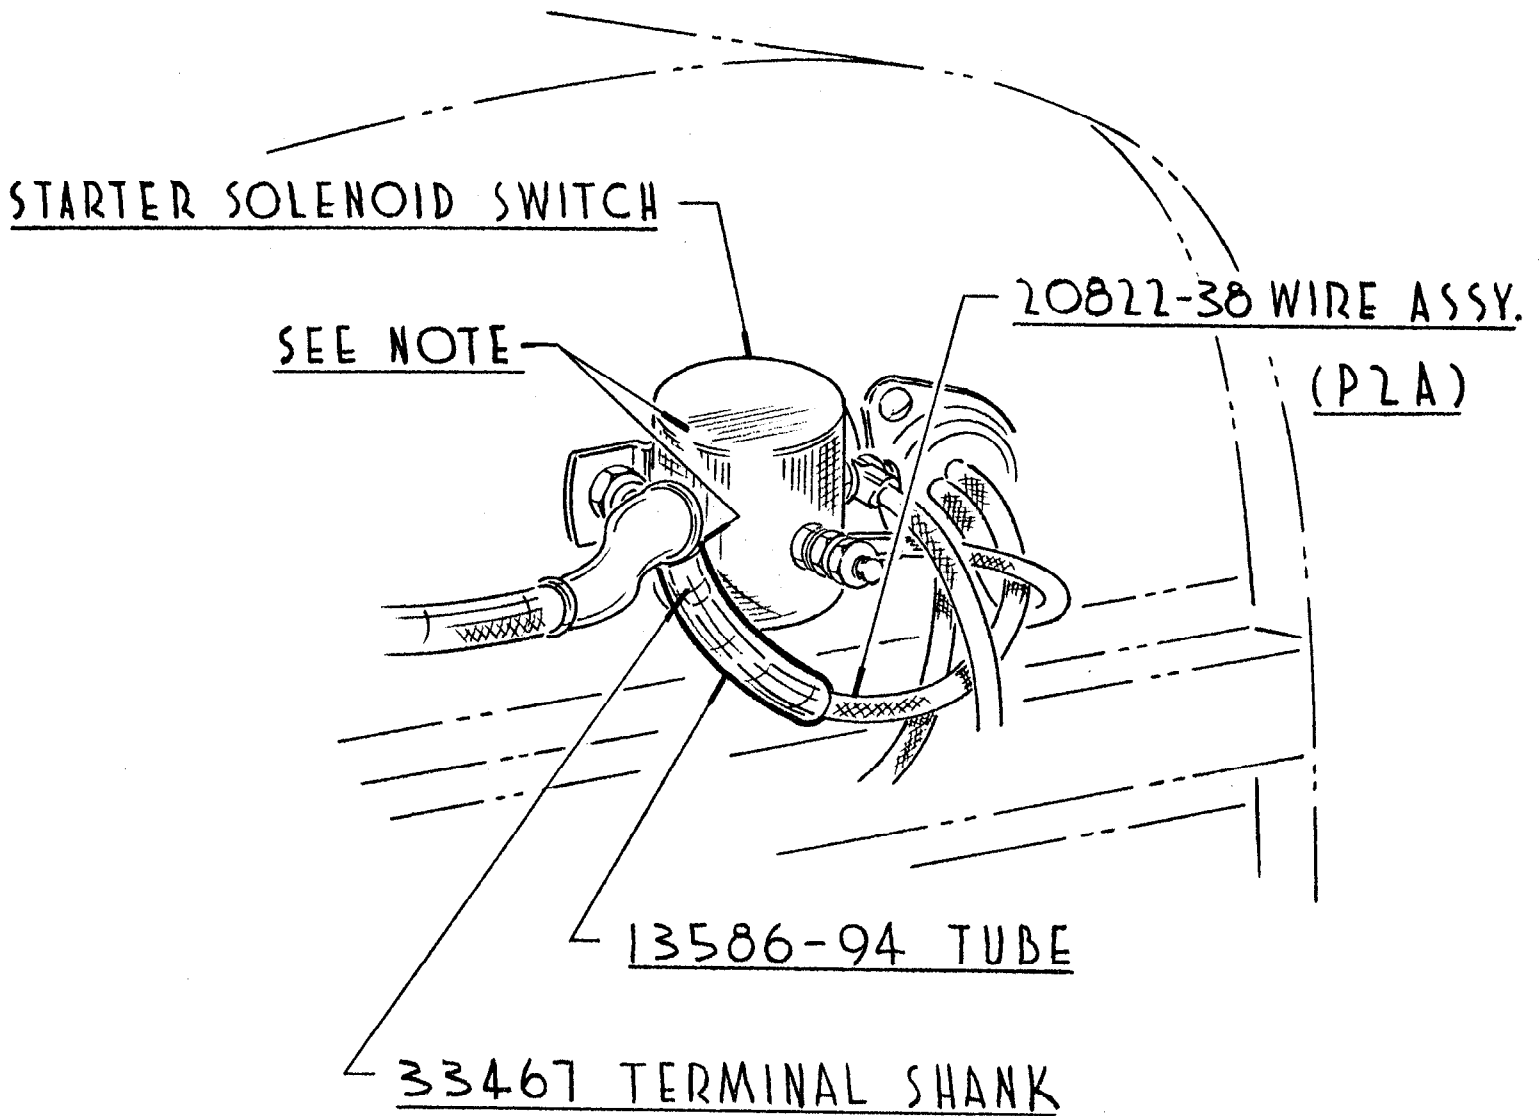
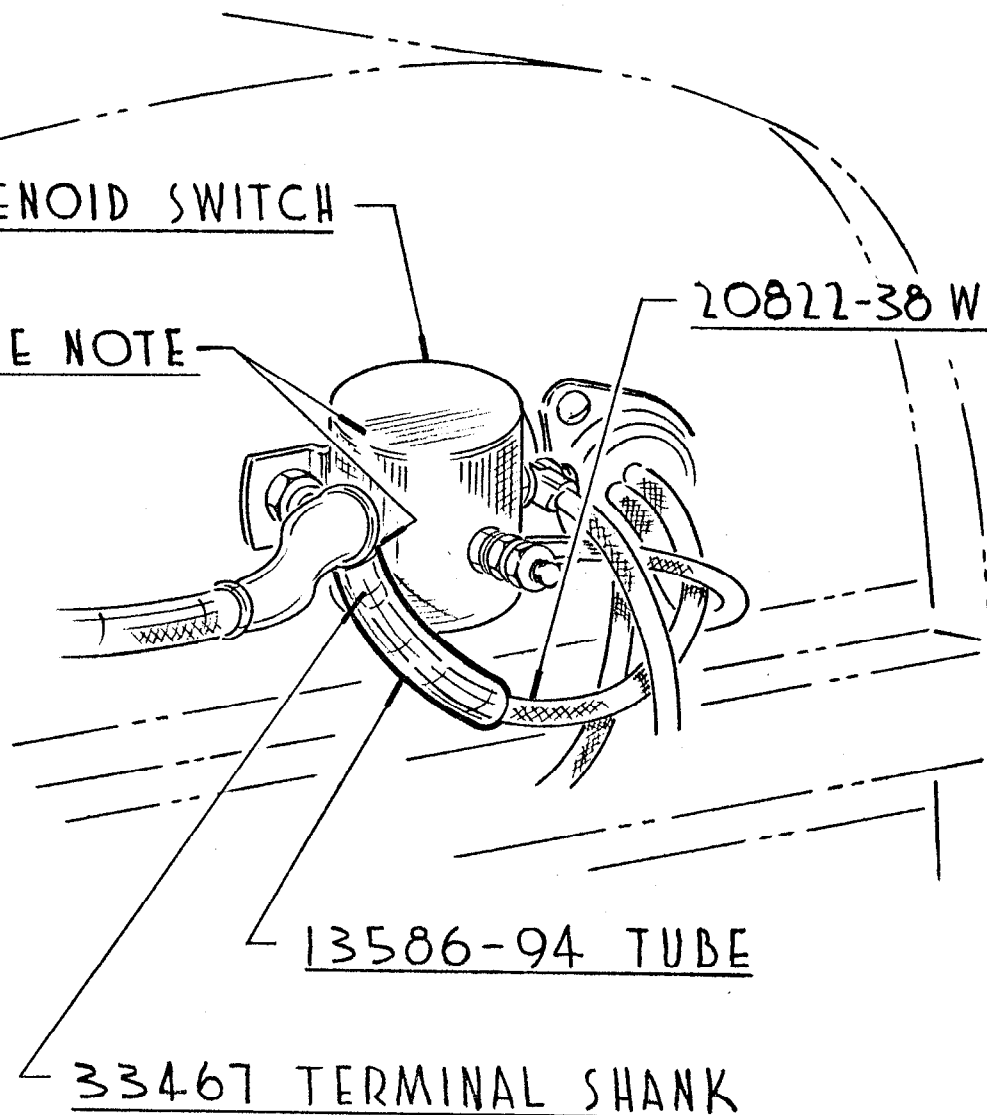
INSTALL TERMINAL TO PROVIDE MAX. CLEARANCE
BETWEEN TERMINAL SHANK & SOLENOID HOUSING

1. A piece of plastic insulating tubing, part number 13586-94, two inches long shall be installed over part number 33467, terminal shank, on wire assembly, part number 20822-38.
2. The subject terminal, part number 33467-00, located on the right side of the starter solenoid switch on the forward side of the firewall shall be installed in such a manner as to provide maximum clearance between the terminal shank and the solenoid housing.

The wire assembly, part number 20822-38 installed on Serial Numbers 24-1 to 24-102 inclusive, is of a smaller diameter than those used on succeeding aircraft. The insulated tubing supplied would be of a slightly larger diameter. These must be secured at each end.
