Service Letter No. 347

SUBJECT: Installation of Dry Vacuum Pump Exhaust Tube

MODELS AFFECTED: PA-24 and PA-24-250 Comanches - Serial Nos. 24-2176, 24-2177, 24-2179 to 24-2184 inclusive, 24-2186 to 24-2202 inclusive, 24-2204 to 24-2218 inclusive and 24-2222.

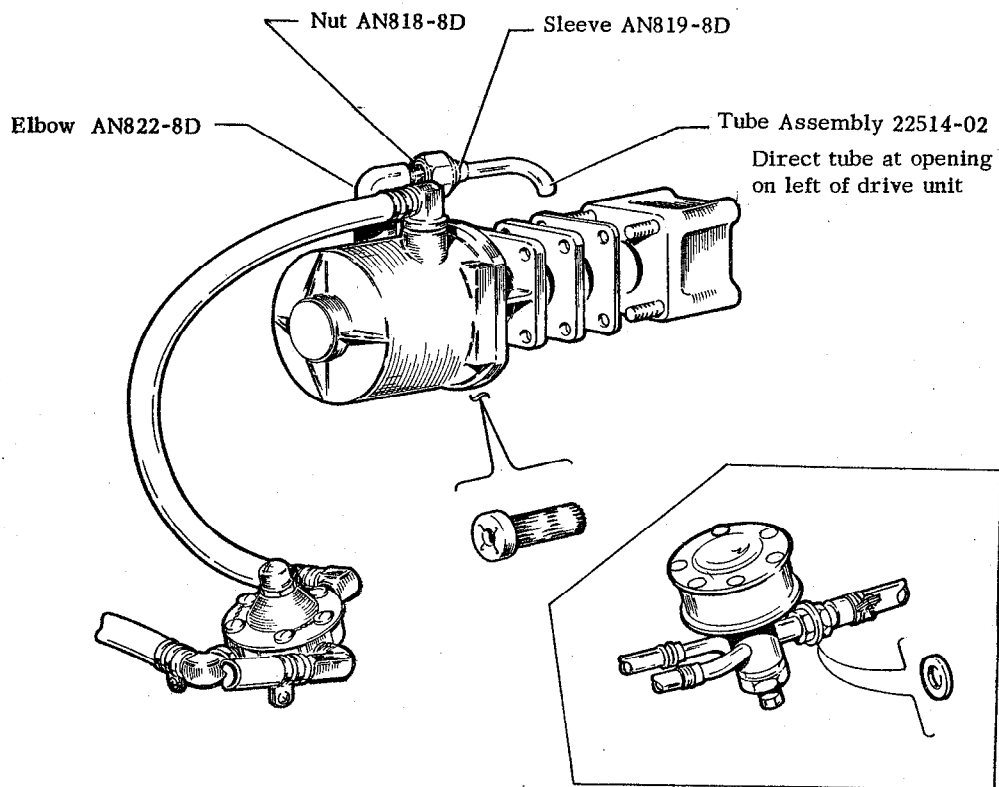
We have been advised that during maintenance operations, where cleaning solvents are used to wash the engine and engine components, these solvents in a few instances have found their way into the vacuum pump via the exhaust vent on top of the pump. The introduction of this fluid to the pump has resulted in its malfunction. In order to prevent this fluid from entering the pump, an exhaust tube shall be installed.

The subject aircraft shall be modified by the installation of Kit No. 754 358. The sketch on the reverse side may be referred to for further details.

Remove cap and fitting  
supplied with pump and  
replace with AN822-8D  
elbow and tube assembly
