Service Letter No. 352

SUBJECT: Modification of Windshield Defroster System

MODELS AFFECTED: PA-24, PA-24-250 Comanches, Serial Nos. 24-2299 to 24-2338, 24-2340, 24-2341, 24-2342, 24-2344 to 24-2360 inclusive, 24-2363 to 24-2369 inclusive, 24-2371 to 24-2379 inclusive, 24-2381, 24-2383 to 24-2396 inclusive, 24-2398, 24-2399, 24-2400, 24-2402, 24-2405, 24-2406, 24-2409, 24-2411 and 24-2412.

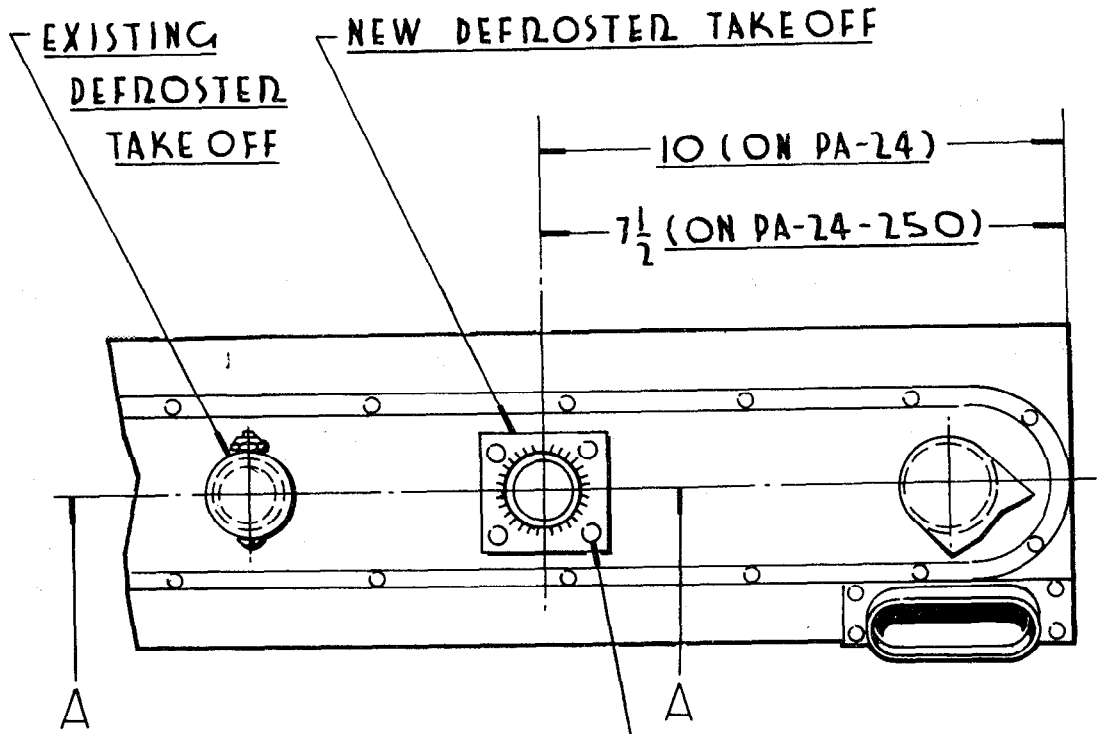
SERVICE LETTER NO 352

The defroster system as installed on the subject airplanes is capable of delivering hot air to the windshield at a temperature high enough to distort the windshield glass if used on a warm day.

The modification of these defroster systems may be accomplished by referring to the sketch on the reverse side of this Service Letter.

1/4 HOLE (IN DUCT + HOUSING)
(USE EXTREME CAUTION TO
AVOID PUNCTURE OF MUFFLER)
