Service Letter No. 364A (Supersedes No. 364)

SUBJECT: Detached or Loose Rubatex Blocks in Wing Panels

MODELS AFFECTED: PA-24 and PA-24 "250" Comanches - Serial Nos. 24-1 to 24-2264 inclusive

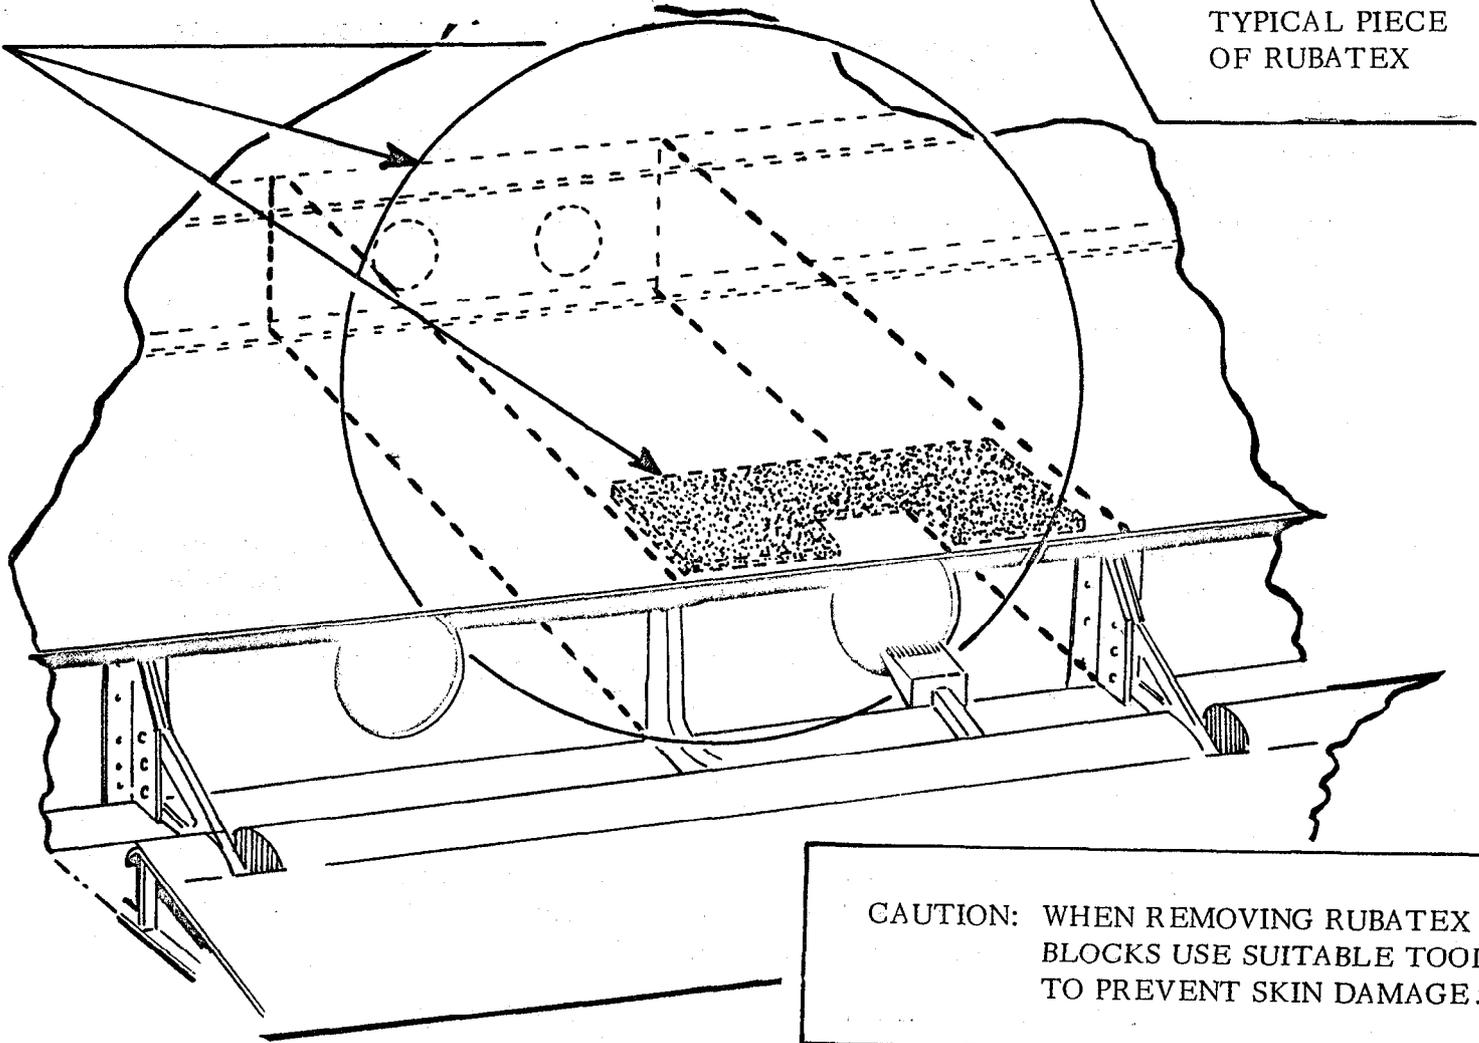
SERVICE LETTER NO 364 A

Rubatex blocks were used in a few instances to reduce the tendency of oil canning in the areas of the wing panels, as shown on the sketch on the reverse side of this Service Letter. Prior to but not later than the next 50 hours of operation, this entire area on both wings must be inspected and where these blocks are observed either loose or attached, they are to be removed.

REMOVE ALL RUBATEX FOUND IN
THIS AREA - UPPER AND LOWER SKINS

TYPICAL PIECE
OF RUBATEX

CAUTION: WHEN REMOVING RUBATEX
BLOCKS USE SUITABLE TOOL
TO PREVENT SKIN DAMAGE.
