Service Letter No. 370

SUBJECT: Modification to Engine Breather Line

MODELS AFFECTED: PA-24 and PA-24 "250" Comanches - Serial Numbers 24-2175, 24-2299 to 24-2675 incl., 24-2677 to 24-2801 incl., 24-2803, 24-2804, 24-2806, 24-2808 to 24-2888 incl., 24-2890 to 24-2935 incl., 24-2937, 24-2939 to 24-2943 incl., 24-2945 to 24-2948 incl., 24-2950 to 24-2956 incl., 24-2958 to 24-2966 incl., 24-2969 to 24-2982 incl., 24-2984, 24-2986 to 24-2989 incl., 24-2991, 24-2992, 24-2994 to 24-3005 incl., 24-3007 to 24-3009 incl., 24-3011, 24-3012, 24-3014, 24-3016, 24-3018, 24-3020 to 24-3023 incl., 24-3027 to 24-3040 incl., 24-3042, 24-3043, 24-3046 to 24-3049 incl., 24-3052, 24-3055, 24-3059, 24-3060, 24-3062, 24-3068.

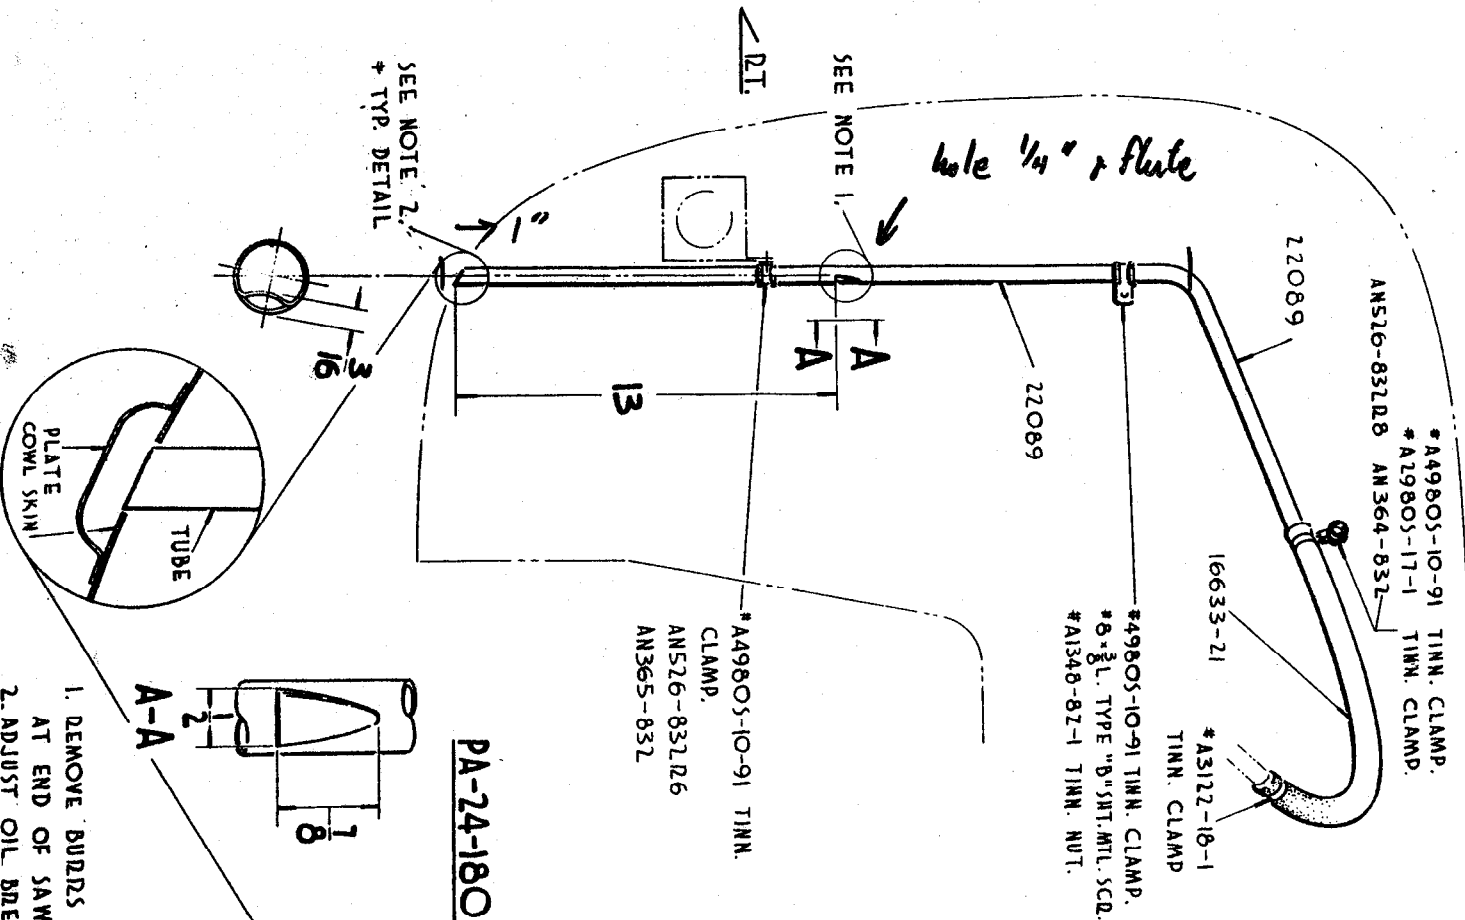
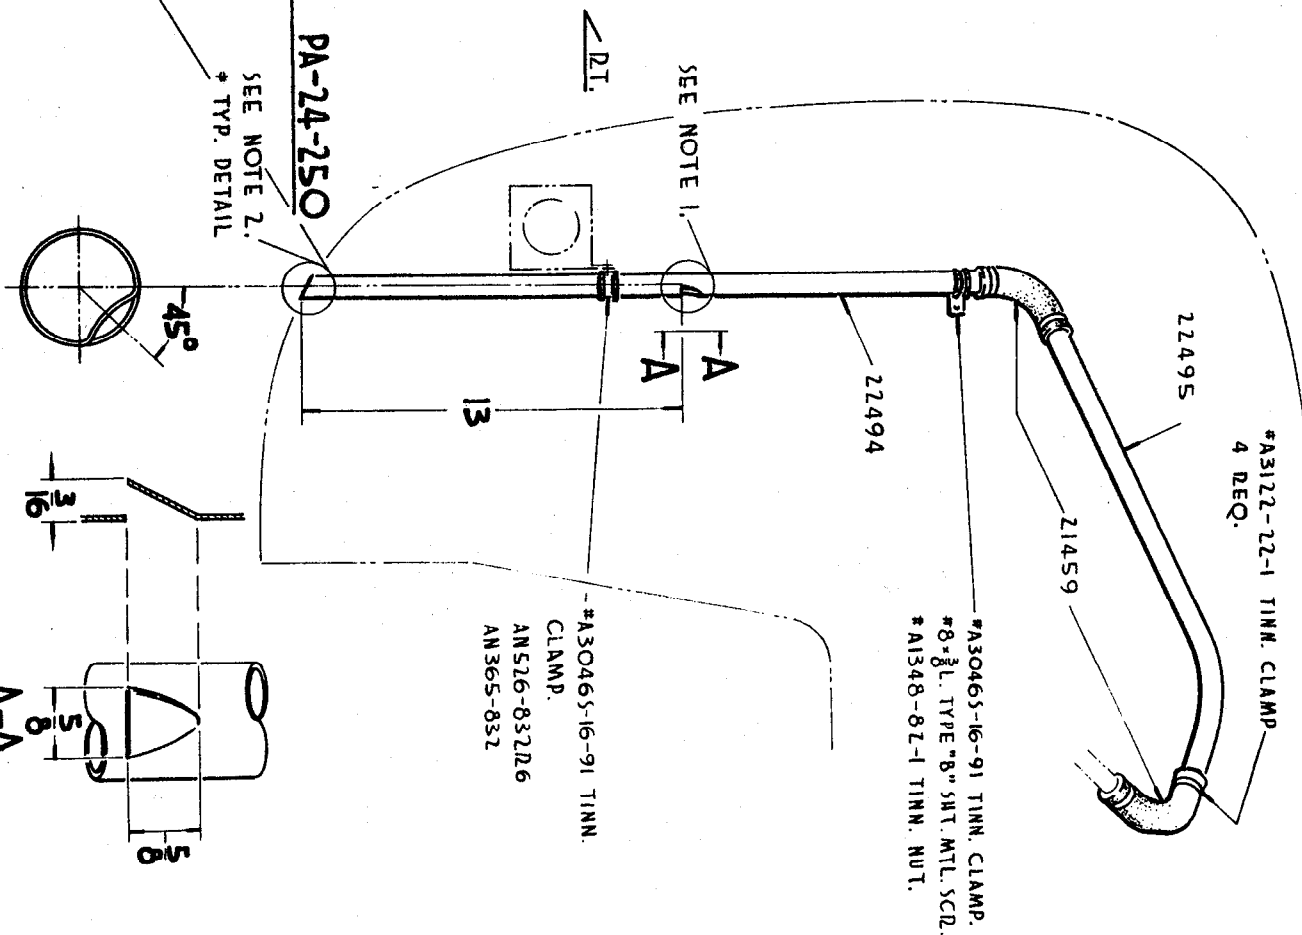
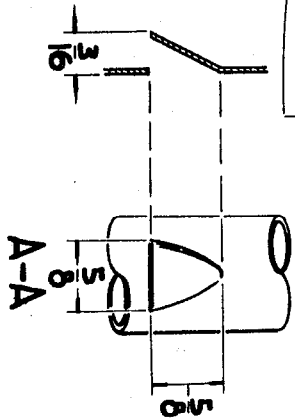
# SERVICE LETTER NO 370

A few reports have been filed with the Service Department indicating that the engine breather line on the subject aircraft may extend below the opening in the bottom cowl.

The engine breather line should be inspected and, if necessary, adjusted so that it is flush with the bottom cowl. Refer to sketch on the reverse side of this Service Letter. The adjustment of this breather line, flush with the bottom cowl, will prevent the accumulation of ice at the opening of the engine breather line and in the scoop into which it vents.

As a precautionary measure, for operations in extensive icing conditions it is recommended that the engine breather line be modified to provide an alternate vent. This modification consists of a saw-cut across the engine breather line and forming the area above the saw-cut as shown in the sketch on the reverse side of this Service Letter.

NOTE: CARE SHOULD BE EXERCISED WHILE FORMING THE VENT  
SO THAT THE TUBE IS NOT FLATTENED OR DISTORTED.

1. REMOVE BURRS THAT MAY BE FORMED AT END OF SAW SLOT.
2. ADJUST OIL BREATHER TUBE FLUSH WITH SKIN.
