Service Letter No. 397

SUBJECT: Inspection of Alternate Air Door Hinge Pin

MODELS AFFECTED: PA-24 "250" Comanches with Fuel Injection, Serial Numbers 24-2563, 24-2929, 24-2949, 24-3205 to 24-3213 incl., 24-3215, 24-3218, 24-3219, 24-3221, 24-3222, 24-3226, 24-3229, 24-3232, 24-3233, 24-3234, 24-3242, 24-3243, 24-3245 to 24-3247 incl., 24-3251, 24-3260, 24-3265, 24-3267, 24-3270, 24-3273, 24-3274 and 24-3276

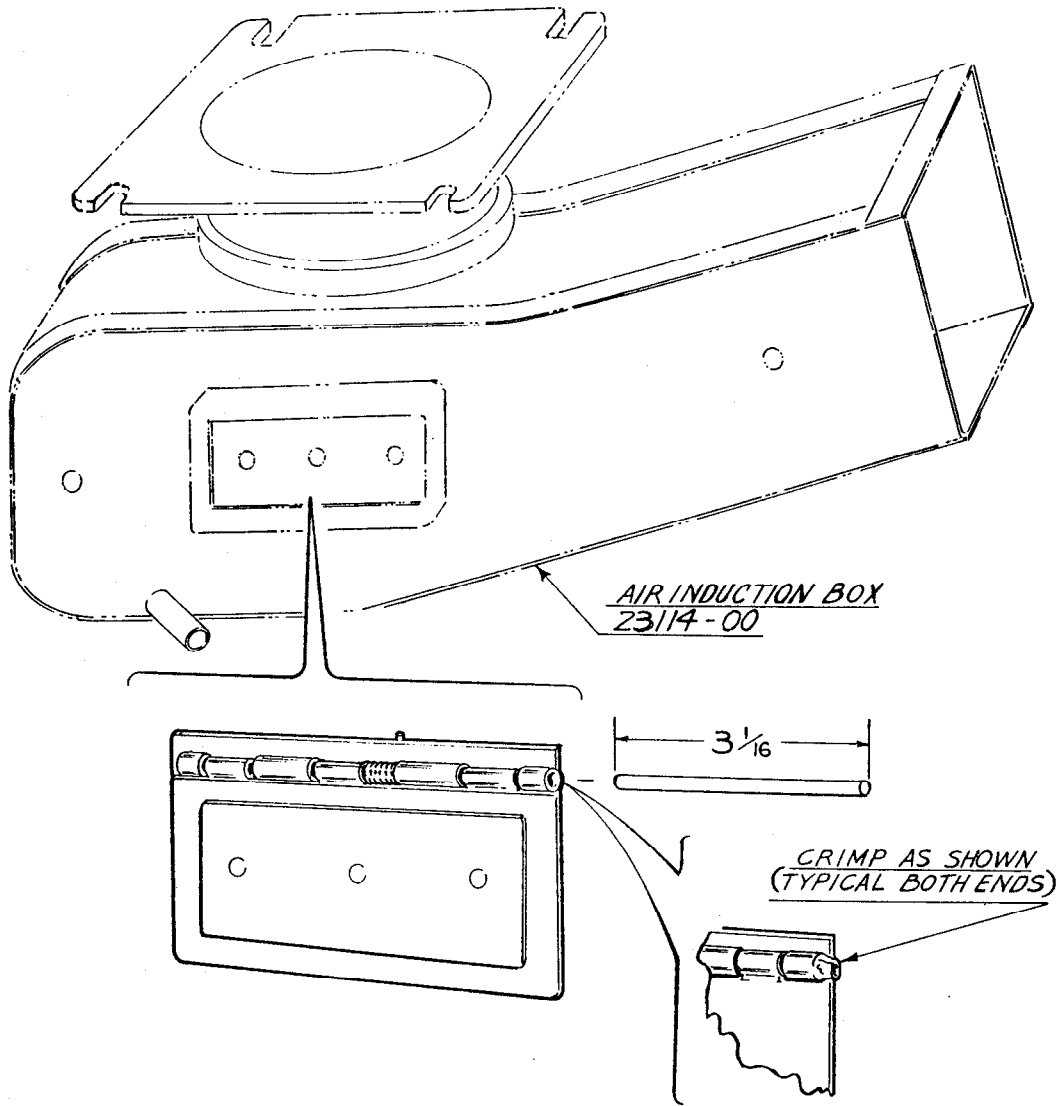
It has been brought to our attention that the hinge pin in the hinge of the alternate air door on the engine air induction box, part number 23114-00, of Fuel Injection Comanches, in a few instances, has not been adequately secured in the hinge. The hinge pin is secured by crimping each end of the hinge.

It is requested that an inspection be made of the alternate air door hinge to determine if both ends of the hinge are crimped to prevent the hinge pin from moving out of the hinge.

If the hinge pin is too long, it will prevent adequate crimping of each end of the hinge and the hinge pin should be shortened to a length of 3-1/16 inches. This will provide adequate material on each end of the hinge to permit sufficient crimping. See sketch on reverse side of this letter for further details.
