Service Letter No. 404

SUBJECT: Inspection of Altimatic and Altimatic II Pitch Servo Assembly Chain Adjustment Screw

MODELS AFFECTED: PA-23 Apaches, Serials 23-1502 to 23-2046 inclusive
PA-23-250 Aztecs, Serials 27-1 to 27-504 inclusive
PA-23-235 Apaches, Serials 27-505 to 27-572 inclusive
PA-23-250 (6 place) Aztecs, Serials 27-2000 to 27-2388 inclusive
PA-24 and PA-24 "250" Comanches, Serials 24-2003, 24-2203, 24-2299 to 24-3557 inclusive

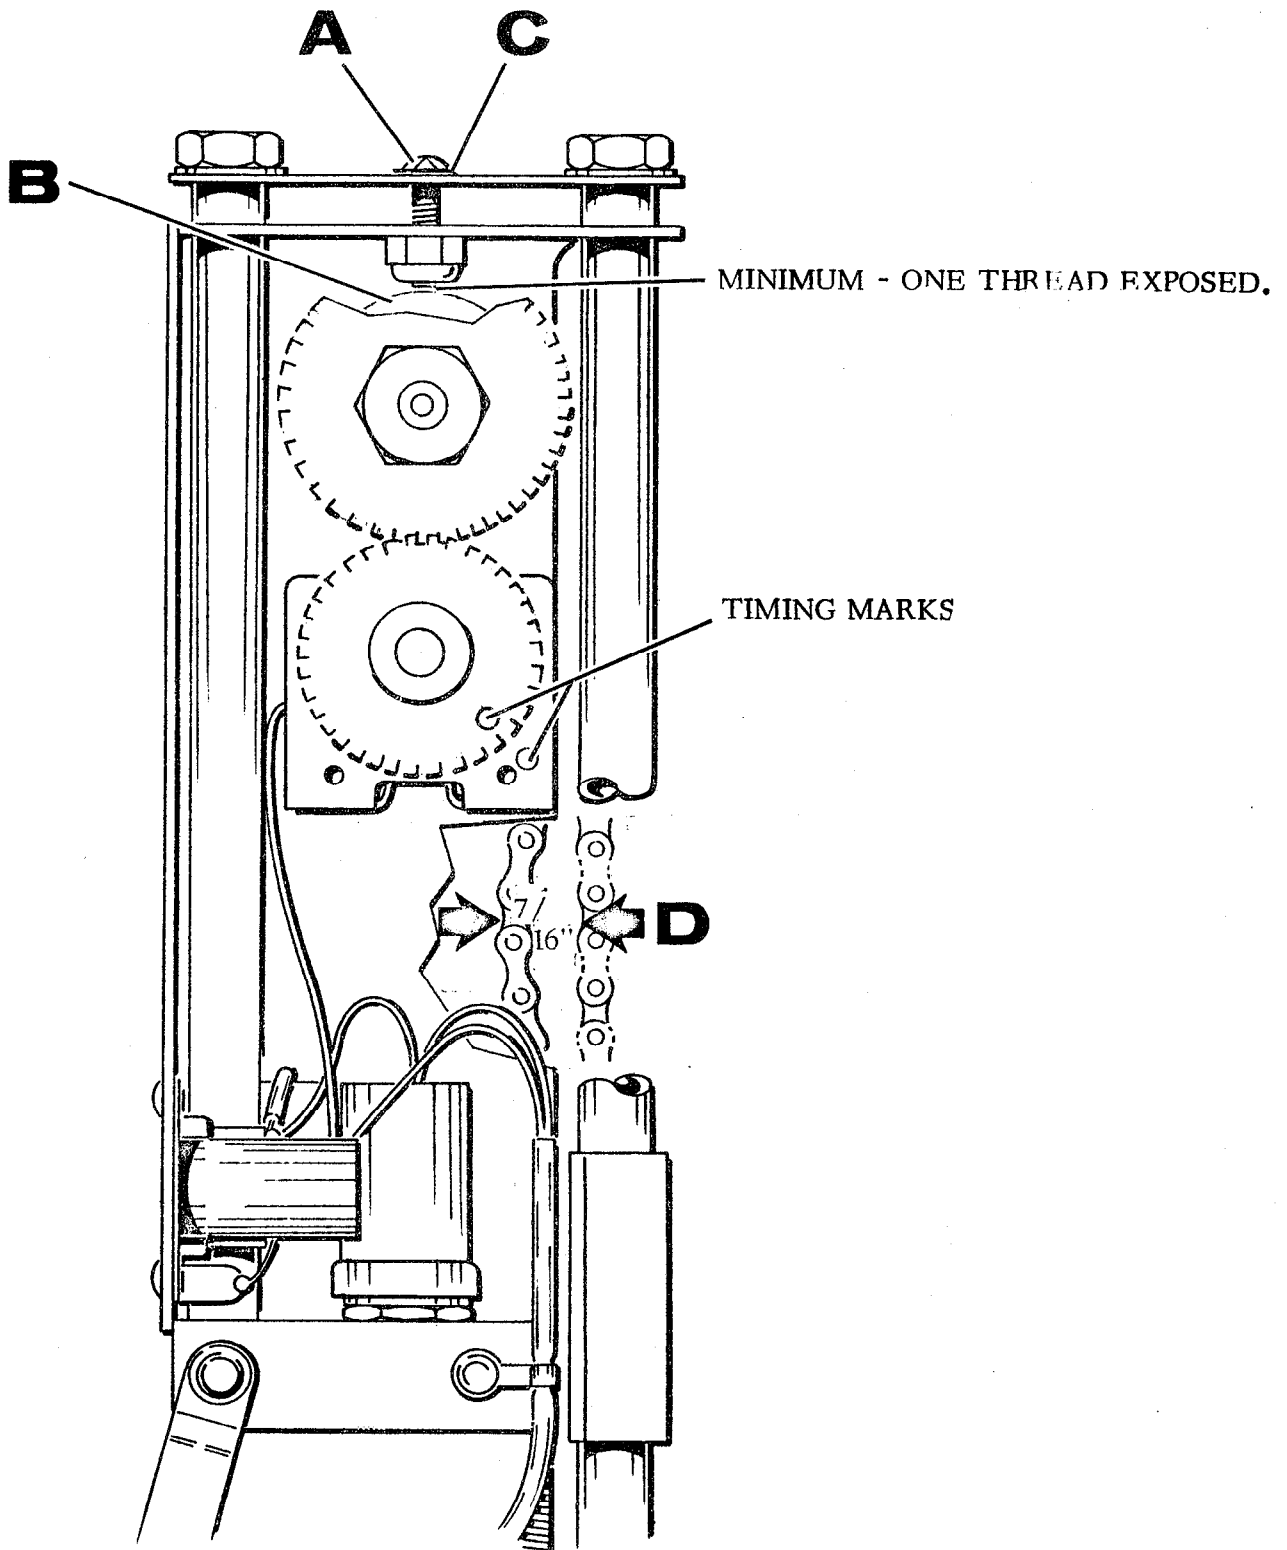
SERVICE LETTER NO 404

In order to provide a positive lock of the screw, at least one or more threads must protrude through the nut. If this cannot be accomplished without maladjustment of the pitch servo chain tension, (See pitch servo chain adjustment procedure on the following page.) it will be necessary to remove the screw and replace it with a "long-lok" type screw (Mitchell part number 3S275). Standard AN 1/32" thickness washers may be used as required under the head of the screw to prevent driving the screw end against the adjacent sprocket mounting.

See sketch attached to this letter for screw location and chain adjustment details.

1. Completely disengage the servo.
2. Measuring on the opposite side of the slide bushing or break-away link in the center of the servo, the chain should have approximately 7/16" slack.
3. By turning the adjusting screw clockwise, the chain tension is increased and by turning counter-clockwise, the chain tension is decreased.

IF LONG-LOK SCREW (A) CONTACTS SPROCKET MOUNTING (B), REMOVE SCREW AND INSTALL PACK WASHERS (C), UNDER HEAD OF SCREW AS REQUIRED TO MAINTAIN CHAIN TENSION OF 7/16" SLACK (D).
