Service Letter No. 415

SUBJECT: Sealing of the Nose Wheel Well

MODELS AFFECTED: PA-30 Twin Comanches, Serials 30-1 to 30-205 inclusive

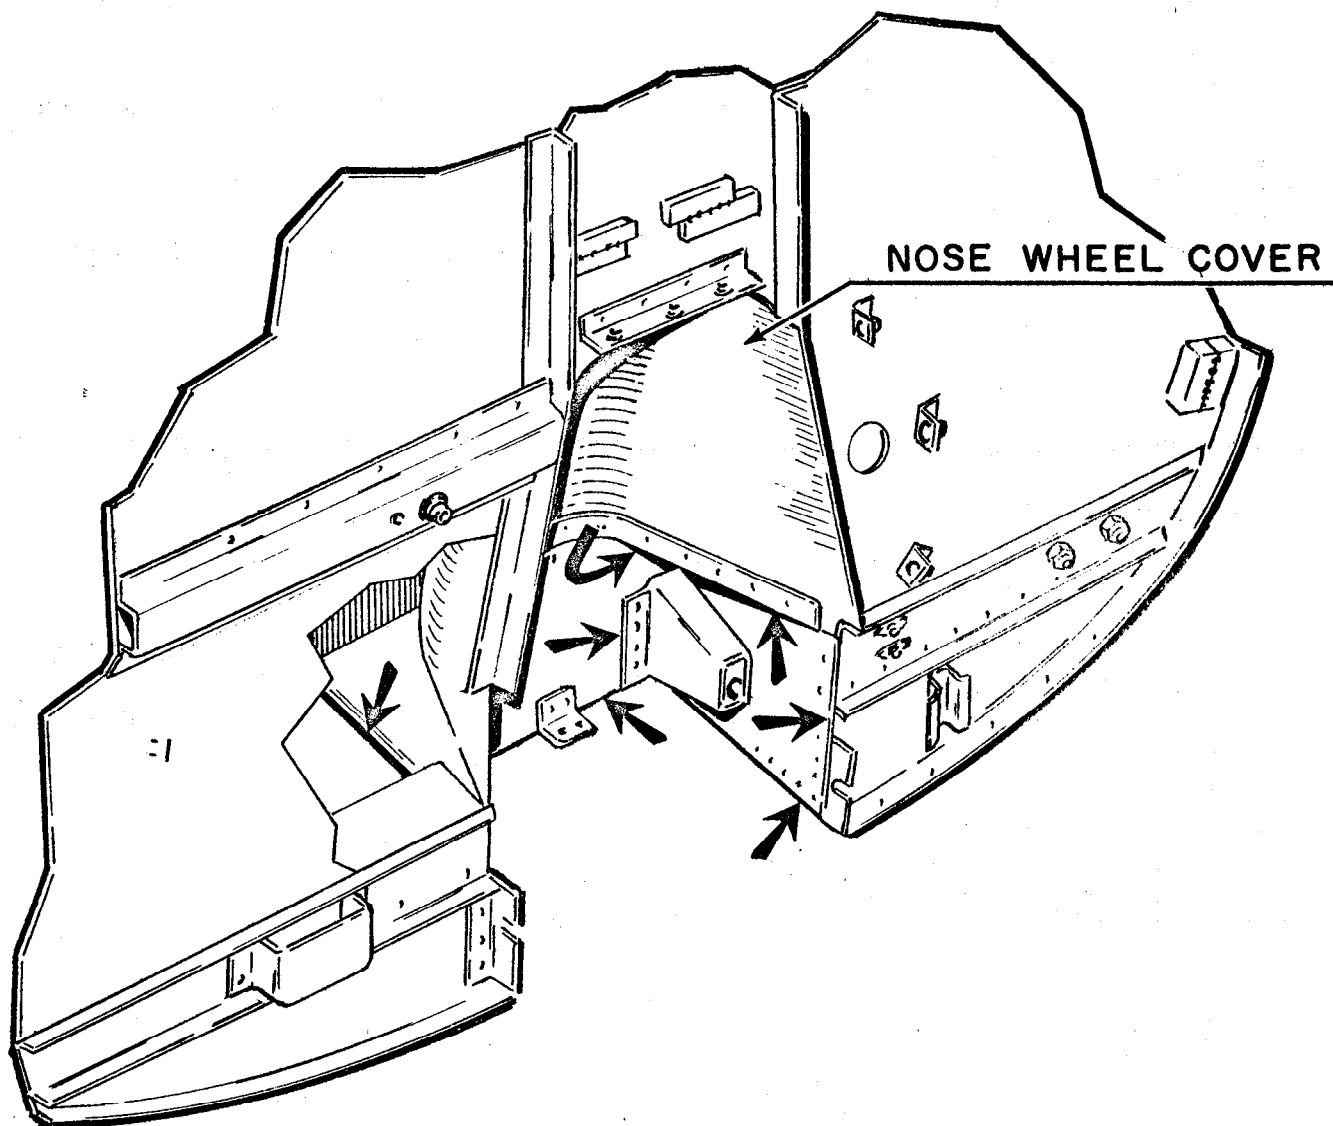
**Service letter No. 415**

Reports have been received of moisture entering the fuselage area occupied by the circuit breakers causing the circuit breakers to trip.

To eliminate this problem, additional sealing of the seams in the nose wheel well will be necessary in those aircraft indicated by the serial numbers listed above. Permagum Bead #576 and shellac or an equivalent method of sealing should be used. Please refer to sketch on the reverse side of this letter which indicates the areas affected.

➔ SEAL THESE JOINTS WITH PERMAGUM BEAD # 576 & SHELLAC OR EQUIVALENT.
