Service Letter Number 426

SUBJECT: Crankshaft Propeller Flange Inspection, per Lycoming Service Bulletin No. 300 and

SERVICE BULLETIN

- DATE: November 2, 1964 Service Bulletin No. 300A
Approved by FAA
- SUBJECT: Crankshaft Propeller Flange Inspection
- MODELS AFFECTED: All Model IO-320-B1A Engines installed in Piper Model PA-30 Twin Comanche Aircraft
- TIME OF COMPLIANCE: I Following any flight involving prohibited aircraft maneuvers, inspect crankshaft flanges in accordance with section 2.
- II Engines with more than 50 hours service time prior to the date of this bulletin must have crankshaft inspected in accordance with section 3 below at first engine overhaul not to exceed 1200 hours total service time.
- III Engines with less than 50 hours since new prior to the date of this bulletin need not comply with the 1200 hour time compliance provided flight recommendations have been observed.

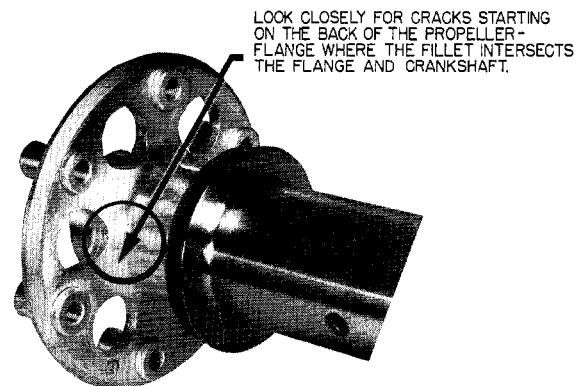
a. Remove the propeller and starter ring gear from the mounting flange of the engine and examine the entire area of the crankshaft flange from the crankshaft seal forward for evidence of cracks. Use a magnifying glass of approximately 10 power and adequate lighting for this purpose or portable magnetic particle test equipment. Pay particular attention to the flange area and fillet radius on rear face of propeller flange. See accompanying illustrations for possible location of where cracks might appear and type of structural damage which can occur. Because of machining marks, the factory does not recommend using dye penetrant for this inspection. Further flight with a cracked propeller flange is not permissible.

Figure 1. Rear View of Propeller Mounting Flange Showing Area of Lightening Holes.

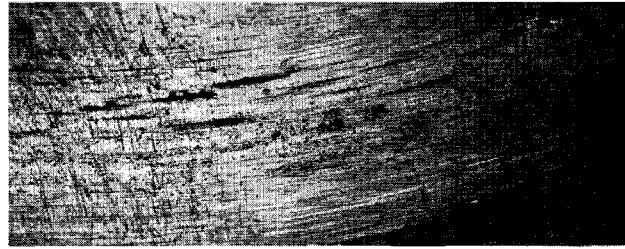
Tests prove that both the crankshafts with the lightening holes and revised crankshafts which eliminate the lightening holes beginning with engine Serial No. 681-55 and up are subject to certain flight restrictions in order to obtain maximum safety of flight and infinite crankshaft service life. High internal stresses can be accumulated in the area of the propeller mounting components whenever power-on stalls are performed at engine speeds above 2150 RPM. In addition, tests indicate that aircraft yaws which are performed excessively fast by applying rapid full left and full right hand rudder consecutively will create high stresses from gyroscopic action.

Figure 2. 10X magnified view showing appearance of area cracked due to abnormal loading imposed on the propeller flange during periods of unauthorized maneuvers.
