Service Letter No. 439

SUBJECT: Lycoming Service Bulletin No. 300A (Crankshaft Propeller Flange Inspection)

Service Bulletin No. 300A
Approved by FAA

SUBJECT: Crankshaft Propeller Flange Inspection

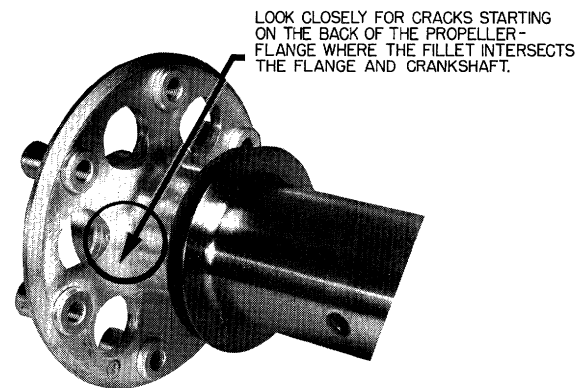
Extensive testing and field inspection reports that followed release of Service Bulletin No. 300 and FAA Airworthiness Directive 64-15-5 show that IO-320-B1A engines manufactured with lightening holes in the crankshaft propeller mounting flange are satisfactory and normal service life can be expected if the following precautionary measures are observed.

Figure 1. Rear View of Propeller Mounting Flange Showing Area of Lightening Holes.

a. Remove the propeller and starter ring gear from the mounting flange of the engine and examine the entire area of the crankshaft flange from the crankshaft seal forward for evidence of cracks. Use a magnifying glass of approximately 10 power and adequate lighting for this purpose or portable magnetic particle test equipment. Pay particular attention to the flange area and fillet radius on rear face of propeller flange. See accompanying illustrations for possible location of where cracks might appear and type of structural damage which can occur. Because of machining marks, the factory does not recommend using dye penetrant for this inspection. Further flight with a cracked propeller flange is not permissible.

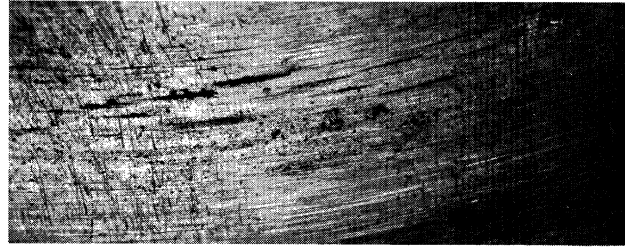
Tests prove that both the crankshafts with the lightening holes and revised crankshafts which eliminate the lightening holes beginning with engine Serial No. 681-55 and up are subject to certain flight restrictions in order to obtain maximum safety of flight and infinite crankshaft service life. High internal stresses can be accumulated in the area of the propeller mounting components whenever power-on stalls are performed at engine speeds above 2150 RPM. In addition, tests indicate that aircraft yaws which are performed excessively fast by applying rapid full left and full right hand rudder consecutively will create high stresses from gyroscopic action.

Figure 2. 10X magnified view showing appearance of area cracked due to abnormal loading imposed on the propeller flange during periods of unauthorized maneuvers.

a. During magnetic particle inspection, particular care should be taken to examine the propeller flange area in the large fillet radius tangent to the crankshaft in addition to the normal flange and shaft areas for possible cracks or other evidence which indicates bending.
