Service Letter No. 447

SUBJECT: Inspection of Landing Gear Transmission Retract Spring

MODELS AFFECTED: All PA-24 Comanche Series and PA-30 Twin Comanche Series Aircraft

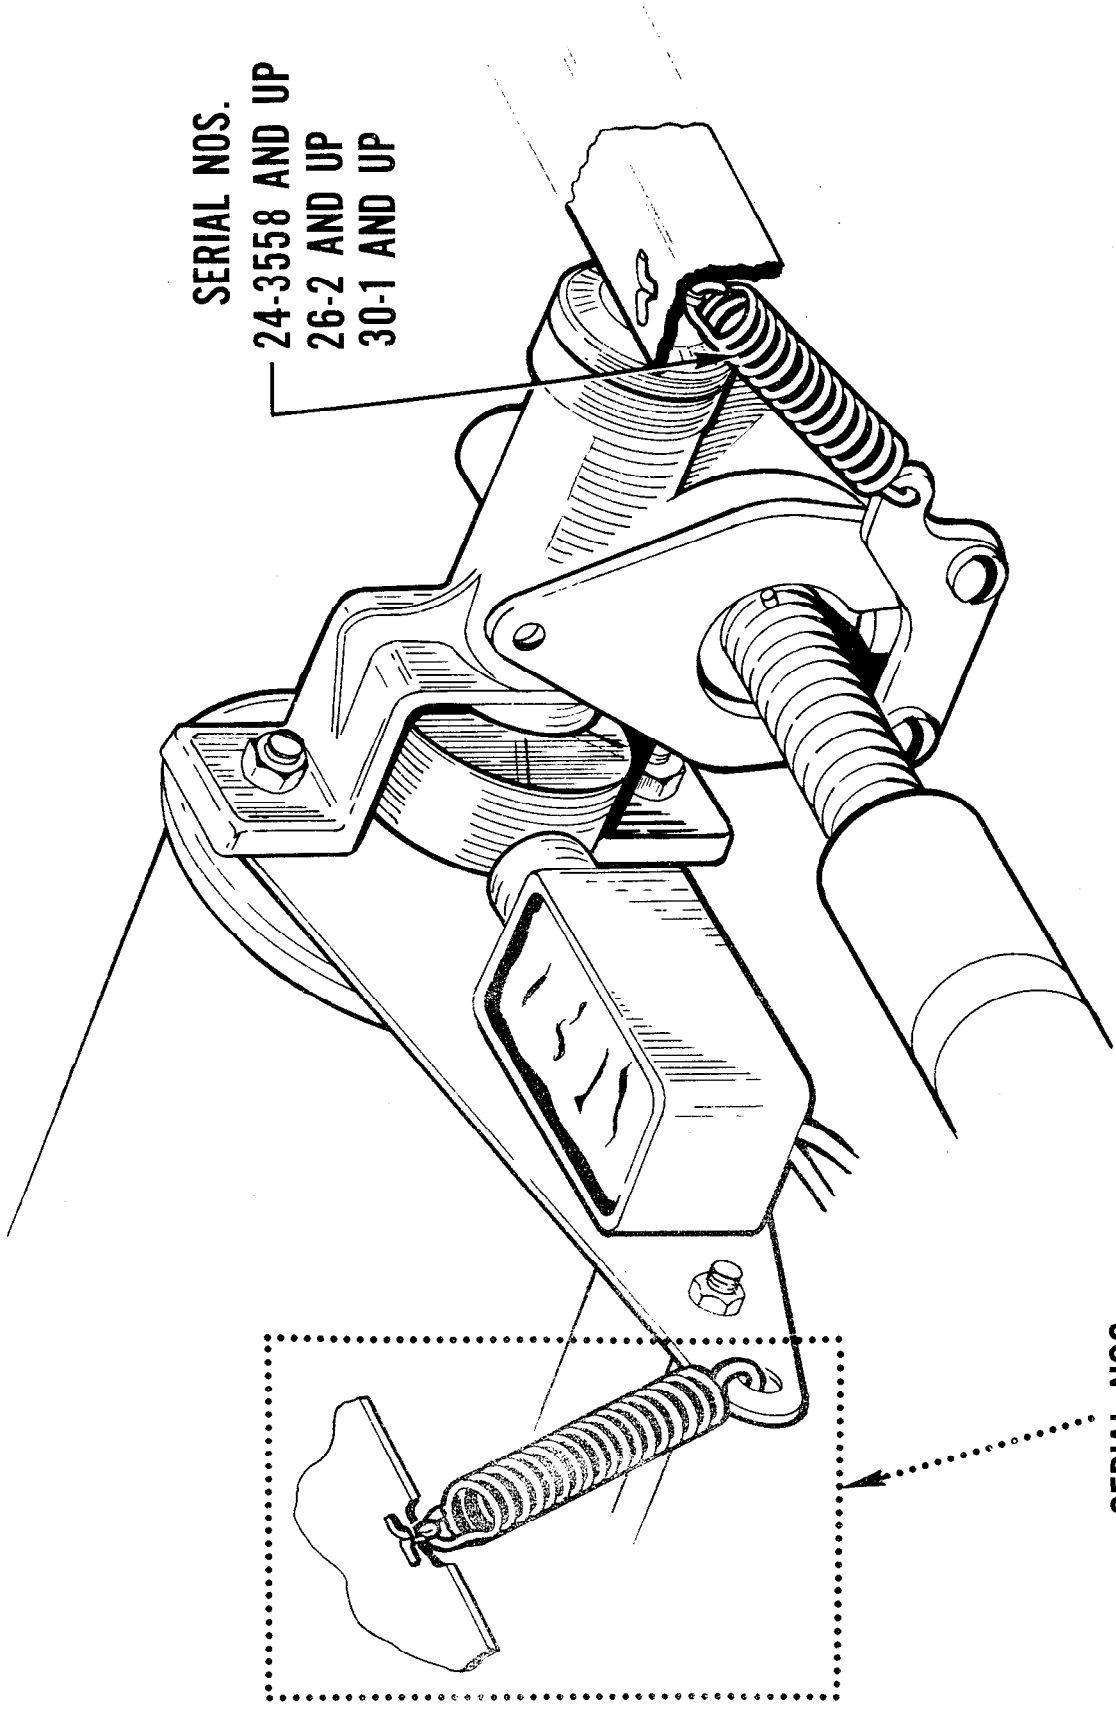
SERVICE LETTER NO. 447

The subject spring is located in the landing gear transmission well and raises the landing gear transmission jack screw to prevent the jack screw from dropping down and interfering with the landing gear mechanism during manual extension of the gear. See sketch on the reverse side of this Service Letter.

SERIAL NOS.
24-3558 AND UP
26-2 AND UP
30-1 AND UP

SERIAL NOS.
24-1 TO 24-3557 INCL.

It is requested that this spring be inspected during routine inspections and, if broken, missing, or not functioning properly, a new spring must be installed.
