SERVICE LETTER

No. 541

Piper Aircraft Corporation

Subject: Fuselage Nose Cone Drain Holes

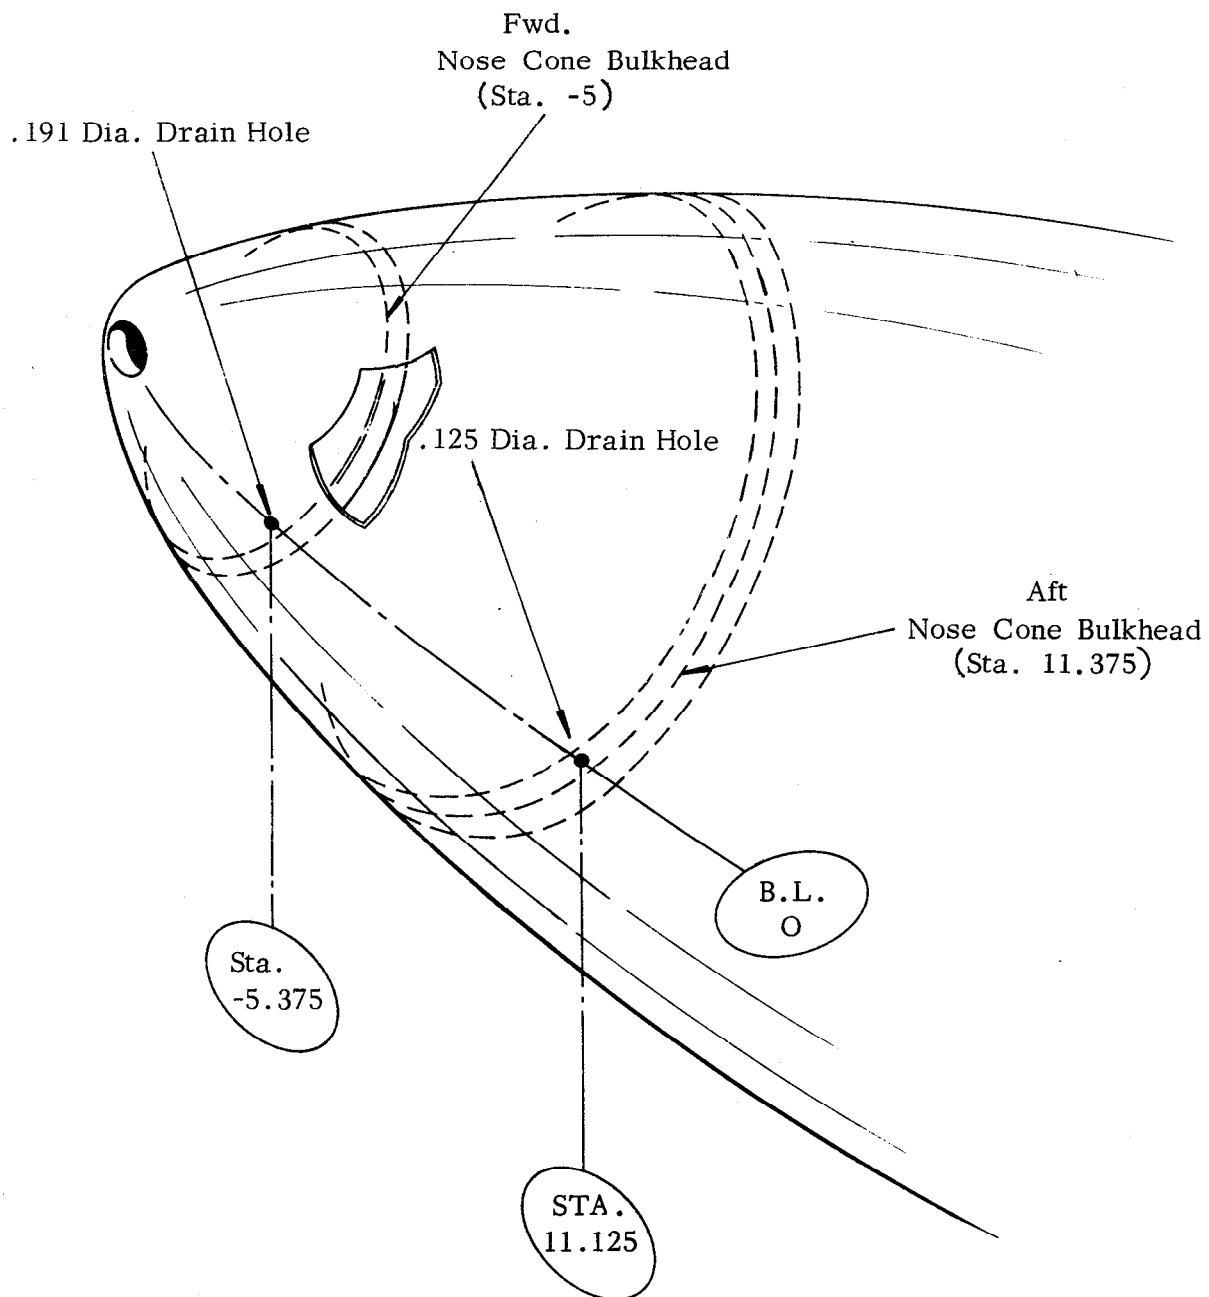
FUSELAGE NOSE CONE

Purpose: To inspect the fuselage nose cone section of the above referenced aircraft to ascertain that drain holes are present in the fuselage nose cone, as indicated by the sketch on the reverse side of this letter.

Instructions: If the above referenced inspection reveals that drain holes do not exist at stations 11.125 and -5.375, add drain hole(s) per sketch on reverse side of this letter.
