SERVICE LETTER

No. 556A

Piper Aircraft Corporation

Subject: Turbocharger Waste Gate Return Spring

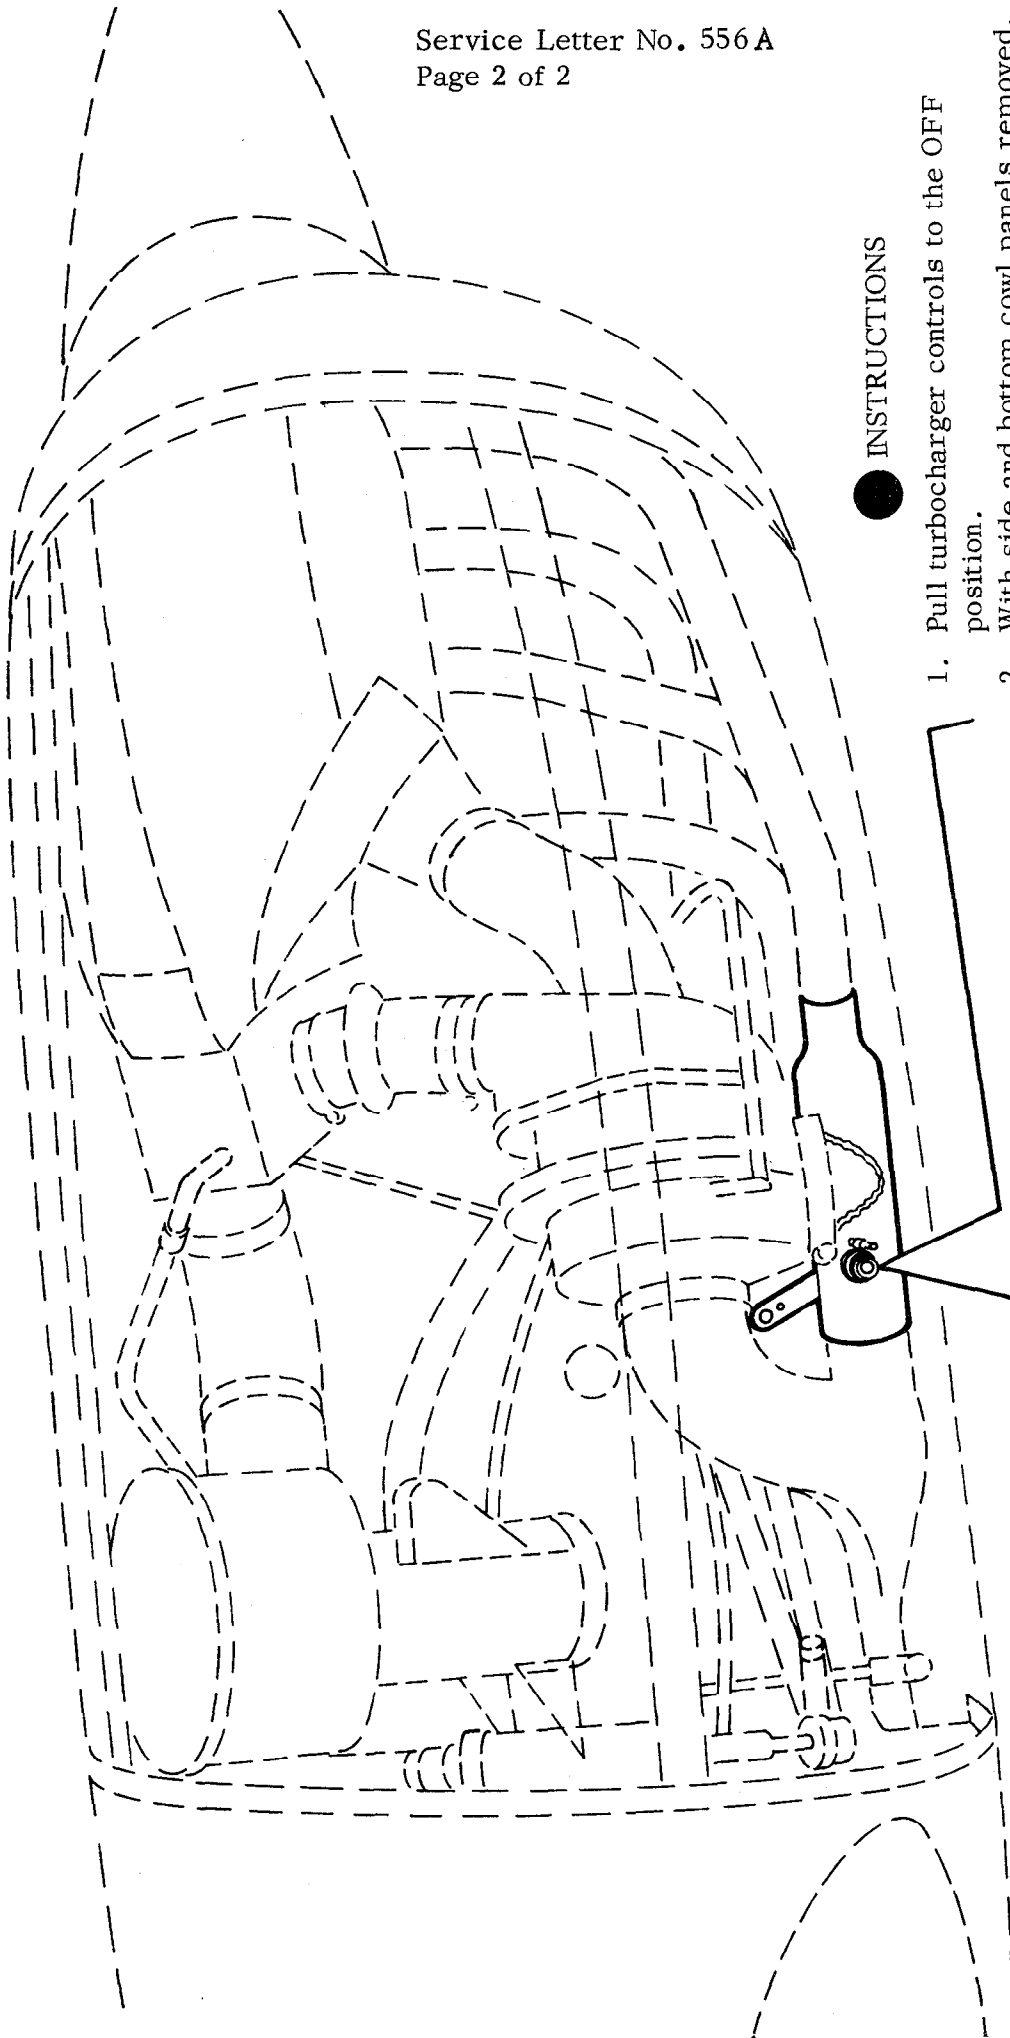
Purpose: To replace the existing turbocharger waste gate return spring with a new heavy duty return spring.

● INSTRUCTIONS

1. Pull turbocharger controls to the OFF position.
2. With side and bottom cowl panels removed, remove the existing turbocharger waste gate spring.
3. Install new turbocharger waste gate spring, Rajay Part Number RJ4120-11, being careful to install center tang in hole 180° to hole from which old spring was removed.
4. Place turbocharger waste gate spring on spring retainer as shown.
5. Actuate turbocharger controls to determine spring winds and unwinds freely.
6. Reinstall cowlings.
