# SERVICE LETTER

No. 565

Piper Aircraft Corporation

Rear Cabin Dome Light Mounting Screw

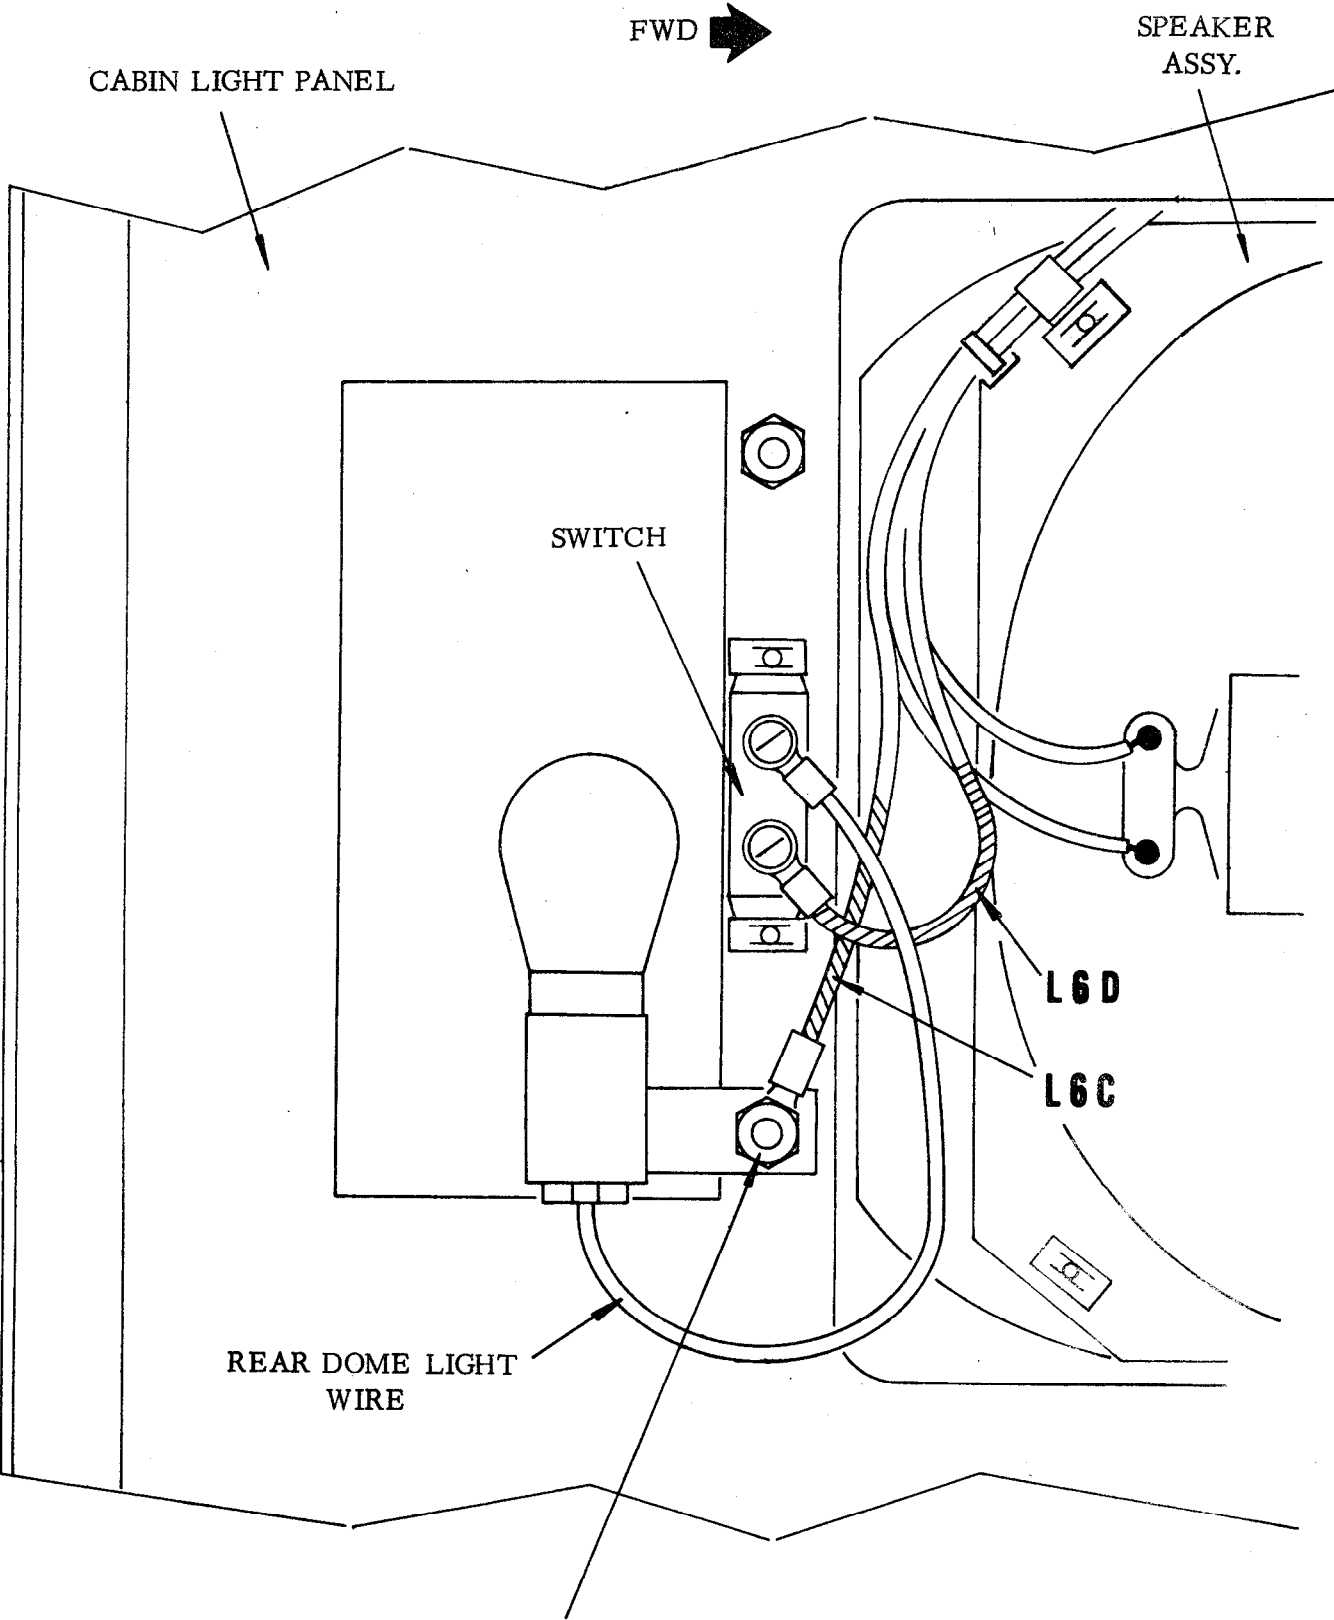
To determine if a voltage potential exists at the rear cabin dome light mounting screw.

APPLY THE VOLT METER  
LEAD TO THE HEAD  
OF THIS MOUNTING SCREW.

1. Apply volt meter leads to the rear cabin dome light mounting screw and to an appropriate airframe ground (as indicated in sketch on reverse side of this letter).
2. Turn the aircraft master switch on, and check to see if the volt meter registers a voltage reading.
3. If a voltage reading does exist, it will be necessary to lower the cabin light panel and revise the rear cabin dome light wiring per the sketch on the reverse side of this letter.
4. If a voltage reading is not apparent per numbers one and two, above, no further action is required.
