SERVICE LETTER

No. 574

Piper Aircraft Corporation

Subject: Revision to Emergency Gear Check List

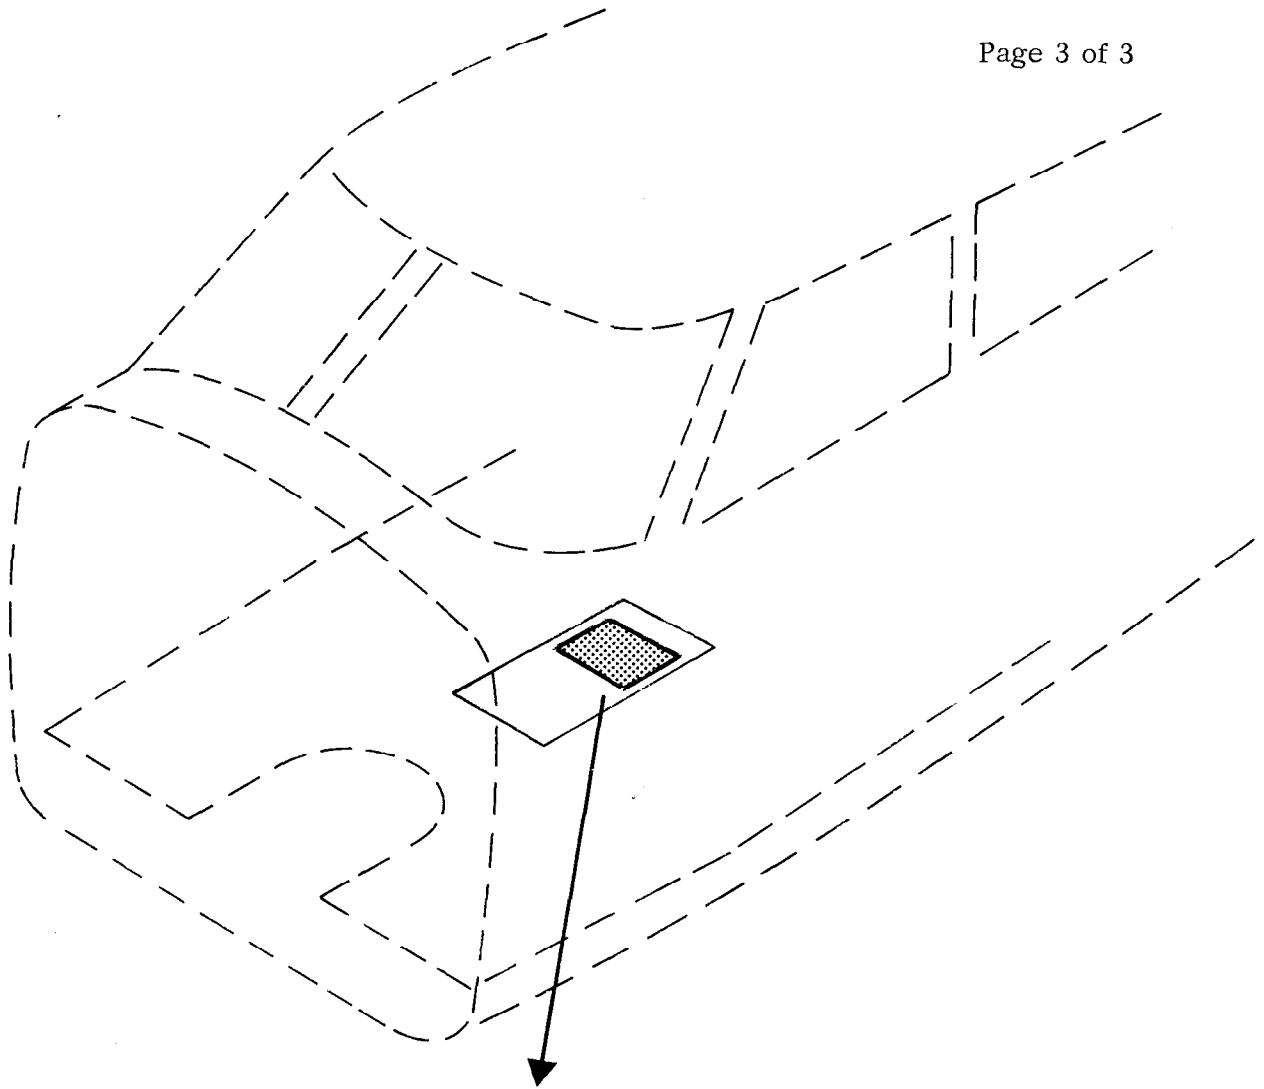
Purpose: To revise the emergency gear extension check list
on the emergency gear extension placard (installed on
the underside of the landing gear release access door) and
in the emergency procedures section of the applicable air-
craft owner handbook operating instructions section by
deleting the words "Master and" from the statement "Master
and Gear Circuit Breakers - IN."

Remove the emergency gear extension access door and obliterate the words "MASTER AND" from the placard on the underside of the door with red paint.
