# SERVICE LETTER

No. 575

Subject: Nose Landing Gear System Inspection

Models Affected: PA-30 and PA-39 Twin Comanche

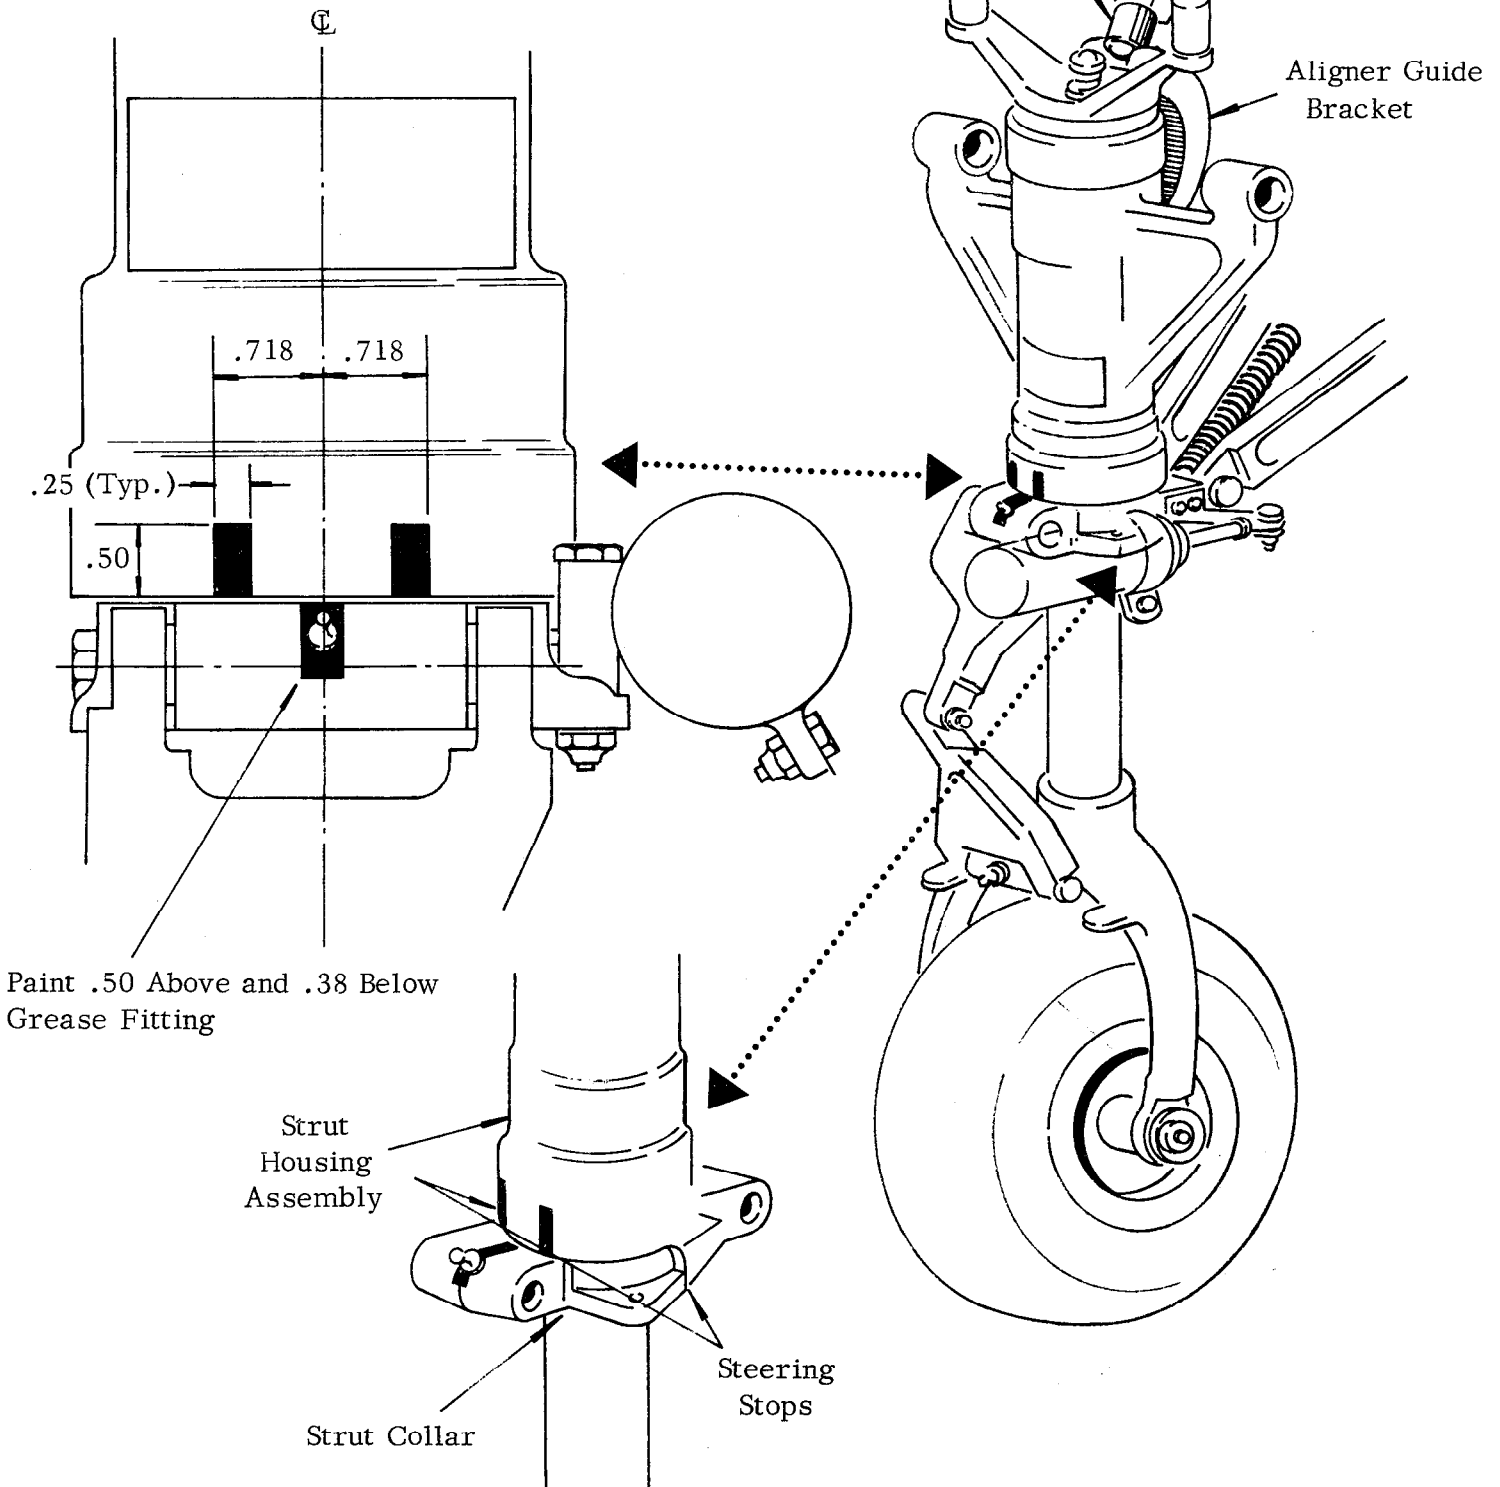
***Service Letter No. 575***

cycling, observe that the aligner roller is engaged within the nose gear aligner guide bracket channel (reference attached sketch for a pictorial description).

- a. If the aligner roller does not engage within the aligner guide bracket during gear cycling as specified above, it will be necessary to recheck nose gear steering travel limits.
4. Apply steering limit markings on the nose gear strut housing as denoted on attached sketch.

Note: Apply steering limit markings (red paint) on the strut assembly as shown.
