SERVICE LETTER

No. 599

Subject: Wing Panel Exhaust Corrosion Protection

Models Affected: PA-30 Twin Comanche
PA-39 Twin Comanche C/R

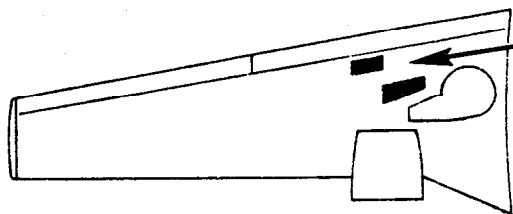
BOTTOM VIEW OF LEFT WING

Purpose: Recent product condition reports received from the field describe exhaust corrosion appearing in the right and left wing panel cavity, between wing stations nos. 55 and 78, aft of the landing gear support bulkhead and in front of the rear spar assembly (the sketch on the reverse side of this service letter depicts the location).

1. Remove the two access plates located on the underside of the left and right wing panels as shown.
2. Thoroughly clean all internal surfaces of the left and right wing structure between wing stations 55 and 78, aft of the landing gear support bulkhead to the rear spar assembly removing oil, dirt, exhaust deposits and corrosion. Also clean the internal surfaces of the top and bottom skins and the two access plates. Cleaning procedures should be accomplished in accordance with applicable F.A.A. Regulations contained in AC43.13-1.
