SERVICE LETTER

No. 627

Piper Aircraft Corporation

Propeller Installation

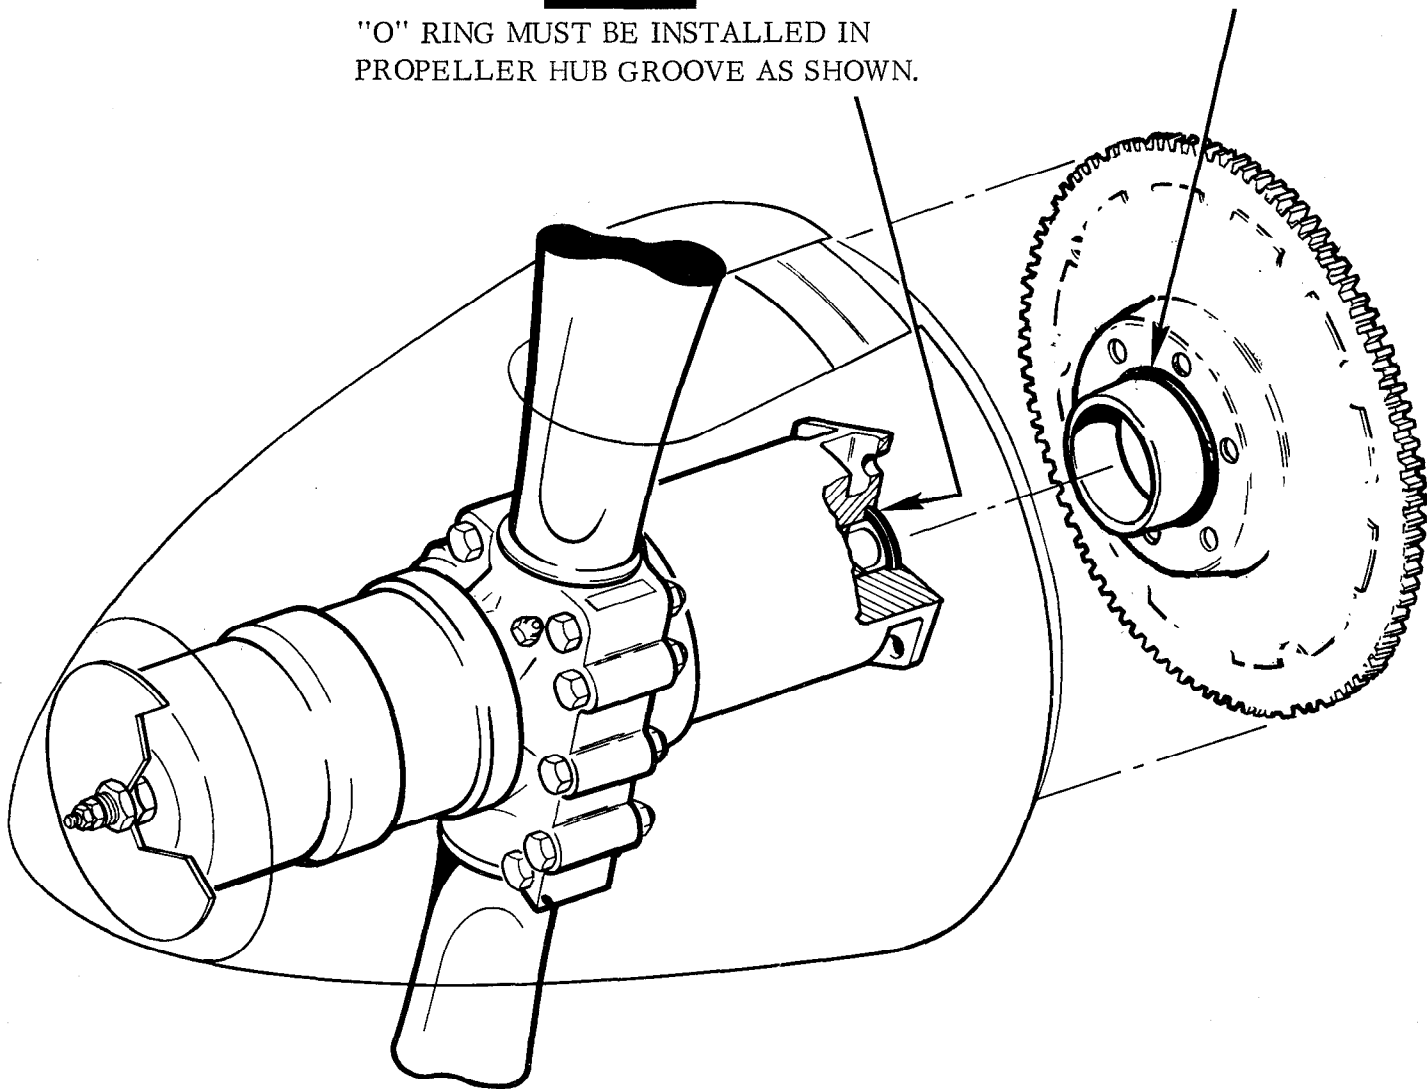
A recent report was received concerning the loss of a propeller on one of the above referenced aircraft during aircraft operation. A subsequent investigation revealed that the affected propeller had been recently removed and was apparently incorrectly installed -- with indications of (1) inadequate propeller mounting bolt torque and (2) incorrect installation of an extra "o" ring between the prop flange and the engine crankshaft flange.

"O" RING MUST BE INSTALLED IN PROPELLER HUB GROOVE AS SHOWN.

DO NOT INSTALL "O" RING OVER CRANKSHAFT FLANGE.

- A. If an "o" ring exists in this location, the "o" ring must be discarded and the propeller should be removed from the aircraft and inspected to insure that the proper "o" ring is correctly installed in the propeller hub groove -- as shown in attached sketch.
3. Reinstall propeller, insuring that prop mounting bolts are properly torqued.
4. Make appropriate log book entry.
