SERVICE LETTER

No. 637

Piper Aircraft Corporation

Subject: Rajay Service Letter No. 19, dated September 5, 1972.

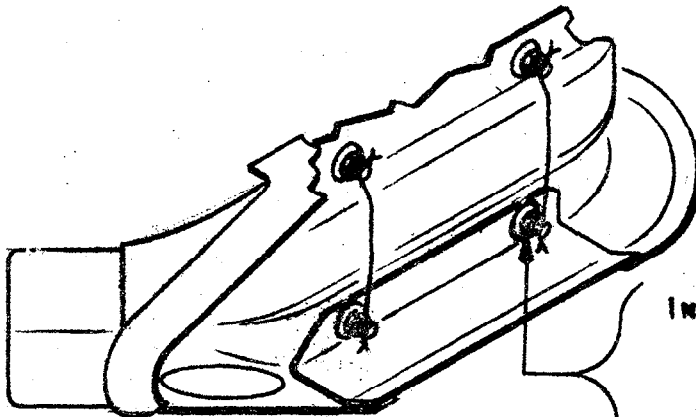
THERE HAVE BEEN ISOLATED REPORTS OF THE TURBOCHARGER INDUCTION DUCT RETAINING STUDS BACKING OUT AND BEING INGESTED INTO THE COMPRESSOR SECTION OF THE TURBOCHARGER. TO PRECLUDE THIS FROM OCCURRING ON ANY FUTURE INSTALLATIONS, A REVISED ASSEMBLY WILL BE USED AS SHOWN BELOW:

INSTALL:
NAS 183-4-8 STUD
AN 310-4 NUT
4 EACH REQUIRED
SAFETY WIRE (.030 DIA.) PER
MS 33540 TOP TO BOTTOM AS SHOWN
2 PLACES
