SERVICE LETTER

No. 648

Subject: Battery Ground Inspection and Modification

Models Affected: PA-24-260 "C" Comanche

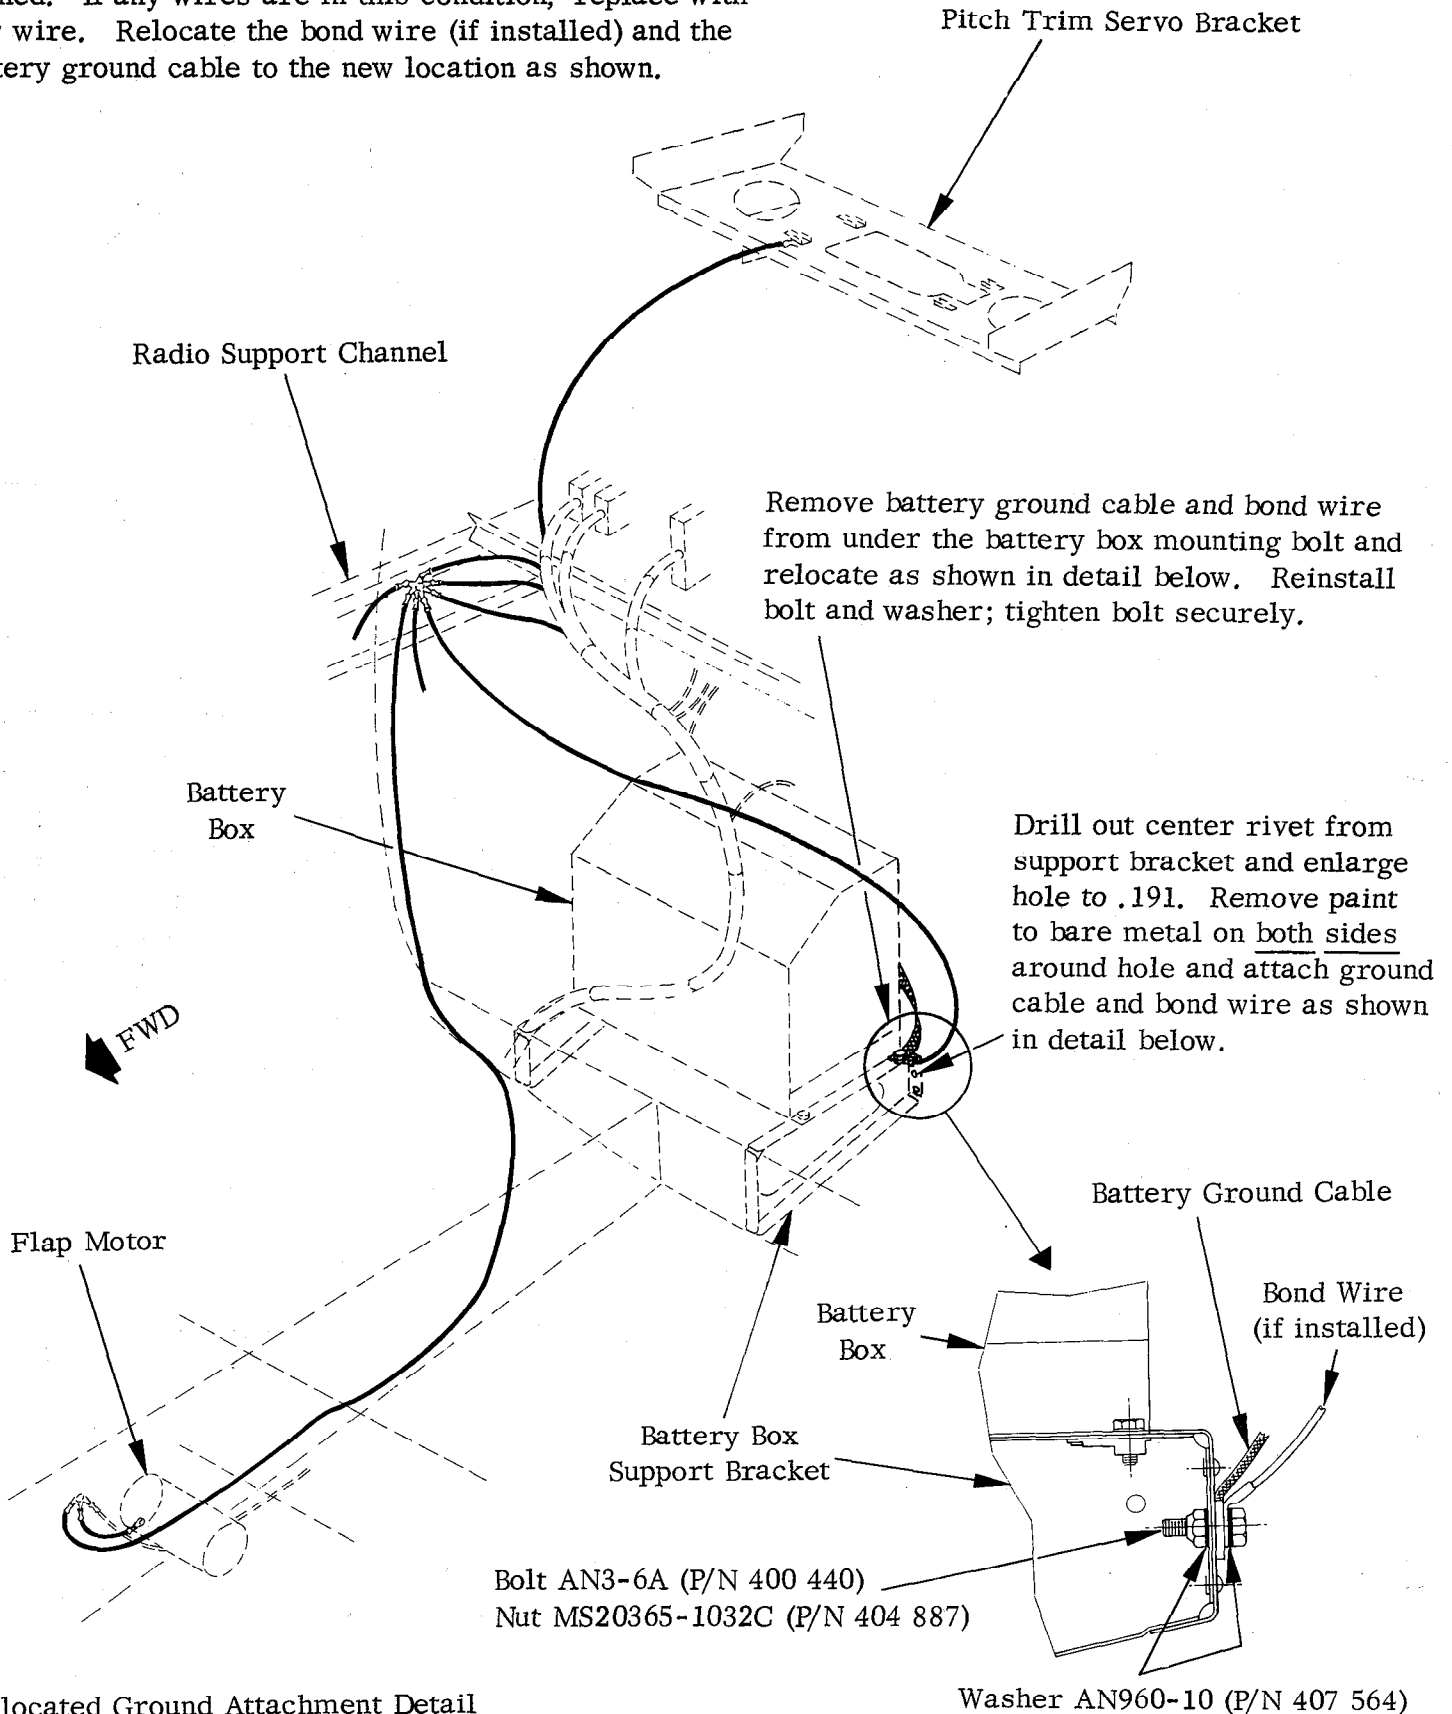
Relocated Ground Attachment Detail

Purpose: A field report has been received describing damaged electrical wiring in the battery area -- in the form of scorched or burned wires. This condition was attributed to improper attachment security of the battery ground strap and bonding wire (if installed) to the battery box mounting bolt.

Inspect all wires (indicated by solid lines) in the battery area for the possibility of any wires being scorched or burned. If any wires are in this condition, replace with new wire. Relocate the bond wire (if installed) and the battery ground cable to the new location as shown.
