SERVICE LETTER

No. 650

Piper Aircraft Corporation

Inspection of Landing Gear Retraction and Flap Control Transmission Assemblies

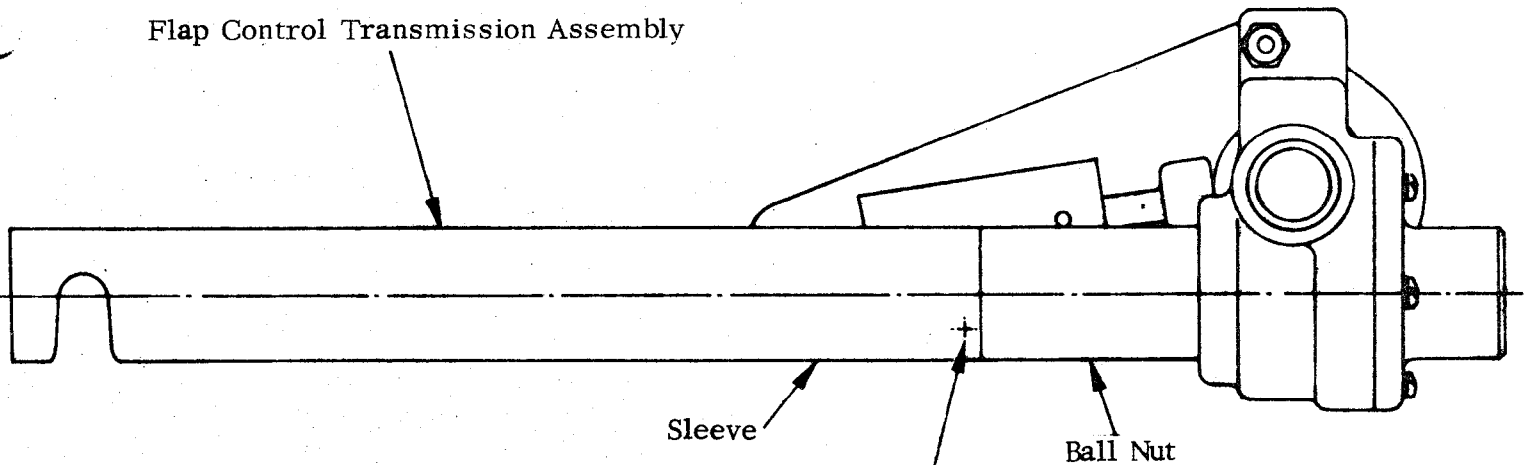
Flap Control Transmission Assembly

Sleeve must be staked at three points
(on circumference of sleeve) to prevent
separation of threaded joint.

1. Refer to the appropriate Service Manual and gain access to the flap control transmission (if installed) and the landing gear retraction transmission.
2. Inspect transmissions to determine if sleeve has been properly staked as shown on above sketch.
3. If the transmission sleeves have been properly staked, no further action is required.
4. If either of the transmission sleeves have not been staked, it will be necessary to remove the transmission from the airplane and stake as shown (sleeve must be tight against ball nut before staking). Use a center punch and carefully stake to a depth of .030 to .040 inches. Refer to the appropriate Service Manual for proper Removal and Installation Procedures.

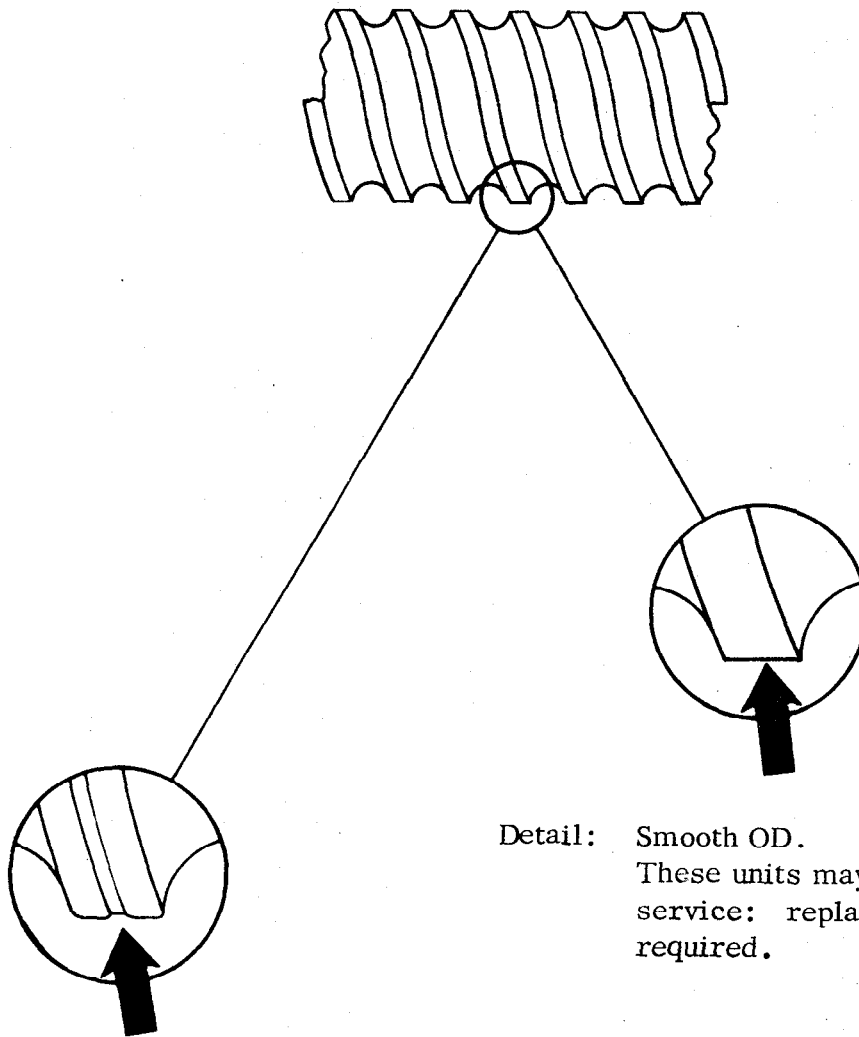
- REFERENCE SERVICE LETTER NO. 650: Purpose II
Identification of Transmission Ball Screw;
Transmission serial numbers 919 thru 1068 inclusive.

Detail: Grooved OD.
These units must be replaced.

Detail: Smooth OD.
These units may remain in
service: replacement not
required.

1. Expose the threaded ball screw portion of the transmission assembly to view.
2. With a magnifying glass, inspect the threads as specified on the sketch on the reverse side of this communication.
3. Refer to the "detailed" call-outs on the sketch to determine whether the transmission assembly must be replaced.
4. Refer to the balance of Piper Service Letter No. 650 for replacement material identification data.
