# SERVICE LETTER

No. 707

Piper Aircraft Corporation

Subject: Modified Flyball Assembly to Improve RPM Control  
-- reference attached Hartzell Service Letter No. 75,  
dated November 16, 1973.

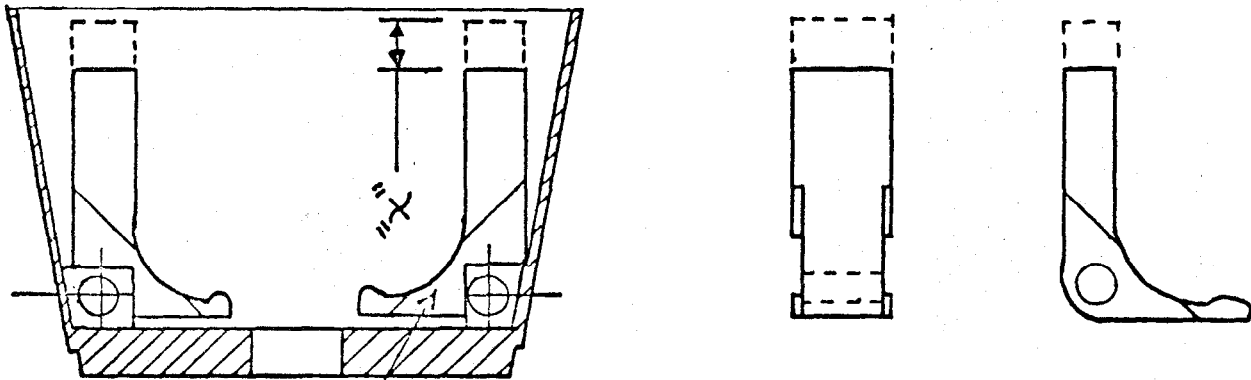
A-153(A)-(C) FLYWEIGHT (SEE CHART)  
(MATERIAL GROUND FROM  
SIDES ON "A" MODIFICATION)

- 1) Determine flyweight assembly needed using parts listed in this letter.
- 2) The flyweight assembly can be changed by:
  - a) removing cover assembly
  - b) removing flyweight assembly locking ring
  - c) removing flyweight assembly
  - d) placing new flyweight assembly in place
  - e) replacing lock ring, making sure it is in place
  - f) replacing cover gasket 50672, and
  - g) installing cover assembly
