SERVICE LETTER

No. 751

Piper Aircraft Corporation

Fin Front Spar Modification.

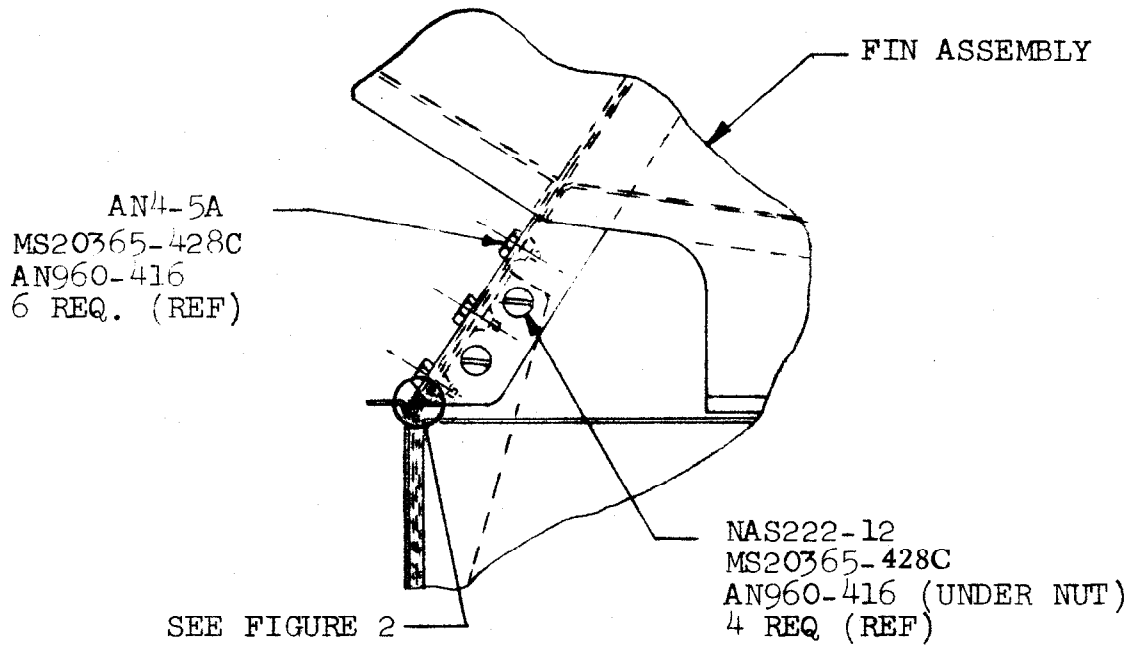
FIGURE 1

Airworthiness Directive No. 75-12-06 requires a repetitive inspection of the fin front spar to fuselage attachment channel bend relief holes for evidence of cracks; repair or replace cracked channel/straps if cracks are detected, etc.

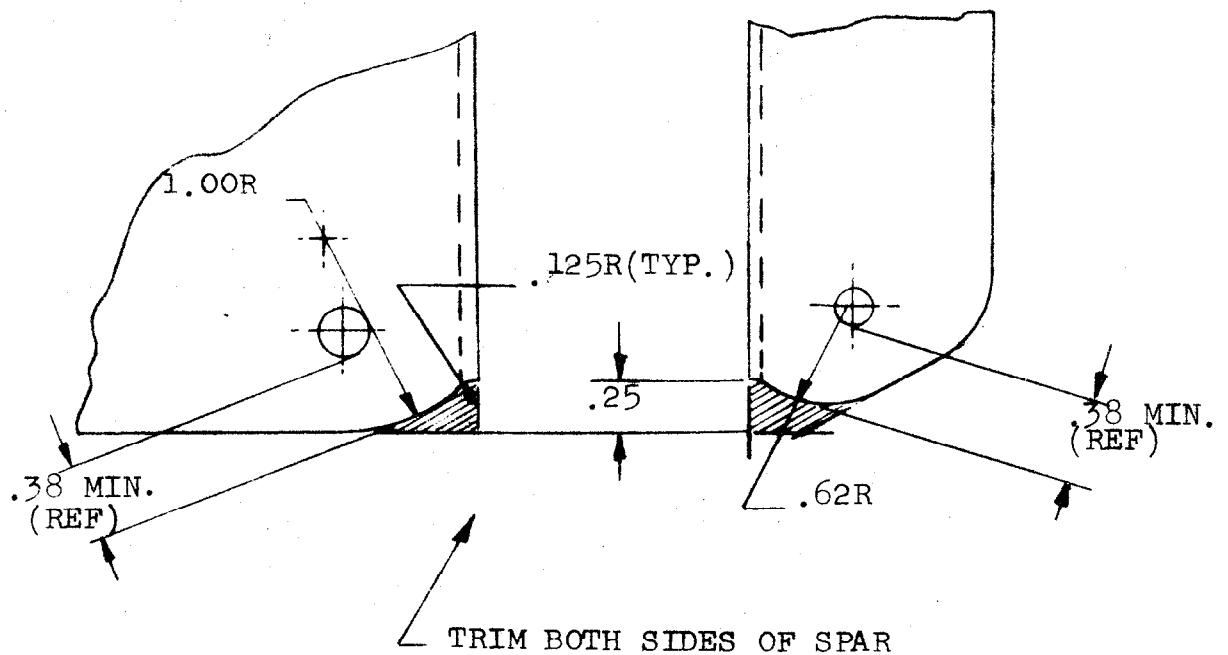
FIGURE 2

Currently, it is necessary to physically remove the fin to gain visual access to the channel relief holes, as the fin front spar extends over the relief holes by approximately 1/2 to 2/3 of the relief hole diameter.

SPAR TRIMMING DETAIL

To eliminate removal of the fin and to enable an easy visual inspection, the fin front spar may be modified in accordance with the sketch/instruction sheet contained on the reverse side of this release.

Refer to "Spar Trimming Detail" on reverse side of this release.
