SERVICE LETTER

No. 758

Piper Aircraft Corporation

Inspection of Bendix Ignition Switches (Rotary Action, Key of Lever Actuated, Twist to Start, Push to Start, Twist to Start/Push to Prime Types). Reference: Bendix Electrical Components Division, Service Bulletin No. 583 (copy attached).

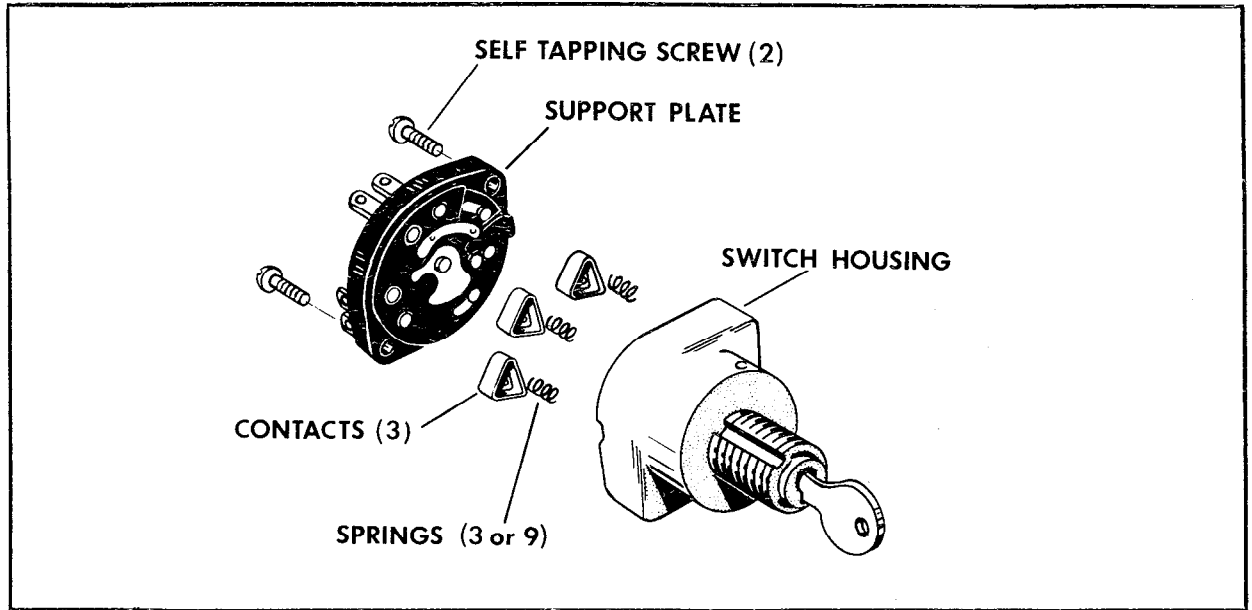
Figure 1. Identification of Switch Parts.

- c. Directly beneath the support plate are three contacts, spring loaded against the support plate. Carefully separate the support plate from the main switch assembly and remove the three contacts and springs (3 or 9).
- d. Retain the springs for use during reassembly. Discard old support plate and contacts.
- e. Inspect remainder of switch assembly for smoothness of operation

and check the rotor for any visible defects. If any faults are found, replacement of the complete switch assembly is recommended using Table III for replacement part number information.

B. To install a new Support Plate and Contacts, proceed as follows using Figure 1 as a guide for parts identification.

- a. Apply a light coating of Beacon P-290* non-conductive grease or equivalent to contact surfaces, contact wells in rotor and insulating surfaces over which contacts slide.
- b. Reinstall contact loading springs (3 or 9) in rotor. Position new contacts over springs so contacts will move into triangular recesses when pressure is applied.
- c. Locate boss on new support plate over locating slot in switch housing
