SERVICE LETTER

No. 667A

Piper Aircraft Corporation

Stabilator Attachment Bolts

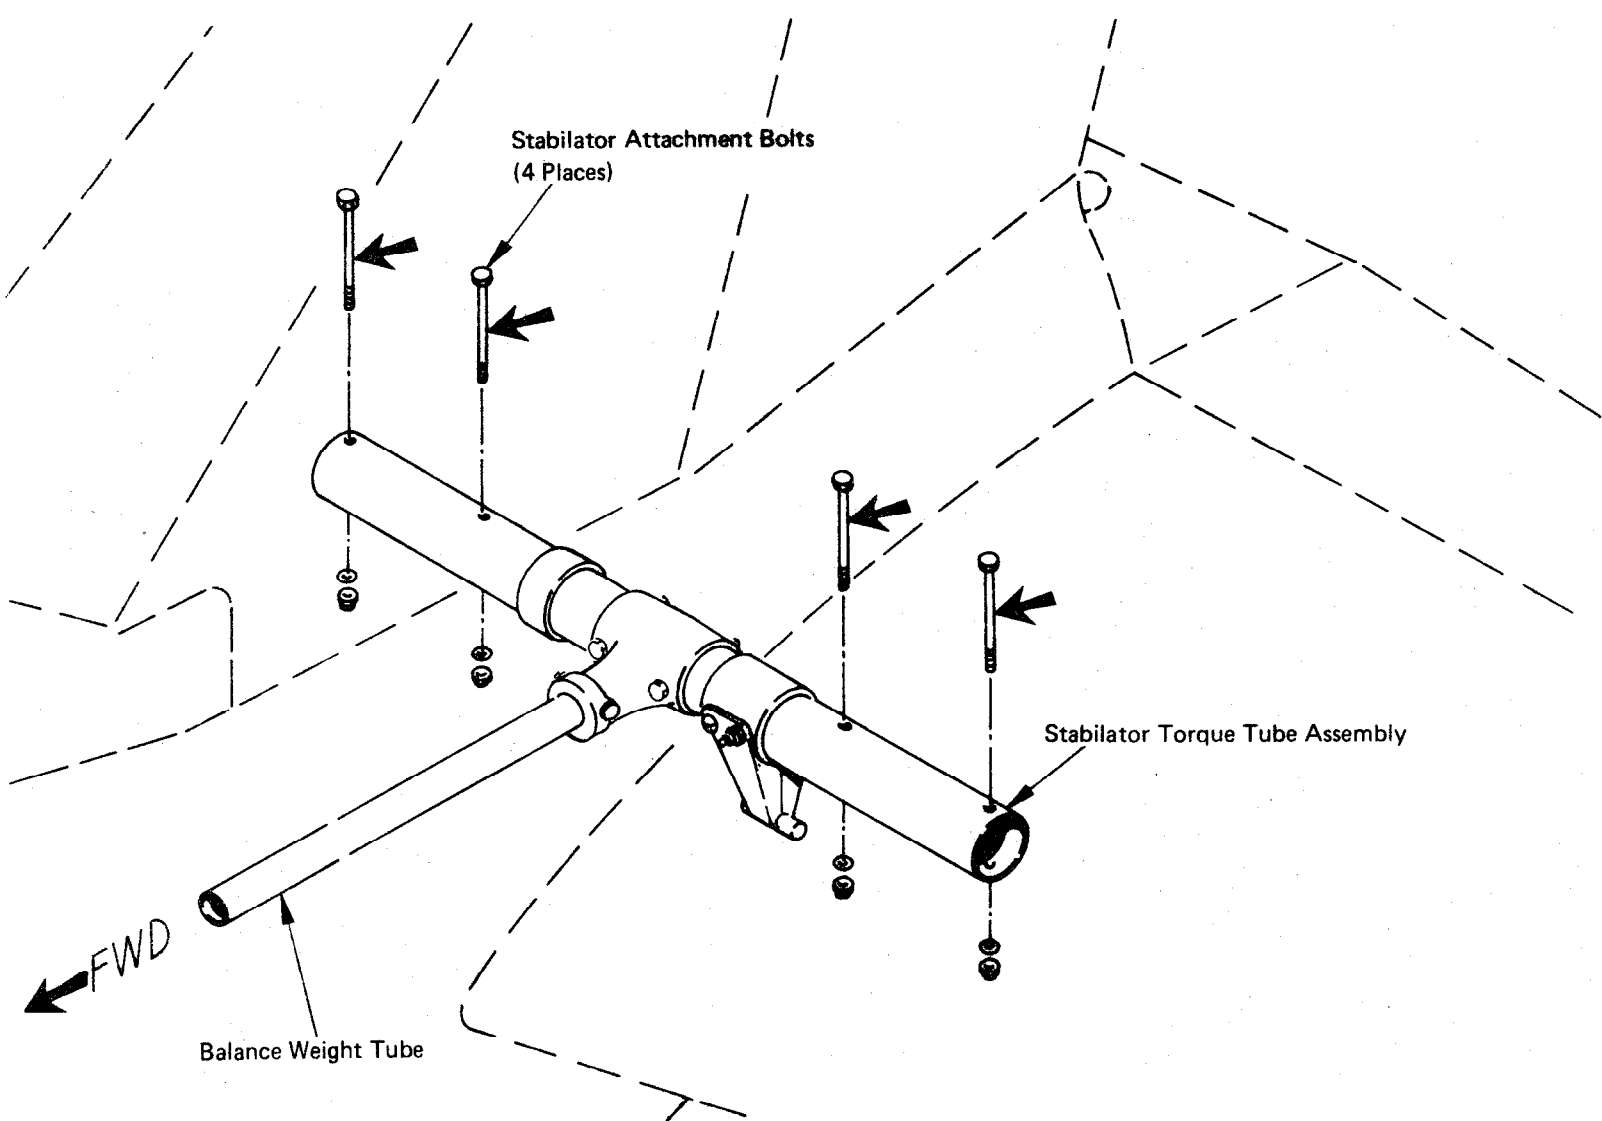
Stabilator Attachment Hardware

It has been determined that the stabilator attachment bolts on the above referenced aircraft may corrode. This situation has occurred primarily on high time aircraft at least five years old and/or operating in areas likely to induce corrosion -- near salt water, etc.

Remove existing stabilator attachment bolts, washers and nuts, indicated on sketch, and install new bolts and attaching hardware. **CAUTION:** Remove and replace one bolt at a time. Refer to sketch for correct replacement hardware identification and proper assembly of bolts, washers and nuts.

2. Correct torque value for bolts is as follows:

- a. PA-24-180/250 and 260 - torque to 30-40 inch lbs.
- b. PA-23-235/250/250 (Six Place) and PA-24-400 - torque to 60-85 inch lbs.
- c. PA-30 - Refer to the Twin Comanche Service Manual (Section 4 - paragraph 49) which states that the nuts ("holding the stabilator to the torque tube") should "be tightened just enough to take the play out of the washers."

Bolt AN174-C32A P/N 502 329 (Corrosion Resistant) or Bolt AN174-32A P/N 402 329 (Non-Corrosion Resistant)
Washer AN960-416L P/N 407 585
Nut MS20365-428C P/N 404 888

Bolt AN175-C32A P/N 502 342 (Corrosion Resistant) or Bolt AN175-32A P/N 402 342 (Non-Corrosion Resistant)
Washer AN960-516 P/N 407 566 (PA-23-235/250 and 250 Six Place only)
Washer AN960-516L P/N 407 586 (PA-24-400 and PA-30 only)
Nut MS20365-524C P/N 404 889
