SERVICE LETTER

No. 679

Piper Aircraft Corporation

Fuselage Aft Bulkhead Inspection

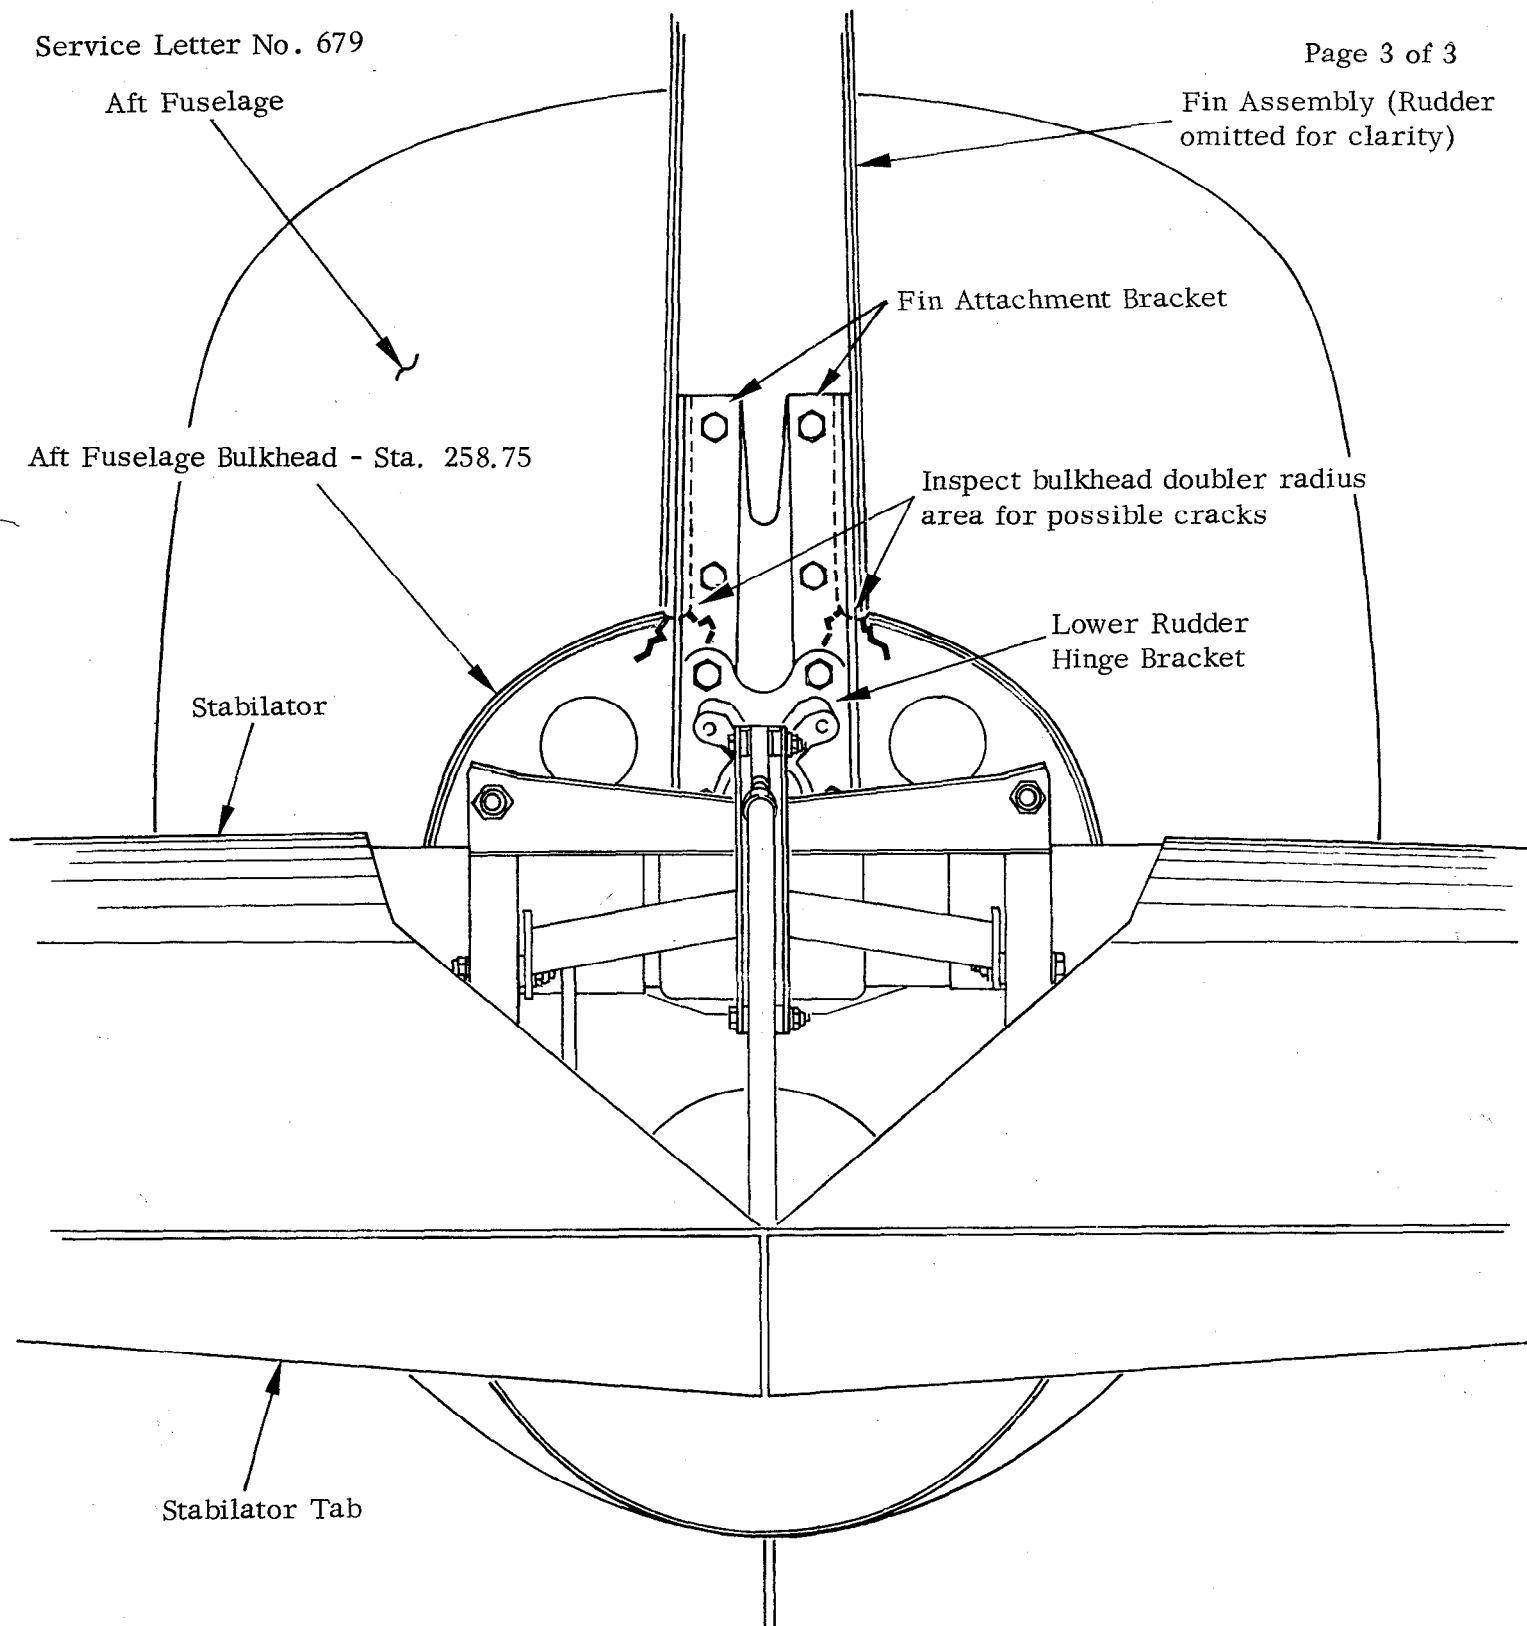
TYPICAL VIEW OF AFT FUSELAGE (LOOKING FORWARD)

To provide instructions to inspect the fuselage aft bulkhead doubler at fuselage station 258.75 in the area of the aft fin attachment brackets for evidence of cracks and to provide material and instructions to reinforce this area (1) if cracks are detected or (2) to alleviate the repetitive inspection requirements as stated in Compliance Time, above.

1. Remove tail cone fairing assembly from aft fuselage.
2. Carefully inspect bulkhead doubler on both sides of fin attachment brackets, as shown above, for evidence of cracks.
3. If cracks are detected, it will necessary to install the Fin Attachment Bracket Installation Kit P/N 760 783.
4. If cracks are not present, no further action is required at this time. (See Compliance Time.)
5. Reinstall tail cone fairing assembly.
