SERVICE LETTER

No. 777

Piper Aircraft Corporation

Fin Front Spar Modification.

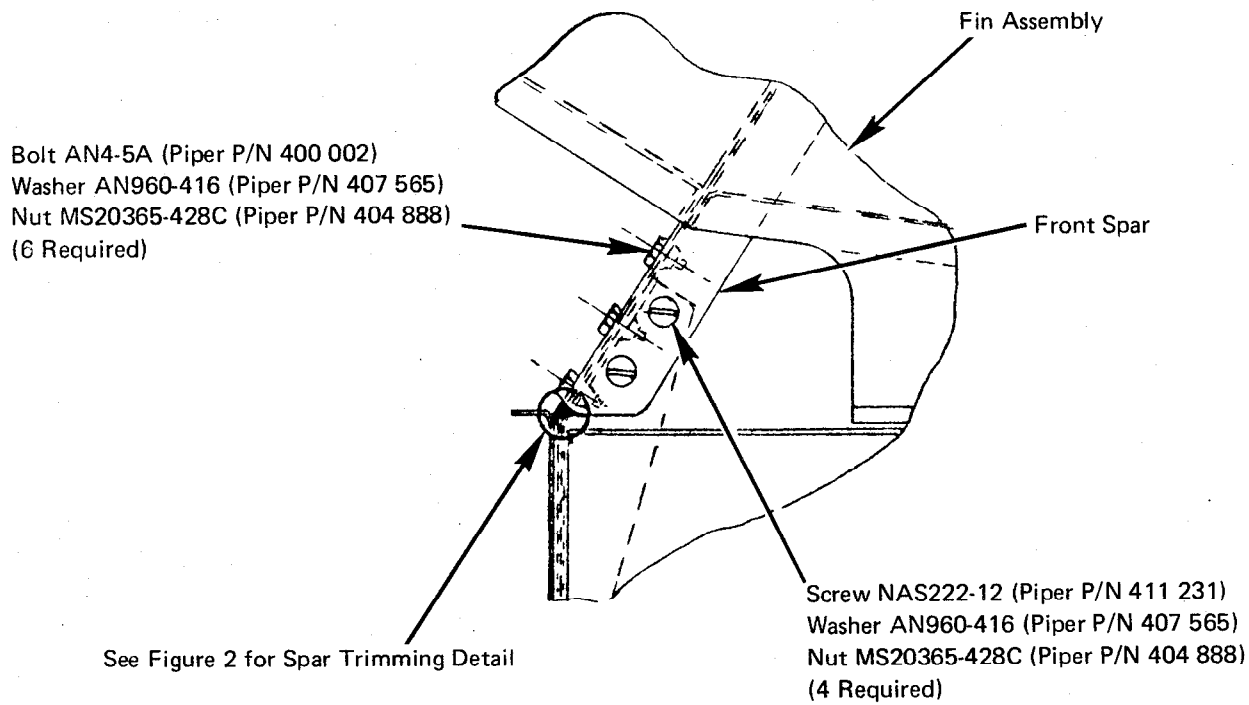
FIGURE 1

FAA Airworthiness Directive #75-12-06 dated June 5, 1976 required a repetitive inspection of the PA-24 Comanche series Fin Front Spar to Fuselage Attachment Channel bend relief holes for evidence of cracks; repair or replace cracked channels/straps if cracks are detected...etc. We have been advised that, in the near future, the FAA is planning a similar action relative to the PA-30 and PA-39 Twin Comanche series.

Since it is necessary to physically remove the Fin Assembly to gain visual access to the channel relief holes (as the Fin Front Spar extends over the relief holes approximately 1/2 to 2/3 of the relief hole diameter), this service release provides instructions to modify the Fin Front Spar to eliminate repetitive removal of the fin and to enable an easy visual inspection.

(FIN FRONT SPAR ATTACHMENT)

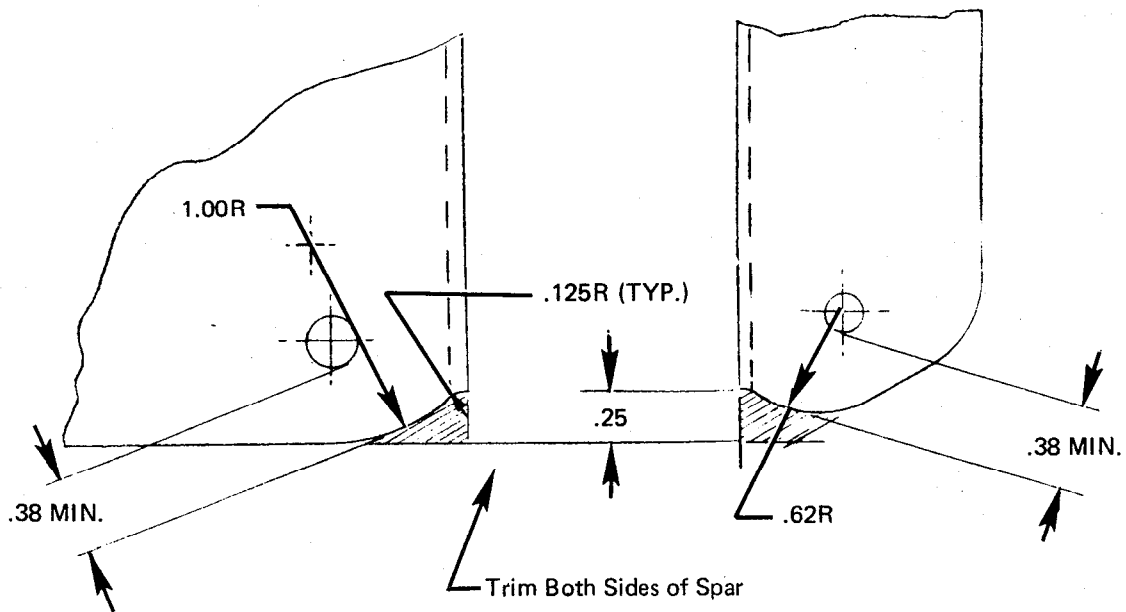
FIGURE 2

(SPAR TRIMMING DETAIL)

Refer to "Spar Trimming Detail" instructions on reverse side of this service release.
