MAJOR REPAIR AND ALTERATION (Airframe, Powerplant, Propeller, or Appliance)

N8842P

DISCRIPTION OF WORK PERFORMED: REPAIR TO REINFORCE CRACKED STRINGERS

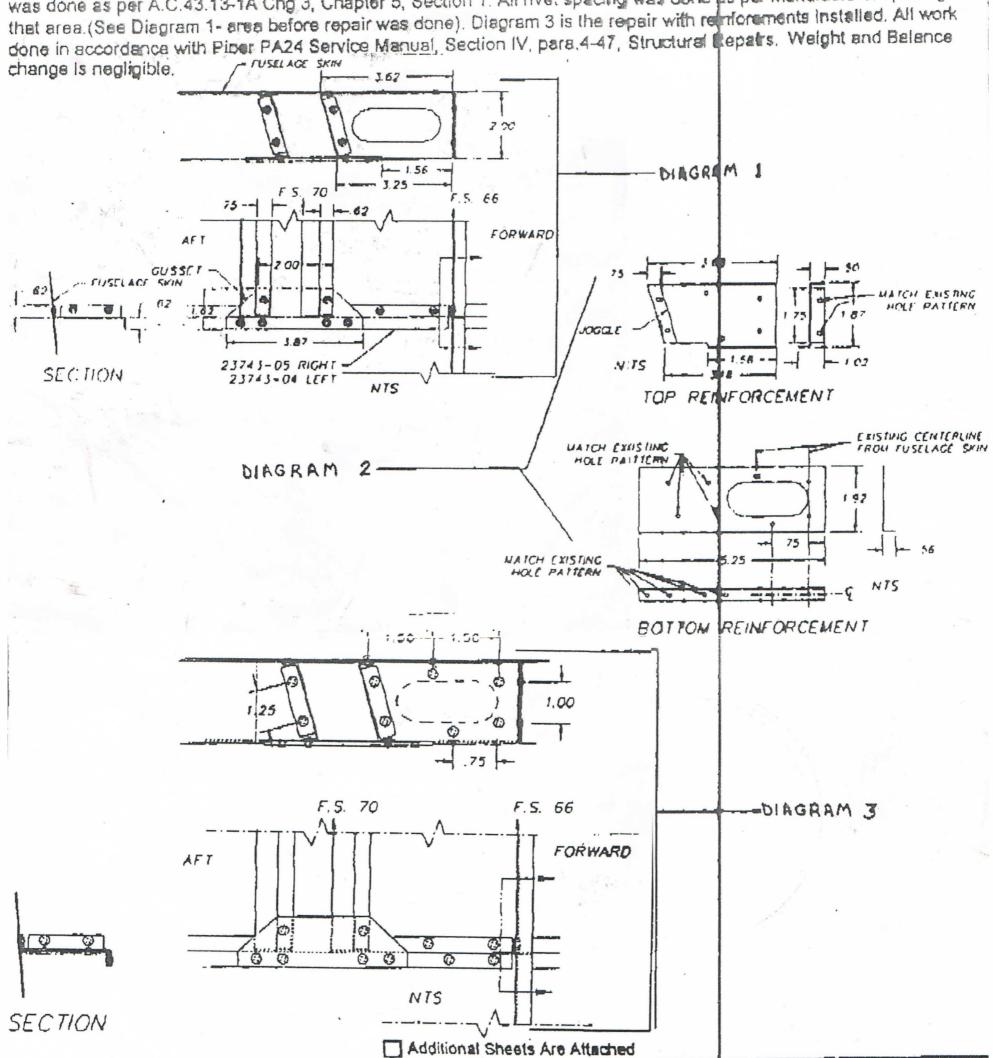
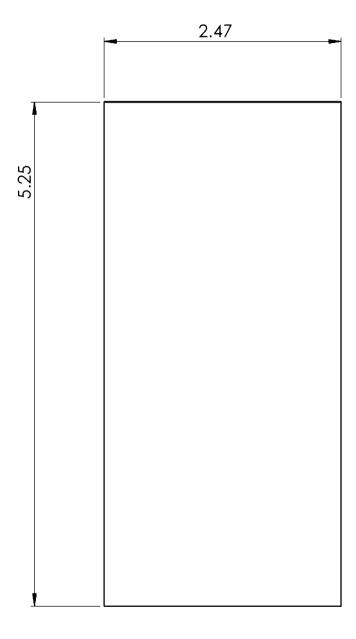
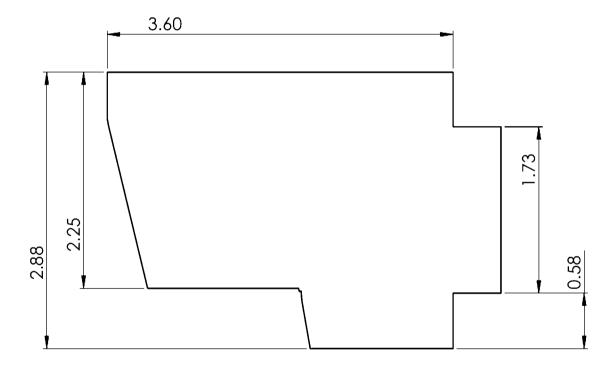
This repair was done to reinforce cracked stringers part numbers 23743-04 left and 23743-05 right, between bulkhead fuselage stations 66.0 and 70.0. The two, top and bottom, reinforcements(see diagram 2 below) are made from Alclad .040 2024 T3 Aluminum. Forming reinforcements was done as per A.C.43.18-1A Chg 3, Chapter 2, Section 3, pars. 97.a. The design of the repair was done as per A.C.43.13-1A Chg 3, Chapter 2, Figure 2.25; Pars. 100 for working with a stringer; and Paragraph 101 for repairing a cracked member. Treated reinforcements with zinc chromate before assembly. All riveting was done as per A.C.43.13-1A Chg3, Chapter 2, Section 3, Pars. 99. All hardware selection was done as per A.C.43.13-1A Chg.3, Chapter 5, Section 1. All rivet spacing was done as per manufacturer spacing in that area. (See Diagram 1- area before repair was done). Diagram 3 is the repair with reinforements installed. All work done in accordance with Piper PA24 Service Manual, Section IV, pars.4-47, Structural Lepatrs. Weight and Balance
