# SERVICE

NUMBER 164

# BULLETIN

MODEL AFFECTED: PA-24 Comanche

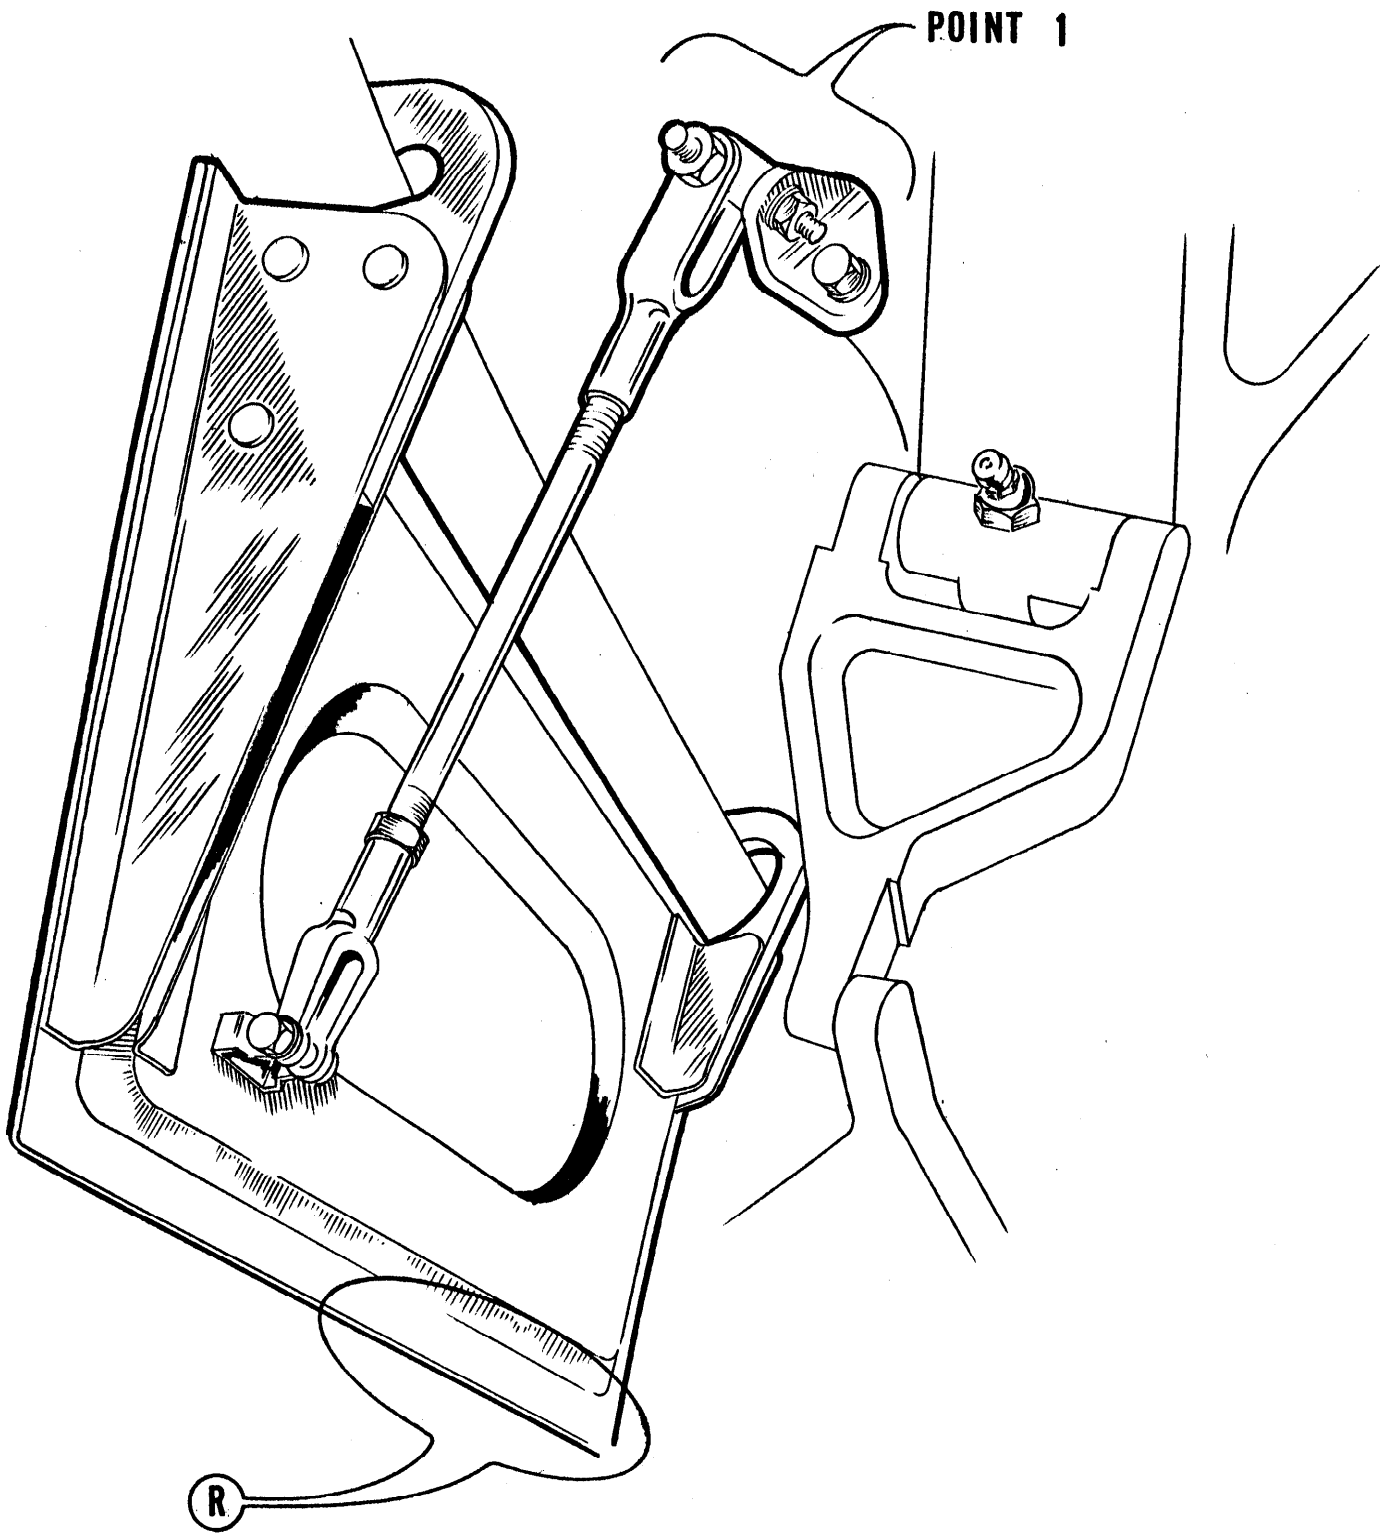
SKETCH "A"

To preclude the possibility of damage to the nose gear door, it is recommended that the door retraction rod attachment on serials 24-1 to 24-76 inclusive be inspected and changed, if necessary, per Sketch "A" and instructions attached to this bulletin. The lock nut for the upper rod end fitting for the retraction rod must be removed on aircraft serials 24-1 to 24-106 inclusive.

If nose gear door rubs the gear strut when retracting gear, trim rear edge of door with tin snips in area "R".

1. Place aircraft on jacks and tail pedestal. (300 lbs. ballast on pedestal.)
2. Check eye bolt at upper end of retraction rod at point 1.
3. If eye bolt is not installed as shown, remove and reinstall per sketch.
4. Remove upper rod end fitting and lock nut.
5. Replace upper rod end fitting.
- \*6. Disconnect lower end of rod from door assembly and back off upper rod end fitting approximately two (2) turns.
- \*7. Reinstall lower end of rod to door temporarily and retract landing gear.
- \*8. Keep adjusting the rod end fitting until the door closes flush with bottom cowl skin.
- \*9. Tighten lock nut on bottom rod end fitting and complete installation of rod end to gear door.
