# SERVICE BULLETIN

No. 280

Case leakage of R. C. Allen 3" Artificial Horizon  
(See attached R. C. Allen Inc., Service Bulletin No. 1.)

SERVICE BULLETIN  
FOR  
ARTIFICIAL HORIZON  
MODEL RCA 21

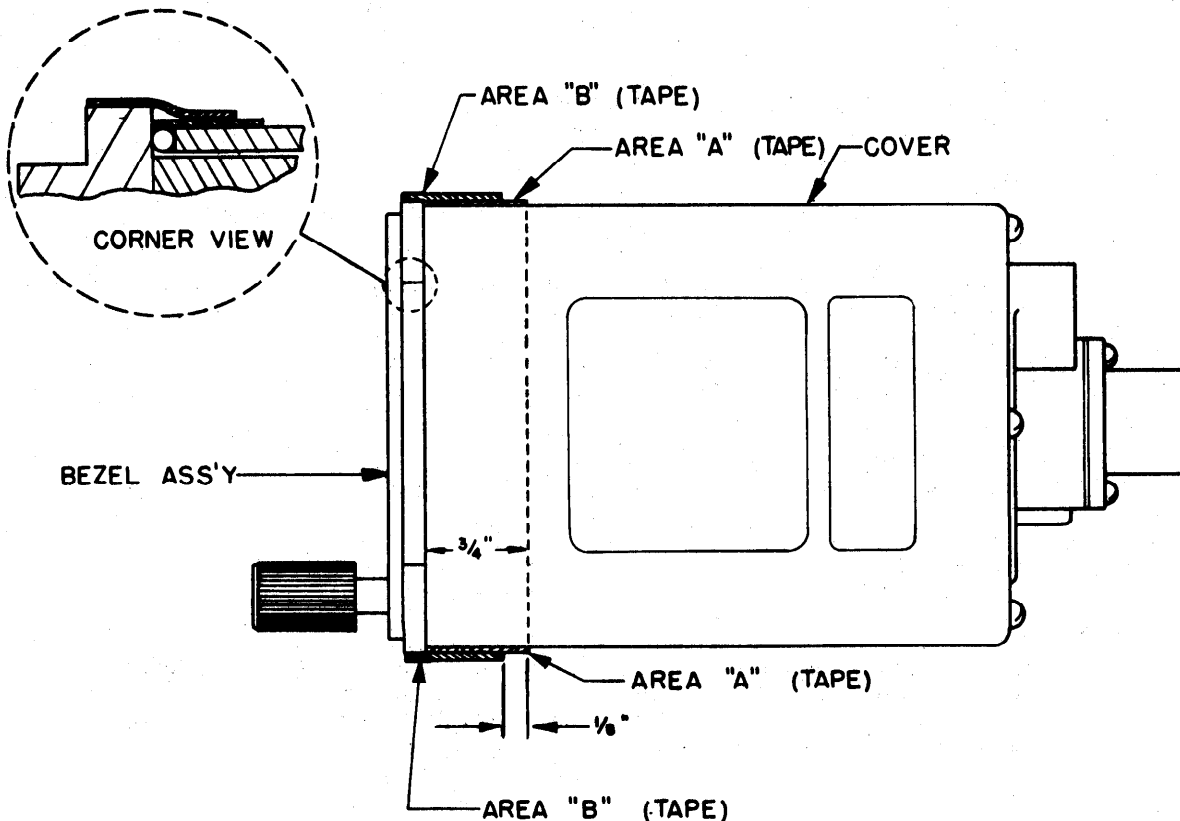
Figure 1. Application of Pressure Sensitive Tape.

Some deterioration of the gasket used to seal the case to the bezel has been experienced. Such deterioration may occur due to the action of ozone and/or the action of certain solvents to which the gasket may have been exposed. If not corrected, the deterioration may result in leaks which can lead to reduction of vacuum system pressure, sluggish horizon performance and eventually complete failure of the gyro system.

2. Refer to Figure 1 and apply one wrap of pressure sensitive tape, 3/4 inch wide, around the horizon as shown in Area "A". Pull the tape as it is being applied so that a slight amount of stretching occurs. The edge of the tape must butt against the rear surface of the bezel assembly and lay firmly against the cover. Overlap the tape approximately two inches.

3. Again refer to Figure 1 and apply one additional wrap of the tape over that just applied as shown in Area "B". Apply this wrapping so that the edge of the tape is flush with the front surface of the bezel assembly. Stretch as required so that the tape lays smoothly around the irregular corners of the bezel. Overlap the tape approximately two inches.
