SERVICE BULLETIN

No. 464A

Piper Aircraft Corporation

Inspection of Stabilator Torque Tube Bearing Block Attachment Fitting Rivets.

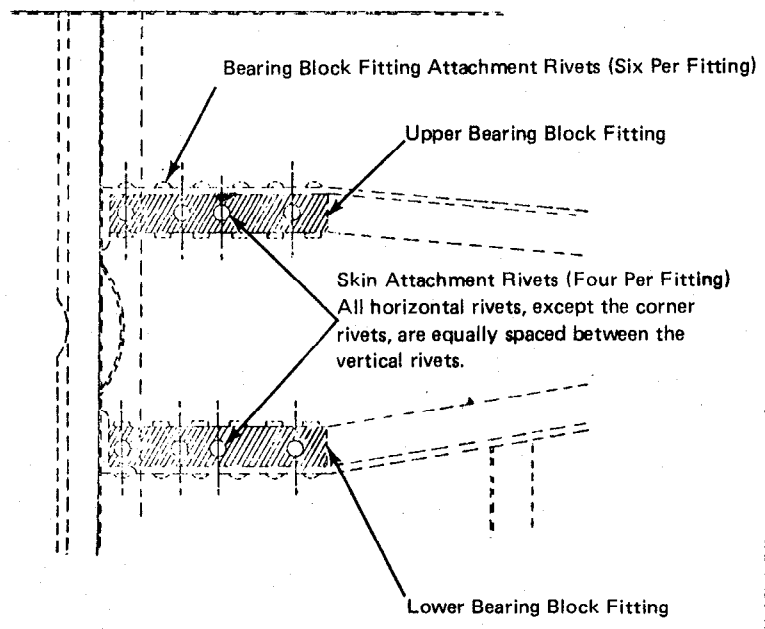
VIEW A-A: CORRECT RIVET ALIGNMENT

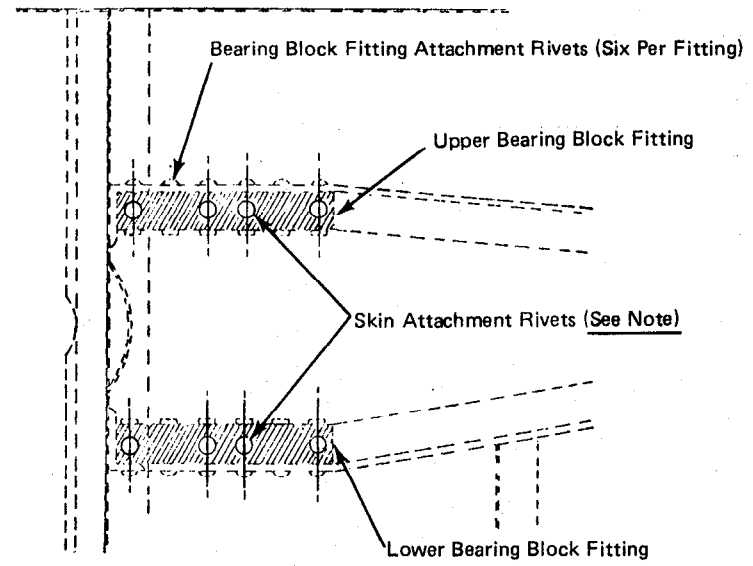
Stabilator Bearing Block Attachment Fitting Rivets (see sketch for an illustration of this condition).

VIEW A-A: RIVET ALIGNMENT which may have resulted in rivet penetration:

NOTE: All horizontal rivets, except the corner rivets, are incorrectly installed in this view as they are aligned with the vertical rivets. If more than two rivet alignments are evident in each fitting, it will be necessary to install Kit 760 835.

1. One (1) each PER FITTING (i.e., each kit contains sufficient material to modify one only Stabilator Torque Tube Bearing Block Fitting), Piper Kit Number 760 835, Hi Shear Rivet Replacement, if required per Instructions number 3, above.
2. Two (2) each per aircraft Cover Plate, Part Number 28216-02, if installation of Kit 760 835 is required per Instructions number 3, above.
