SERVICE LETTER

No. 623

Piper Aircraft Corporation

Subject: Inspection of Rajay Alternate Air Valve Bracket

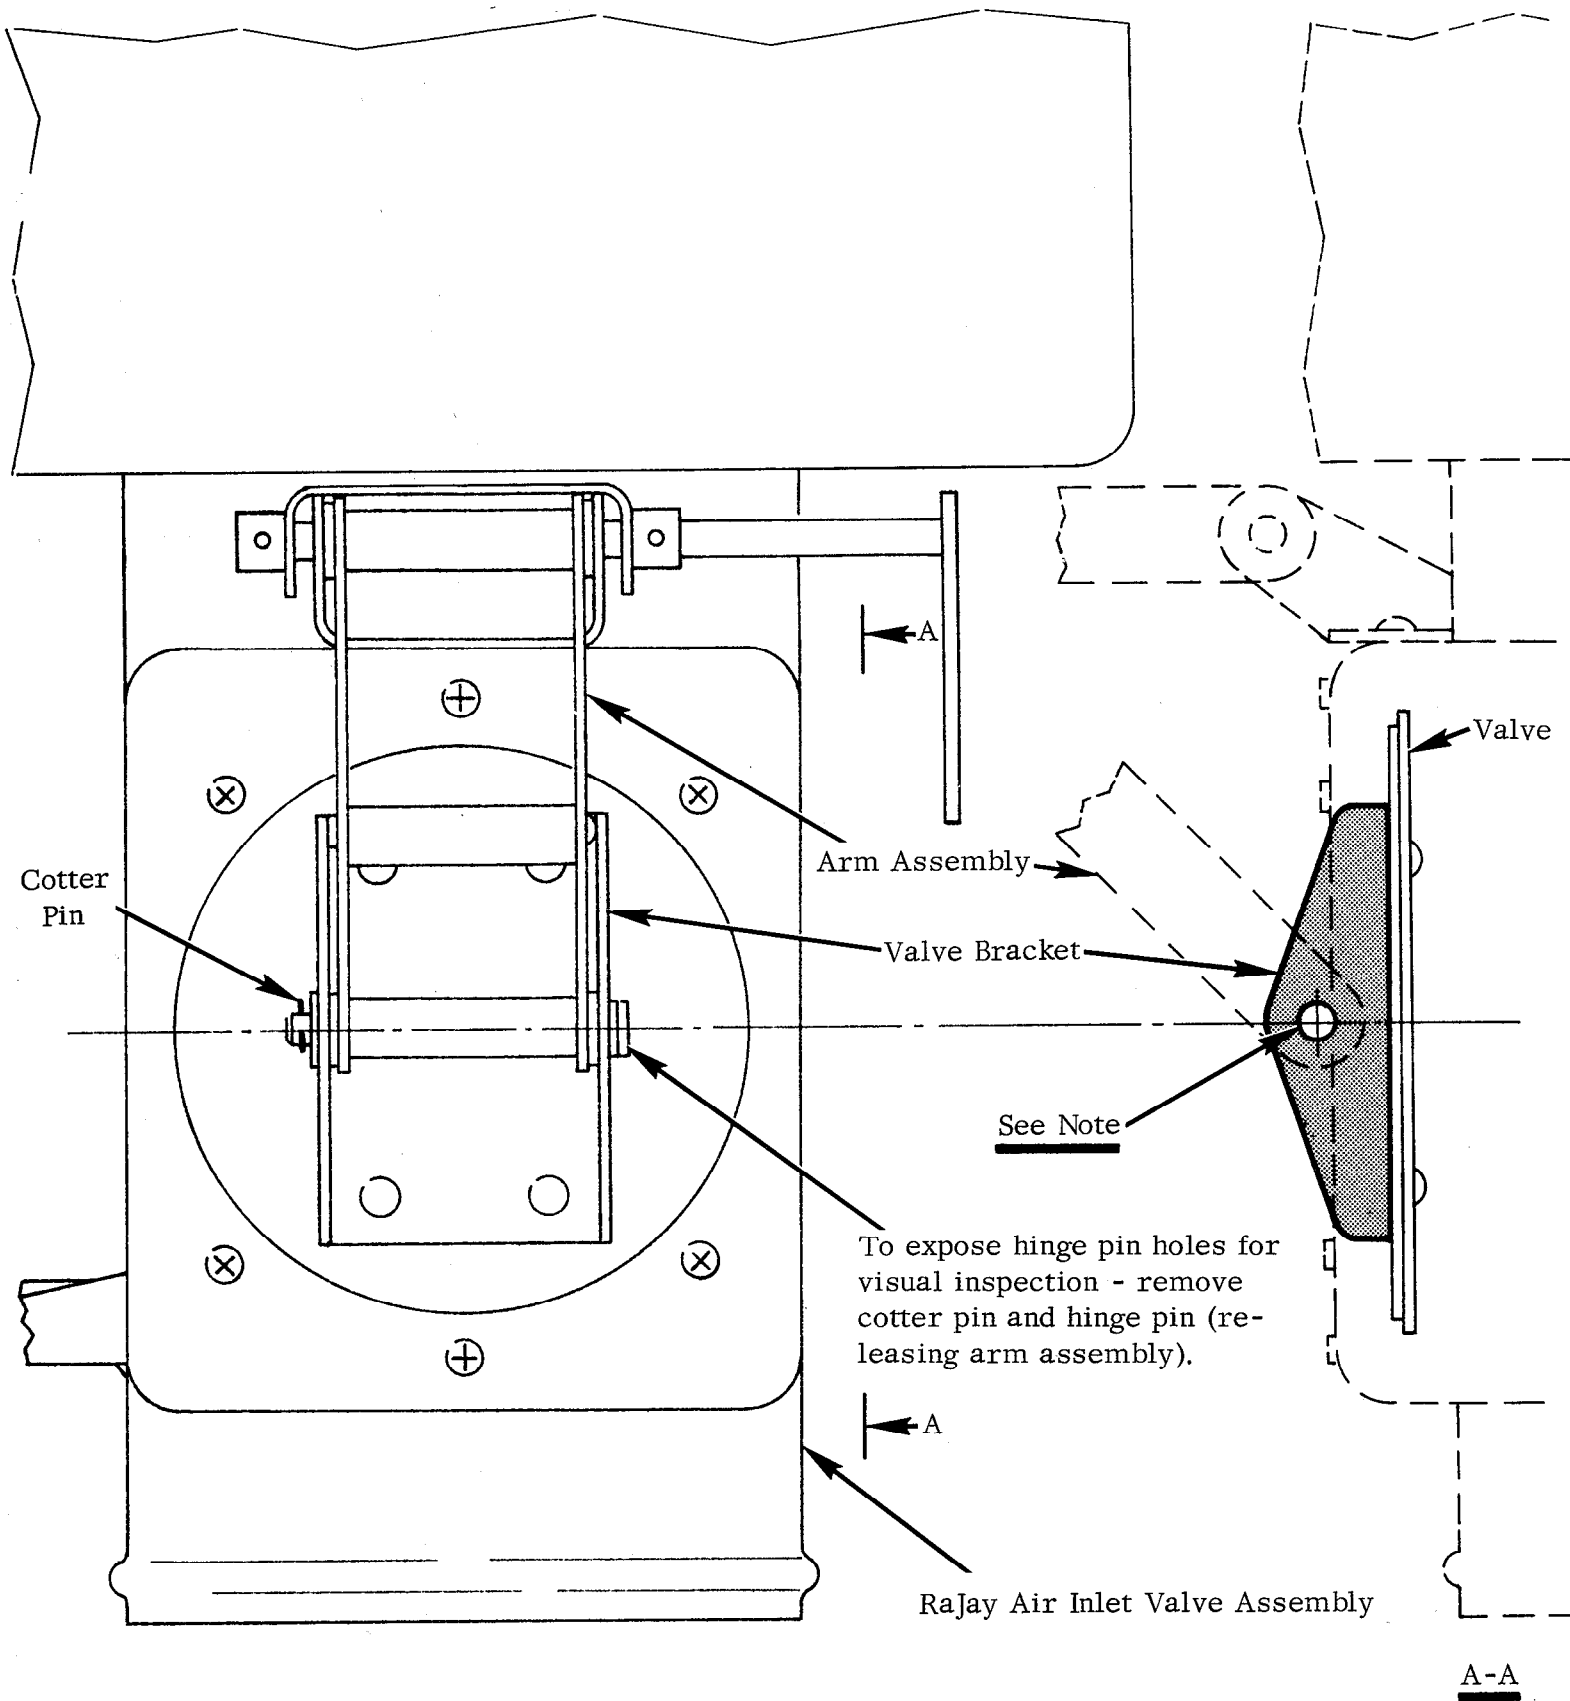
A survey of field reports recently received indicates that the alternate air inlet valve brackets with brass reinforced hinge pin holes are also subject to wear.

NOTE - Inspect Rajay Alternate Air Inlet Valve Bracket hinge pin holes (2) for wear elongation exceeding 1/16 inch. Replace if required with new alternate air inlet valve and bracket assembly Rajay Part No. RJ0605-5/-71.

1. Gain access to the engine air inlet filter assembly in accordance with PA-30/39 Service Manual Section VIIIA, paragraph VIIIA 27 through 31 inclusive.
2. Inspect alternate air inlet valve bracket hinge pin holes for excessive wear, as evidenced by hole elongation exceeding 1/16 inch. Should elongation exceed 1/16 inch, replace alternate air inlet valve and bracket assembly.
