MAJOR REPAIR AND ALTERATION (Airframe, Powerplant, Propeller, or Appliance)

N8842P

DISCRIPTION OF WORK PERFORMED: REPAIR TO REINFORCE CRACKED STRINGERS

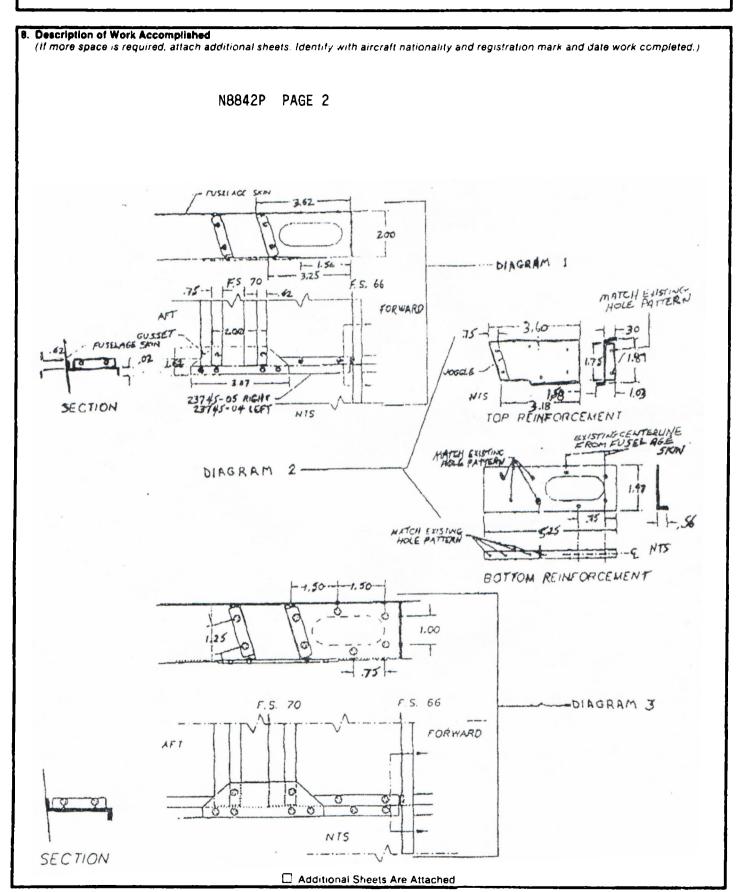
This repair was done to reinforce cracked stringers part numbers 23743-04 left and 23743-05 right, between bulkhead fuselage stations 66.0 and 70.0. The two, top and bottom, reinforcements(see diagram 2 below) are made from Alclad .040 2024 T3 Aluminum. Forming reinforcements was done as per A.C.43.18-1A Chg 3, Chapter 2, Section 3, pars. 97.a. The design of the repair was done as per A.C.43.13-1A Chg 3, Chapter 2, Figure 2.25; Pars. 100 for working with a stringer; and Paragraph 101 for repairing a cracked member. Treated reinforcements with zinc chromate before assembly. All riveting was done as per A.C.43.13-1A Chg3, Chapter 2, Section 3, Pars. 99. All hardware selection was done as per A.C.43.13-1A Chg.3, Chapter 5, Section 1. All rivet spacing was done as per manufacturer spacing in that area. (See Diagram 1- area before repair was done). Diagram 3 is the repair with reinforements installed. All work done in accordance with Piper PA24 Service Manual, Section IV, pars.4-47, Structural Lepatrs. Weight and Balance

THE TWO, TOP AND BOTTOM REINFORCEMENTS ARE MADE FROM ALCLAD .040 T3 2024 ALUMINUM. FORMING REINFORCEMENTS WERE DONE PER AC 43 13-1A CHAPTER 4, FIG. 4-17 PARA 4-58 K THRU I. AND PARA 4-59 A & B REPAIR OF CRACKED MEMBER. REINFORCEMENTS WERE TREATED WITH ZINK CHROMATE BEFORE ASSEMBLY. RIVITING WAS PERFORMED PER AC 43 13 1A CHAPTER 4, PARA 4-57 B,C,&E. RIVIT SPACING
