SERVICE BULLETIN

No. 464A

Piper Aircraft Corporation

Inspection of Stabilator Torque Tube Bearing Block Attachment Fitting Rivets.

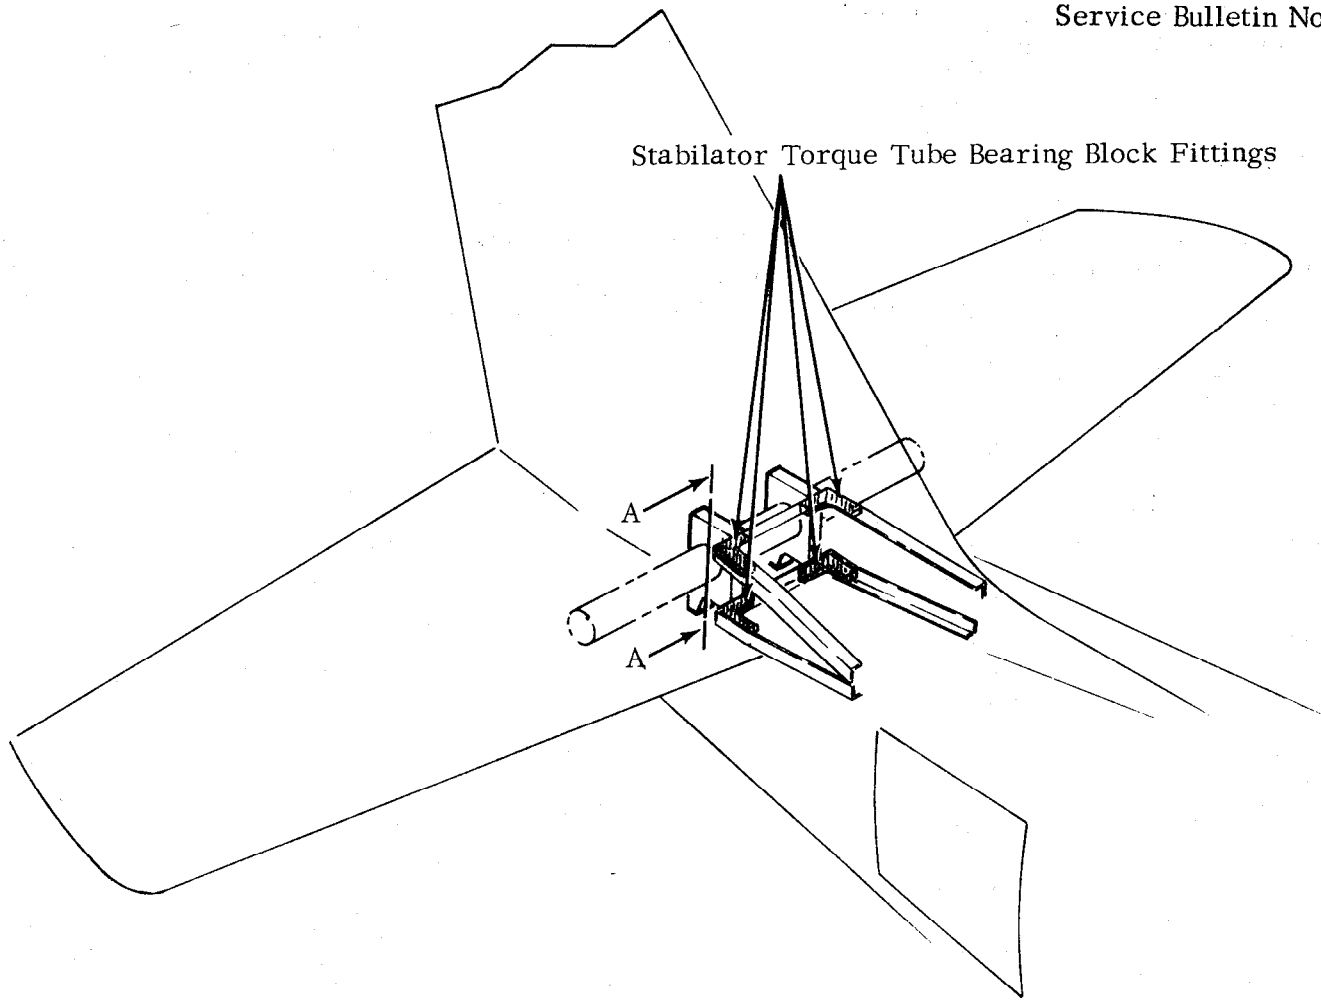
Stabilator Bearing Block Attachment Fitting Rivets (see sketch for an illustration of this condition).

A study was conducted to determine the significance of the above described condition. It was subsequently determined that the rear corner rivet in the bearing block fitting (which is most susceptible to drill penetration) is redundant to the structural integrity of the fitting assembly, and also that one additional rivet located in the bearing block could be removed without reducing the strength of the assembly below an acceptable value. However, if more than two rivets per fitting (described above) have been penetrated during the drilling operation, it will be necessary to install one (1) each per fitting Piper Kit Number 760 835, Hi Shear Rivet Replacement, and install bolts (per kit instructions) in place of the existing rivets in those bearing blocks which contain more than two rivets penetrated during drilling.
