US Department of Transportation Federal Aviation Administration		MAJOR REPAIR AND ALTERATION (Airframe, Powerplant, Propeller, or Appliance)		OMB No. 2120-0020 Exp. 5/31/2018	Electronic Tracking Number
		For FAA Use Only

1. Aircraft	Nationality and Registration Mark XXXXXXXXXXXXXXXXXXXX	Serial No. MC-392	
	Make Beech Aircraft Corp.	Model B24R	Series 24
2. Owner	Name (As shown on registration certificate) XXXXXXXXXXXXXXXXXXXX X	Address (As shown on registration certificate) Address XXXXXXXXXXXX City <u>Cincinnati</u> State <u>OH</u> Zip <u>45251</u> Country <u>USA</u>

4. Type		5. Unit Identification			
Repair	Alteration	Unit	Make	Model	Serial No.
<input type="checkbox"/>	<input checked="" type="checkbox"/>	AIRFRAME	<u>Beech Aircraft Corp.</u>	<i>(As described in Item 1 above)</i>	<u>MC-392</u>
<input type="checkbox"/>	<input type="checkbox"/>	POWERPLANT			
<input type="checkbox"/>	<input type="checkbox"/>	PROPELLER			
<input type="checkbox"/>	<input type="checkbox"/>	APPLIANCE	Type		
			Manufacturer

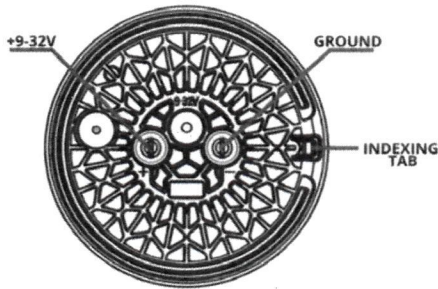
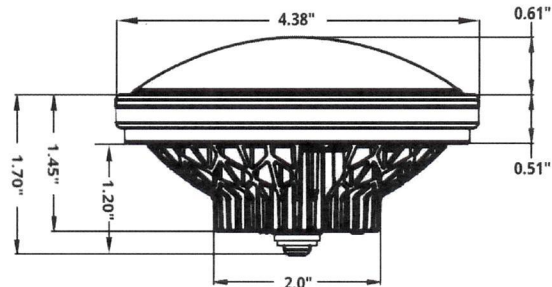
PART #	STYLE	Application	Beam	Weight	Voltage	Input Current
PAR36L204	PAR 36	LANDING/SPOT	10° x 10°	0.70 lbs.	+9-32VDC	2.80a @ 14VDC / 1.45a @ 28VDC (max)
PAR36TR4	PAR 36	TAXI/LINEAR FLOOD	45°X 15°	0.70 lbs.	+9-32VDC	2.80a @ 14VDC / 1.45a @ 28VDC (max)

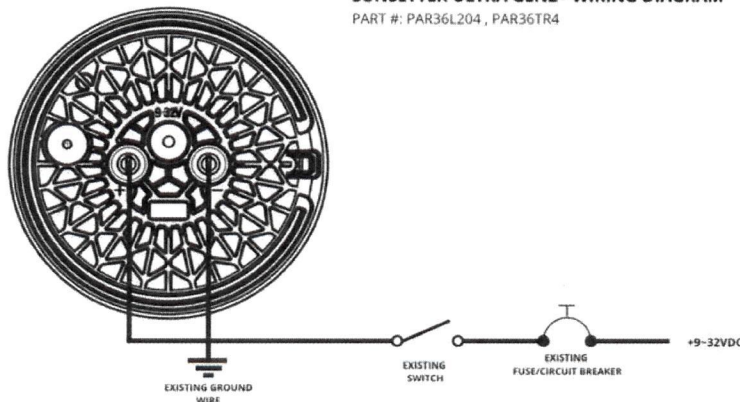
SUNSETTER ULTRA GEN2 - WIRING DIAGRAM

PART #: PAR36L204, PAR36TR4

1. Verify your currently installed lamp is a PAR 36 / 4.5" diameter sealed beam lamp.
2. Verify power is removed from the circuit before attempting installation.
3. Remove existing lamp from fixture (retain all hardware for reassembly) and disconnect both wire leads from lamp.
4. Verify that the wire size is sufficient for the current load of the replacement LED lamp.
5. Install the leads onto the LED bulb with provided 8-32 machine screws such that the power wire is attached to the terminal marked "+", and the ground wire to the terminal marked "-".

NOTE: The lamp will not sustain damage if wired in reverse; however it will not illuminate.

- LED does not illuminate when power applied:
Verify polarity of power and ground leads. *LED will not illuminate in wired reverse polarity.
- Polarity verified but LED does not illuminate:
Use a volt meter to verify voltage measured at "+" terminal is >12VDC and < 30VDC. Verify "-" terminal has continuity to circuit ground.
- Input voltage and polarity verified but LED does not illuminate.
Remove LED and test on bench with 12/28VDC power source. If LED fails to illuminate, replace with new.
